RAILWAY INVESTIGATION REPORT

R01H0005

DERAILMENT

OTTAWA VALLEY RAILWAY

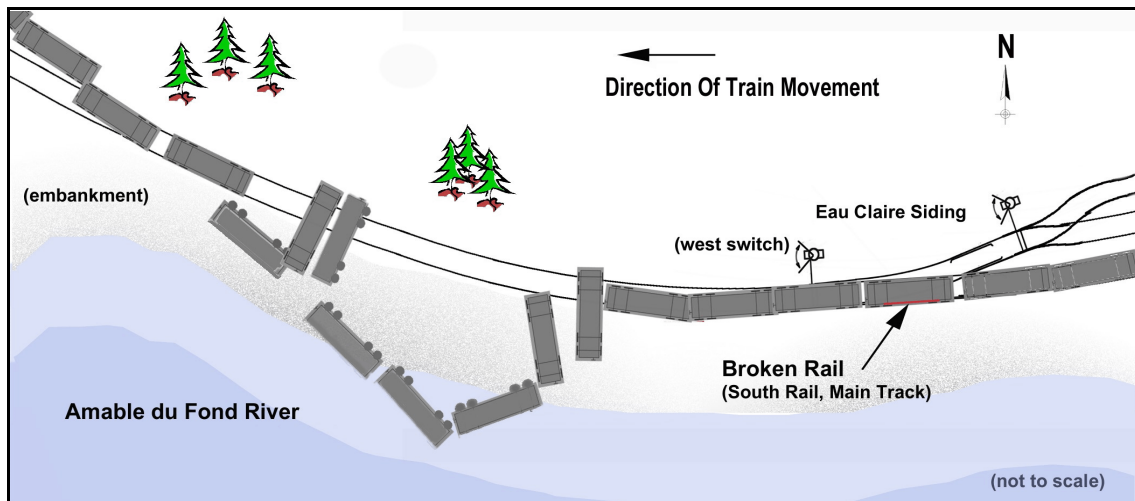
On 11 March 2001, train No. 301-043 (the train) departed Canadian Pacific Railway (CPR) Saint-Luc Yard (Montréal, Quebec) for Coniston, Ontario. At Smiths Falls, Ontario, the train was transferred to the Ottawa Valley Railway (OVR) and proceeded westward on the OVR North Bay Subdivision. At Mile 85.0, near Bonfield, Ontario, the train experienced a train-initiated emergency brake application. After conducting the necessary emergency procedures, the crew members determined that 14 cars (68th to 70th and 72nd to 82nd) had derailed. The derailed cars included one empty hopper car and three residue Class 111A tank cars (methanol, UN 1230) which rolled into the Amable du Fond River (see Figure 1). None of the cars was breached and no product was lost.

Figure 1. Overall view of occurrence site

Approximately 500 feet (152 m) of track and a switch were destroyed. Two cars were destroyed and 11 cars sustained damage.

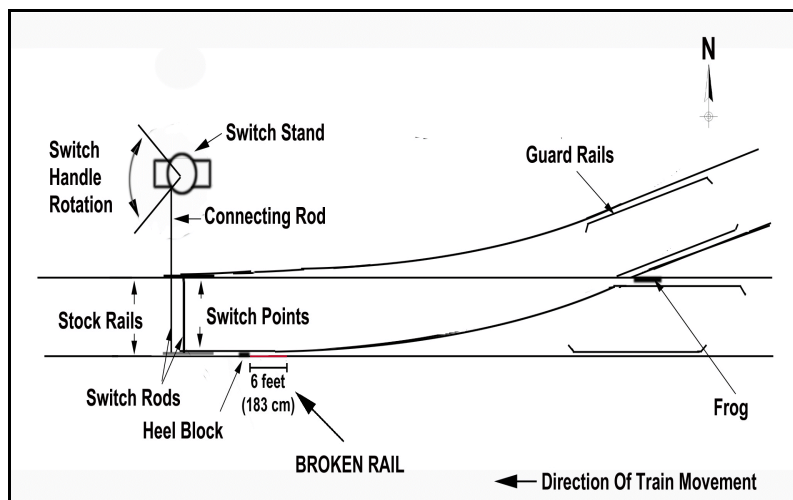
In the vicinity of the derailment, the track was adjacent to the Amable du Fond River and was oriented in an east-west direction. The derailment occurred in a 3-degree, 45-minute curve, near the west end switch of the Eau Claire siding (see Figure 2). The tie plates were secured with 8 spikes per tie in the turnout, and 10 spikes per tie in the rest of the curve. Several rail joints, within a short span, were present on the track east of the switch. The main track stock rail, on the west-end switch, was broken into many pieces over a distance of approximately 6 feet (183 cm). The break extended westward, from a bolt hole located 10 inches (25 cm) west of a rail joint, to the switch point heel block. The rail ends at the joint were battered and exhibited material flow.

Figure 2. Location of the broken rail

The OVR relocated the Eau Claire turnout from its location in curved track onto tangent track.

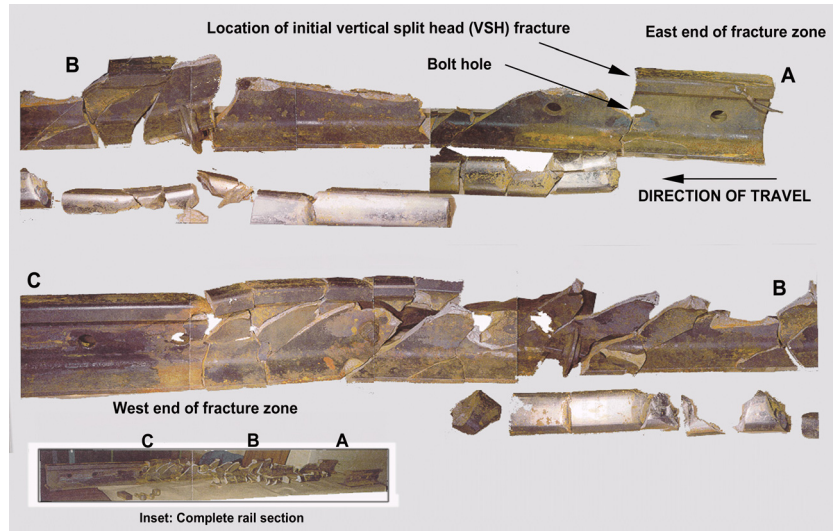
- The rail was made of chromium alloy.¹
- The ultimate tensile strength (UTS) of the rail averaged 165 000 psi, while its elongation was 9.0 per cent. The minimum rail properties specified by CPR are 155 000 psi for UTS and 9.0 per cent for elongation.
- The resistance of the rail to breakage, measured using Charpy impact testing, was 2 to 3 foot-pounds.
- The break occurred 10 inches (25 cm) from the rail joint, through a bolt hole (see Figure 3). The rail head had broken along the centre line consistent with a vertical split head (VSH) fracture.
- Chevron markings indicated that the fractures initiated from the top of the rail surface.
- No long-term cracking was observed, indicating that the VSH fracture was recent.

Figure 3. Composite photo of broken rail showing location of initial VSH fracture (top right), and overall fracture pattern

The rail head broke along the centre line, consistent with a VSH fracture initiated from the top of the rail surface. As the fracture was recent, it was not detected by the ultrasonic rail flaw detection test performed seven months prior to the derailment.

The Charpy impact test values and elongation results for the broken rail indicated a low fracture toughness and rail ductility. These results are consistent with other chromium alloy rail properties, and indicate that the ability of the rail to withstand high transient loads, particularly in cold weather, was limited. Therefore, it is likely that the stresses generated by the wheel R-1 impact load, combined with the tensile thermal stresses due to the low temperature, initiated the break in the main track rail.

1. The train derailed when the main track stock rail fractured as a result of a vertical split head fracture.
2. The frozen ground and the presence of several joints within a short span of track increased the stiffness of the track structure and reduced its damping effect, causing the rail to absorb the full wheel impact loading.
3. Low ductility and poor fracture toughness of the rail reduced the ability of the rail to withstand high transient loads.
4. Stresses generated by the impact loading from wheel R-1 of car CPWX 601303, combined with tensile thermal stresses due to the low temperature, initiated the failure of the main track stock rail.

The frequency of rail flaw detection on all main track rail has been increased to three times per year.

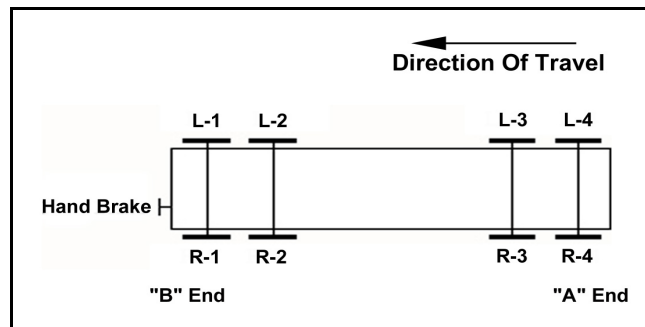
Figure 4. Car CPWX 601303–Wheels R-1 through R-4 travelled on the high rail

- All wheels exhibited built-up tread.
- The shells on wheel R-1 spread over a length of 5.75 inches (146 mm), a width of 1.6 inches (40 mm) and a depth of between 0.06 and 0.18 inches (1.6 and 4.5 mm). The shells on wheel L-2 spread over a length of 12 inches (300 mm), a width of 1.6 inches (40 mm) and a depth of between 0.056 and 0.16 inches (1.4 and 4.1 mm).
- The height of the wheel flange on wheels R-2 and L-2 was $1\frac{15}{16}$ inch (49.2 mm).
- Both wheel R-1 and wheel L-2 contained a flat spot $2\frac{1}{2}$ inches (63 mm) long.
- The maximum out-of-round measurements were 0.115 inches (2.9 mm) for wheel R-1, 0.013 inches (0.51 mm) for wheel R-2, and 0.185 inches (4.7 mm) for wheel L-2.

Out-of-round and flat spot measurements for wheels R-1 and L-2 reached or exceeded Association of American Railroads (AAR) limits.² The flange height on wheels R-2 and L-2 exceeded both Transport Canada (TC) and AAR limits. Relevant AAR and TC allowable limits for freight car wheels are contained in Appendix A.

All examined wheels from car CPWX 601303 had built-up tread; moreover, wheel R-1 had a flat spot and an out-of-round condition exceeding AAR measurement limits. Such conditions would have resulted in high impact loads adversely affecting the rail and equipment. Furthermore, the frozen ground and the presence of several joints within a short span of track increased the stiffness of the track structure and reduced its damping effect, causing the rail to absorb the full wheel impact loading.

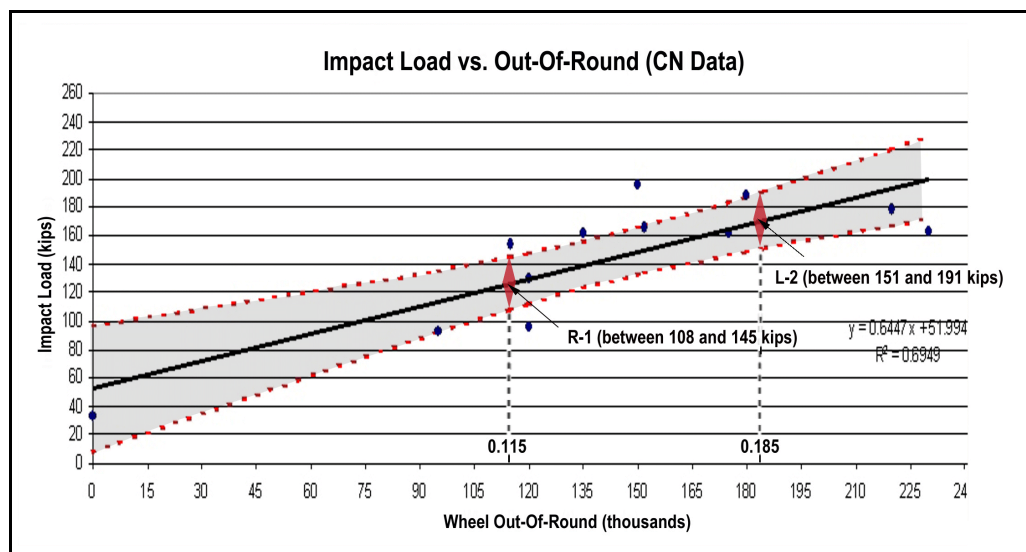
A 1994-1995 study established a correlation between WILD data and out-of-round wheel measurements. The impact loads generated by the wheels of car CPWX 601303 were interpolated using data from this study (see Figure 5). The interpolation shows that, when a 95 per cent confidence interval was used, the impact loads would have been between 108 and 145 kips (108 000 and 145 000 pounds) for wheel R-1 (out-of-round value 0.115), and between 151 and 191 kips (151 000 and 191 000 pounds) for wheel L-2 (out-of-round value 0.185).

Figure 5. Impact load values for wheel R-1 and wheel L-2 plotted against CN data. Shaded area between the dotted lines denotes the 95 per cent confidence interval.
