**RAILWAY INVESTIGATION REPORT
R01W0182**

MAIN-TRACK DERAILMENT

**CANADIAN PACIFIC RAILWAY
TRAIN 218-29
MILE 8.15, BROADVIEW SUBDIVISION
KEMNAY, MANITOBA
01 OCTOBER 2001**

Report Number R01W0182

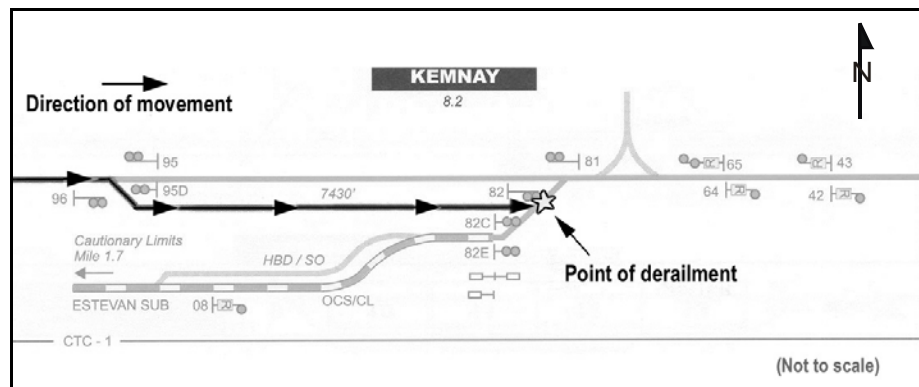
Figure 1. Point of derailment

Marks observed on the south rail head identified the point of derailment (POD) at approximately 10 feet 4 inches (3.15 m) east of the Estevan Subdivision junction switch point. The marks extended diagonally, from gauge to field side, along the top of the rail head for an additional 8 feet 6 inches (2.59 m) before marks on the ballast and tie ends appeared to the field side. Gouge marks were observed extending along the south rail gauge face, east of the POD. Wheel marks and tie damage continued eastward to the derailed cars at the west end of the site.

As the lead locomotive cleared the east-end switch, the train slowly accelerated from 14 mph to 25 mph, at which point it experienced a train-initiated emergency brake application and came to a stop as a result of the derailment. The first derailed car (CGLX 10481) remained upright on the track with the trailing truck derailed. The investigation determined that the lead wheel of the trailing truck (R-2) was the first wheel derailed to the field side of the south rail, approximately 10 feet 4 inches east of the Estevan Subdivision junction switch point.
