RAILWAY INVESTIGATION REPORT

R01M0024

MAIN TRACK DERAILMENT

VIA RAIL CANADA INC.

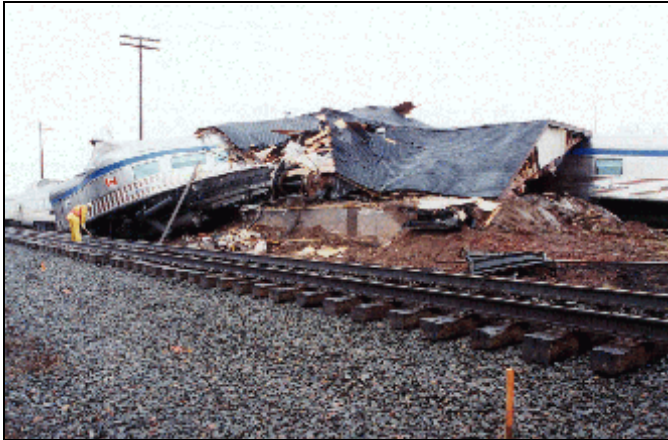
Figure 2 - Damage to diner car and farm supply building. Note foundation wall and roof of building in centre of photograph.

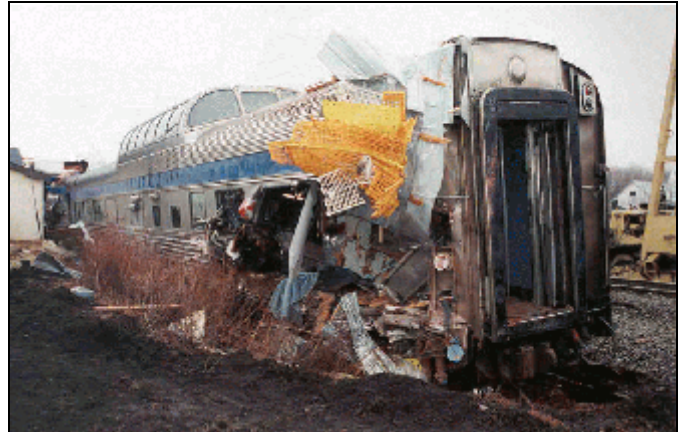
Figure 3 - Damage to Skyline car due to contact with the foundation wall of farm supply building.

Twenty people were transported by ground ambulance to the Colchester Regional Hospital in Truro² and two were airlifted from the site by air ambulance and taken directly to the Halifax Infirmary - Queen Elizabeth II Hospital in Halifax. Nine of the twenty-two sustained serious injuries, including five on-train services (OTS) crew members. Several of the most severely injured persons were located in the heavily damaged Skyline and diner cars. A large piece of concrete from the foundation wall of the farm supply building was sheared off and projected into an occupied area of the Skyline car.

- The leading end of VIA 8503 (Skyline car) had struck the foundation wall of the farm supply building resulting in severe damage to the car. A piece of the foundation wall had been dislodged and entered the occupied compartment area of the car.

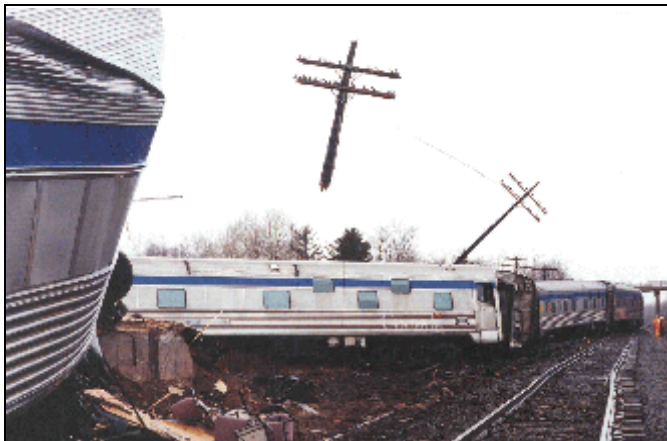
Figure 4 - View from diner car looking toward rear of train.

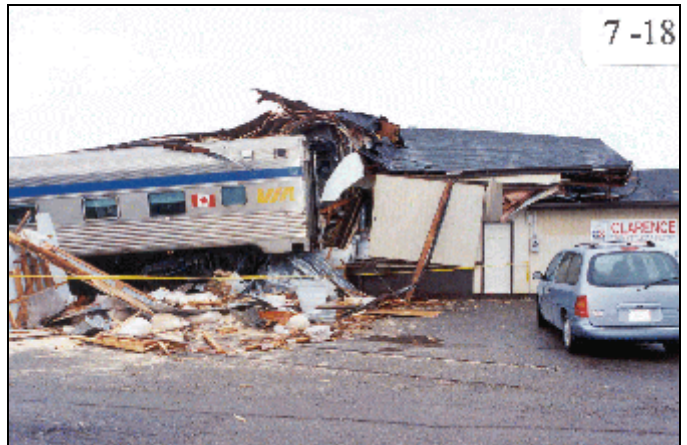
Figure 5 - Sleeper car and farm supply building.

- VIA 8225 (sleeper car) came to rest upright with its forward end within the damaged building. The car was roughly parallel to the main track.
- VIA 8206 (sleeper car) derailed and came to rest upright about 45 degrees to the main track.

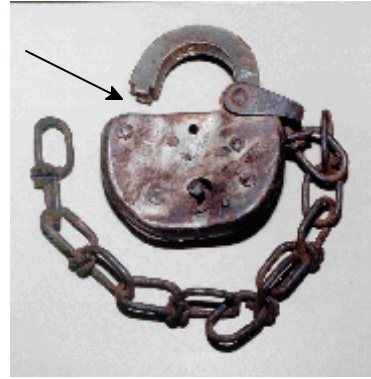
The switch stand was equipped with a standard CN switch lock (Figure 9). The clasp mechanism was broken and the switch lock was hanging loosely, suspended by the chain that affixes the lock to the switch stand. The lock had numerous dents and deformations (Figure 10).

Figure 10 - Damaged switch lock. Note broken clasp mechanism (arrow)

The cause of the accident was not a matter of dispute as the damages to the switch lock and chain were a clear indication that the switch was unsecured due to tampering. The Royal Canadian Mounted Police (RCMP) conducted a criminal investigation that led to a local youth pleading guilty to 'mischief endangering life'. As it is not the function of the TSB to assign fault or determine civil or criminal liability, the TSB investigation concentrated on all other aspects of the occurrence that would allow the further advancement of transportation safety.

1. Damage to the switch lock and chain were a clear indication that the TU-29 main track switch was unsecured due to tampering.
2. The train derailed when cars took a diverging route at the unsecured switch.
3. The presence of a standard switch lock on the TU-29 switch increased the risks associated with switch tampering due to vandalism.

Testing conducted by TSB indicated that a high-security switch lock would have been significantly less prone to damage or vandalism than the standard switch lock. To enhance safety and reduce the risk of vandalism, both CN and Canadian Pacific Railway reviewed their policies and practices regarding the installation of high-security switch locks. As a result, several thousand high-security switch locks were installed on all manually operated main track switches for both signalled and non-signalled territories. Priority was given to those locations with passenger train operations and those prone to vandalism. The applicable sections of the respective railway Standard Practice Circulars were revised accordingly to reflect the more stringent locking requirements.

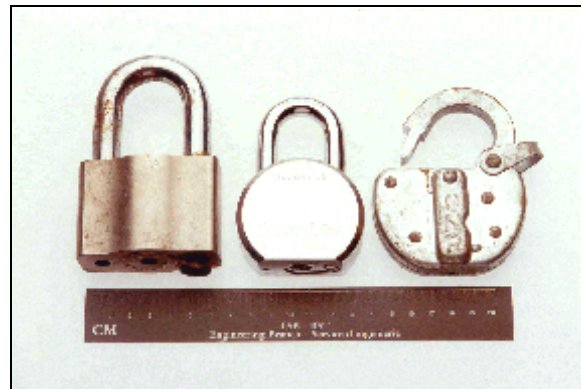
Figure 11 - High-security switch lock on left as compared to a standard switch lock on right. A case hardened lock (used in comparability tests) is shown in the middle.

A tensile test machine with adapters was used to measure the ultimate strength of the locks. The average failure load obtained during the tensile test was 2500 lbs for standard switch locks similar to the type involved in this accident versus 10 000 lbs for high-security locks;

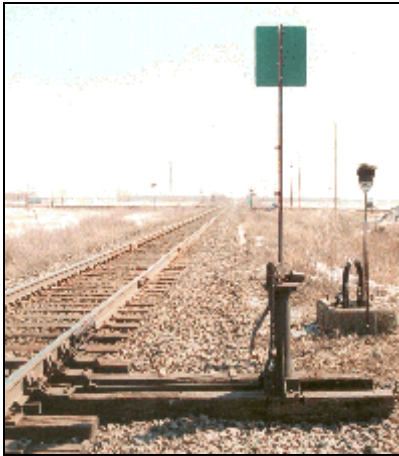
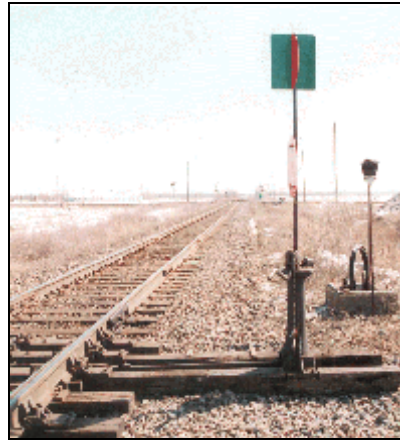
Lateral movement of the interconnected switch points, switch rod, and switch handle is required in order to rotate the switch stand mast and thereby display a red target and red tip assembly to an approaching crew, indicating that the switch is lined for the diverging route. However, when a switch stand handle is unlocked, or the switch points are even slightly open, the switch target will remain displaying a normal (e.g. green) indication, providing false information to an approaching train (figures 15 and 16).

Figure 15 - Switch target for a locked switch. Note lowered position of locked switch handle.

Figure 16 - Switch target for a switch that is slightly open. Note raised position of switch handle on unlocked switch and similarity of target to Figure 15.

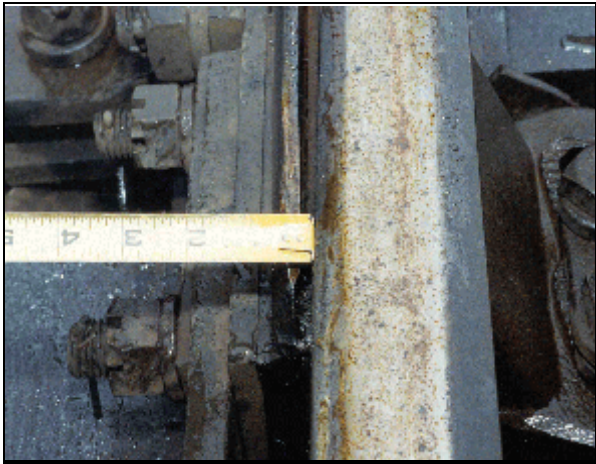
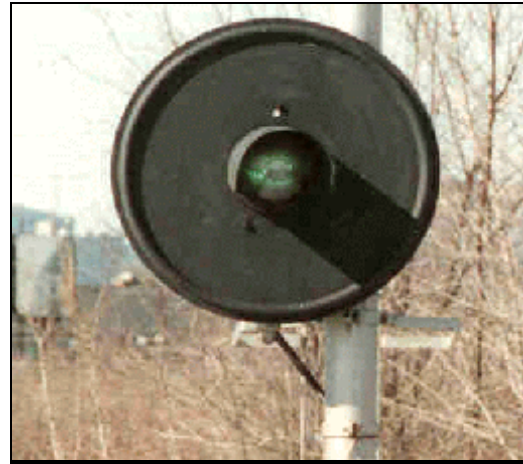
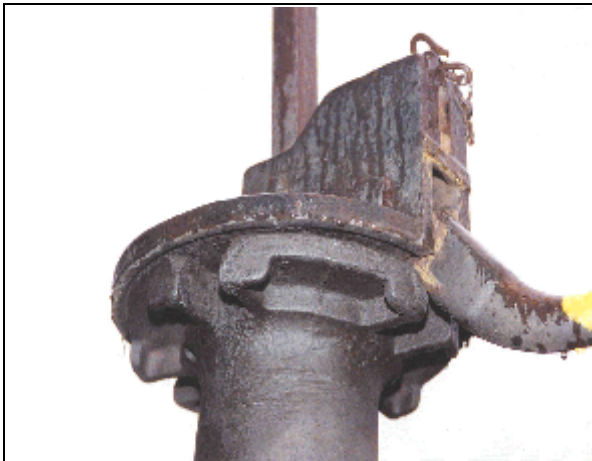
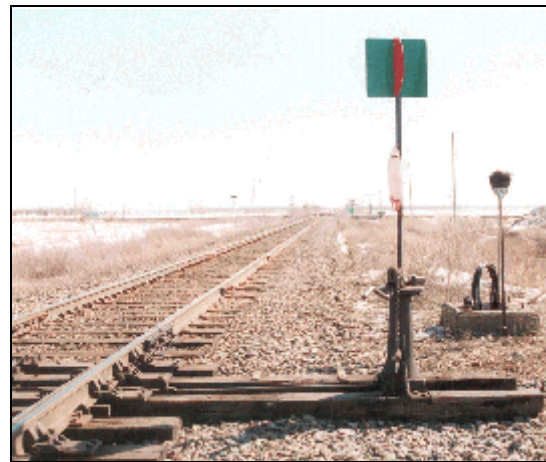
When the securement of a switch has been compromised, but the points have not moved 1/4 inch or more, the railway signal system continues to indicate to the crew of an approaching train that the switch condition is lined as intended. Also, should manually operated switch points be moved after a train has passed the last signal display location, the signal system does not communicate this change to the train crew. In such situations, an approaching train crew would be unaware of the unsafe switch position in front of them, as happened in this accident.

The lack of concordance between the information provided to the crew and the actual switch position resulted in the crew not being able to react to the unsafe condition (Figure 17).

Figure 17 - Top photographs show switch points open 3/16 inch yet a green CTC signal is displayed to a train crew. Bottom photographs show an unlocked and partially raised switch handle, yet a green switch target.
