RAILWAY INVESTIGATION REPORT
R01T0129

PEDESTRIAN FATALITY

CANADIAN NATIONAL
TRAIN NO. Q-143-31-09
MILE 47.95, HALTON SUBDIVISION
BURLINGTON, ONTARIO
09 MAY 2001

Report Number R01T0129

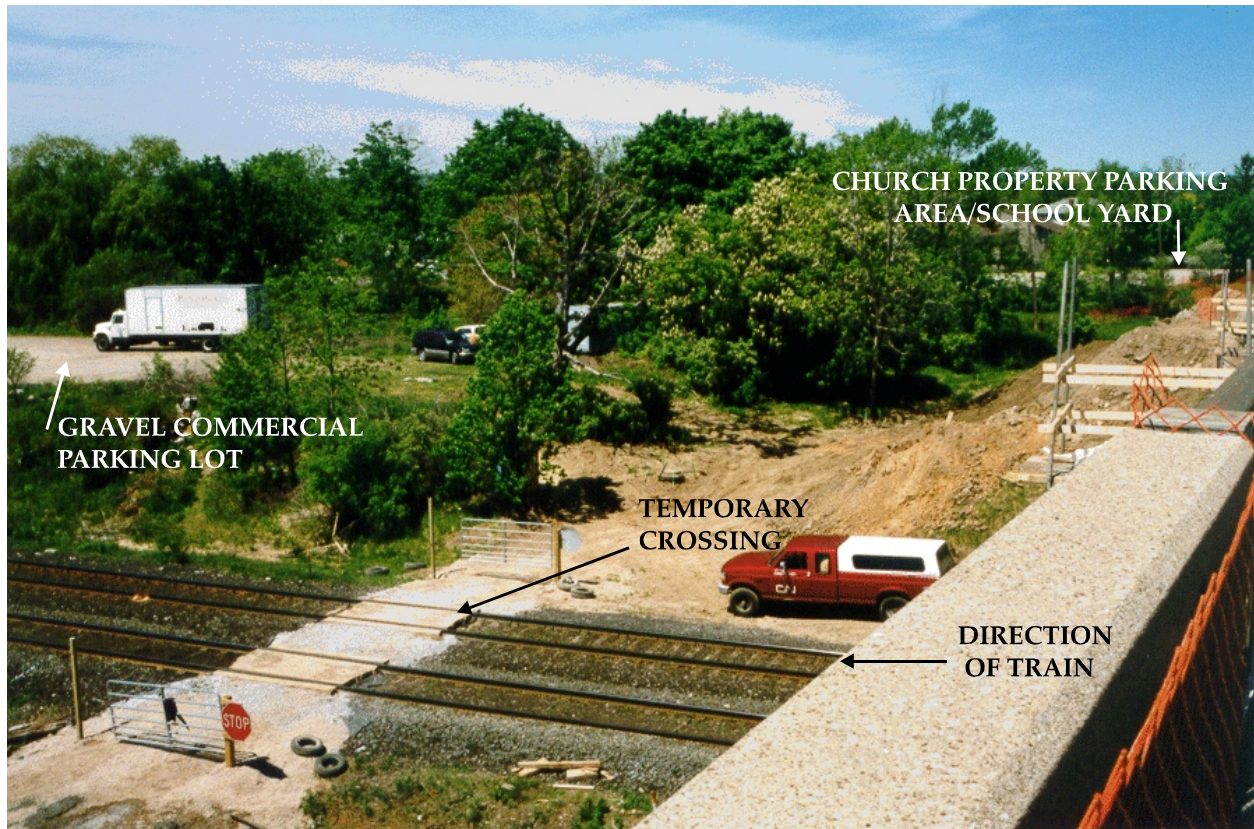
Although this area was not considered a high-trespass area, track workers had observed people traversing this area with their dogs to access the empty field on the south side. Some children in the church congregation had been there a few days before. Those children attended a nearby church school during normal weekday school hours. Figure 1 shows a view of the area.

Figure 1 - View of the accident site

There were at least two possible ways for the child to reach the tracks without encountering significant physical barriers: through the parking lot and through the bush. Because there was no fence along the track at that location, she could either have walked around the swing gates onto the crossing or walked down and across the ditch. There was no indication of plants on her clothing; thus, she likely proceeded directly towards the parking lot to the south, then eastward towards the construction area and onto the crossing.

In the area in which the accident took place, the swing gate has been kept closed outside of working hours and a railway flag person has been present during working hours. Additionally, fencing was extended on both sides of the gate to prevent pedestrians from walking around it to access the right-of-way.
