## **RAILWAY INVESTIGATION REPORT**

**R01T0255**

### **MAIN TRACK DERAILMENT**

**CANADIAN NATIONAL**

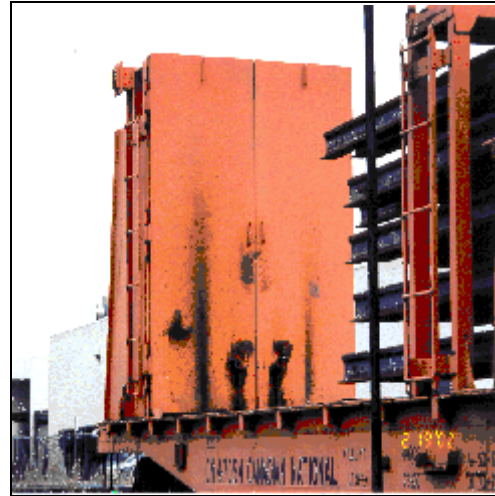
Figure 1 - End Doors

The rail transporter consist is marshalled with a bulkhead door car at each end (see Figure 1). The doors open towards the rail and ensures containment of the rail should it shift in transit. This type of equipment is restricted to a maximum speed of 40 mph.

The door had been supported by three hinges. The hinge weld areas on the fallen door were shiny and rust free, indicating that they had been recently torn off. The door locking device consisted of two brackets welded to the door face with a pin that slides through the brackets into the car floor (see Figure 2).

The manner of train operation played no role in the accident. Train 337 derailed due to track shift attributable to contact with the bulkhead door from CN 46570. The door, having become loose after the makeshift securement device had failed, swung foul of, and contacted, the adjacent train as the stop mechanism was missing. Having been torn from its securement, the bulkhead door fell between the two trains and was jammed against, and shifted, the track.

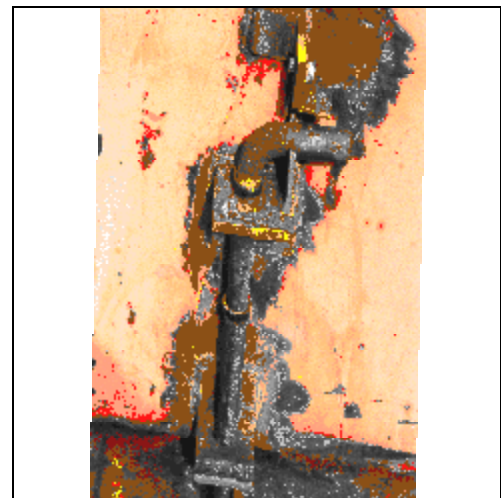
Figure 2 - Locking Pin

The door brackets and locking pin were missing and the weldment areas for the brackets were rust covered. It was determined that a piece of piping with a small valve attached had been inserted into the car floor in front of the door as a means of securement for an undetermined period of time. This makeshift device was not recovered. The door stop, welded to the side of CN 46570 to restrict door swing, was missing and the weldment area was rust covered.

In the six months prior to this accident, this car had seen service in Manitoba, Saskatchewan, Quebec and Ontario, transporting scrap rail to Winnipeg and returning with new rail. The area of the missing locking pin was clearly visible and had been observed by railway employees during loading and unloading. However, there were no reports that the car was in need of repair. There was also no information to indicate that this piece of equipment was kept in service for logistical reasons, i.e. no replacement car was available.

TC stated that CN has now inspected all of their rail transporter cars and completed a program to repair and modify the locking pin mechanisms. CN has also reiterated its loading and unloading inspection program for these cars with their mechanical inspectors and advised them to pay particular attention to the door locking mechanisms and doorstops.
