**RAILWAY INVESTIGATION REPORT**  
**R02M0050**

**MAIN-TRACK DERAILMENT**

**CANADIAN NATIONAL**  
**FREIGHT TRAIN NO. Q13711-13**  
**MILE 38.85, BEDFORD SUBDIVISION**  
**MILFORD, NOVA SCOTIA**  
**13 AUGUST 2002**

Report Number R02M0050

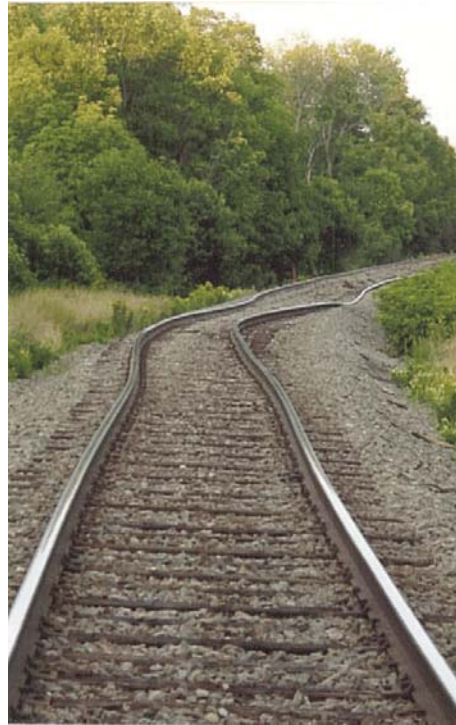
**Photo 1.** Post-derailment view of track buckle, looking westward, at Mile 38.85

The first derailed wheel marks were approximately 45 feet west of the initial indications of the lateral shift in the track structure (i.e. Mile 38.85). At that location, the track structure had shifted approximately 18 inches to the outside of the curve. There was no sign of any appreciable spike lift for the first 35 feet. Track destruction in the derailment zone precluded the identification of any signs of pre-derailment track conditions (e.g. rail creep). The train crew did not see or otherwise detect any problem with the track structure when the locomotives passed over that location.

1. Increased compressive stress in the continuous welded rail due to higher-than-normal ambient temperatures, in addition to an excessive ballast condition due to frequent surfacing, created the circumstances for a track buckle to occur.
2. The forces exerted on the track structure by the moving train and the rail compression could not be contained by the ballast, allowing the track to shift out of alignment and buckle.
3. Seven platforms from the last two five-pak cars of a train travelling at express speed could not negotiate the laterally misaligned track and derailed.

- surveyed track geometry in the area;
- undercut the track to remove the excessive ballast conditions;
- removed some excessive superelevation; and
- destressed the rail.
