RAILWAY INVESTIGATION REPORT

R02C0013

DERAILMENT

CANADIAN PACIFIC RAILWAY
FREIGHT TRAIN NO. 275-03
MILE 30.2, ALDERSYDE SUBDIVISION
CARMANGAY, ALBERTA
03 MARCH 2002

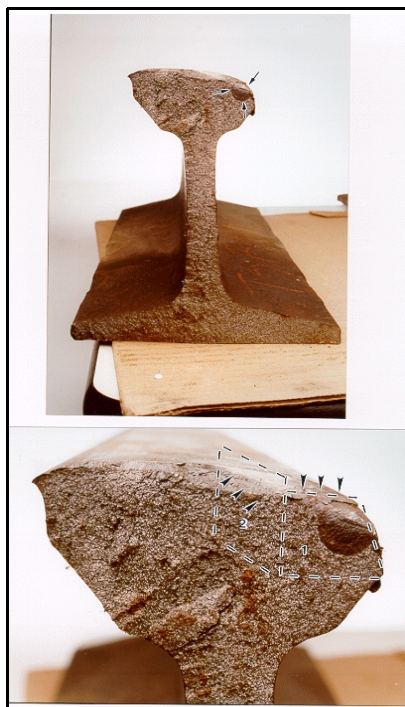
- Two of the rail pieces had fracture surfaces which contained progressive transverse defects on the gauge side of the rail, comprising approximately five and three per cent of the fractured surface area (see figures 2 and 3).
- Significant surface defects (surface cracking, material flow, shelling, flaking) were observed along the gauge side of the rail pieces.
- The transverse defects initiated from surface cracks (surface defects) on the gauge side of the rail. There were no impact marks.
- Wear measurements indicated that the rail was just within maximum allowable wear limits². The rail head had lost 26 per cent of its original surface.
- No material deficiencies which could have contributed to the failure of the rail were identified.

Figure 2 - Transverse defect representing five per cent of the rail fracture surface area.

There was no indication from the examination of the train wheels that an excessive load impact had caused the rail failure to occur. In addition, there was no indication that a material defect had contributed to the failure of the rail. The transverse defects were initiated on the gauge side surface of the rail. When double-shoulder tie plates were installed, and the rail cant was reduced, the contact stresses from wheel loading shifted onto the gauge side of the rail, accelerating the propagation of surface cracks. Further development of the surface cracks, and the excessive rail head wear, reduced the ability of the rail section to resist crack growth. Subsequently, surface cracks formed subsurface cracks that turned downward and developed into two transverse defects. Rail failure occurred when these transverse defects reached a critical size.

1. The derailment occurred when the rail broke under the load of the train.
2. The rail failed when surface defects propagated to transverse defects and reached a critical size.
3. When double-shoulder tie plates were installed, the wheel contact stresses shifted onto the gauge side of the rail, accelerating the propagation of surface cracks.

Canadian Pacific initiated a switch-and-crossing grinding program in May 2002 and completed the grinding of all the main track switches on the Aldersyde Subdivision.

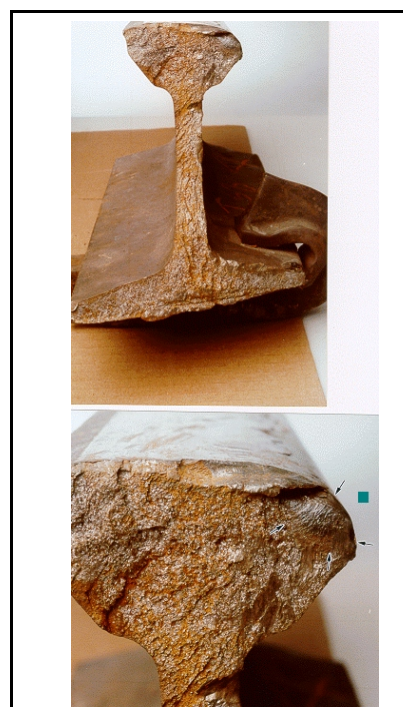
Figure 3 - Transverse defect representing three per cent of the rail fracture surface area.
