RAILWAY INVESTIGATION REPORT
R04W0148

NON-MAIN-TRACK TRAIN DERAILMENT

CANADIAN PACIFIC RAILWAY
FREIGHT TRAIN 494-05
MILE 0.01, BROMHEAD SUBDIVISION
ESTEVAN, SASKATCHEWAN
08 AUGUST 2004

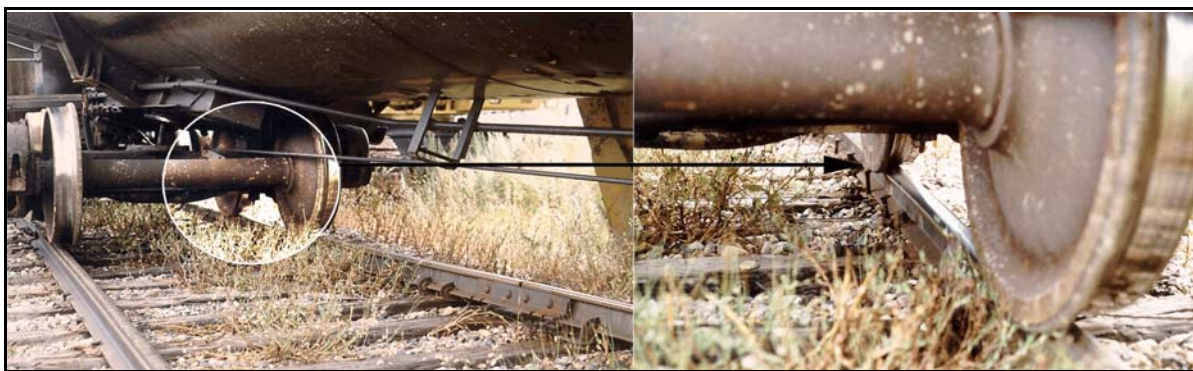
The turnout curve consisted of 115-, 100-, and 85-pound rail. In the 85-pound track structure within the limits of the turnout curve, spike lift was observed on the gauge side of the south rail over a distance of 66 feet, between the 100/85-pound compromise joint² and the insulated joint (see Figure 3). Over the same area, the field-side track spike heads were bent back and the south rail had begun to roll to the field side. Wheel marks were visible on the tie ends approximately 6 feet west of the insulated joint, 275 feet from the point of switch. Approximately 450 feet of track was destroyed. Most of the rail was recovered and re-constructed near the derailment site. All fracture surfaces exhibited brittle characteristics consistent with catastrophic failure; no significant pre-existing defects were observed in any of the rail or joints.

Photo 1. The B-end of car GATX 48058 remained on the canted south rail. A close-up of the shaded area shows the spike lift observed beneath the B-end truck.

On 16 August 2004, all 85-pound rail was replaced beyond the clearance point of the Bromhead turnout curve with 100-pound rail sections, set on double-shouldered tie plates secured with three spikes per plate.

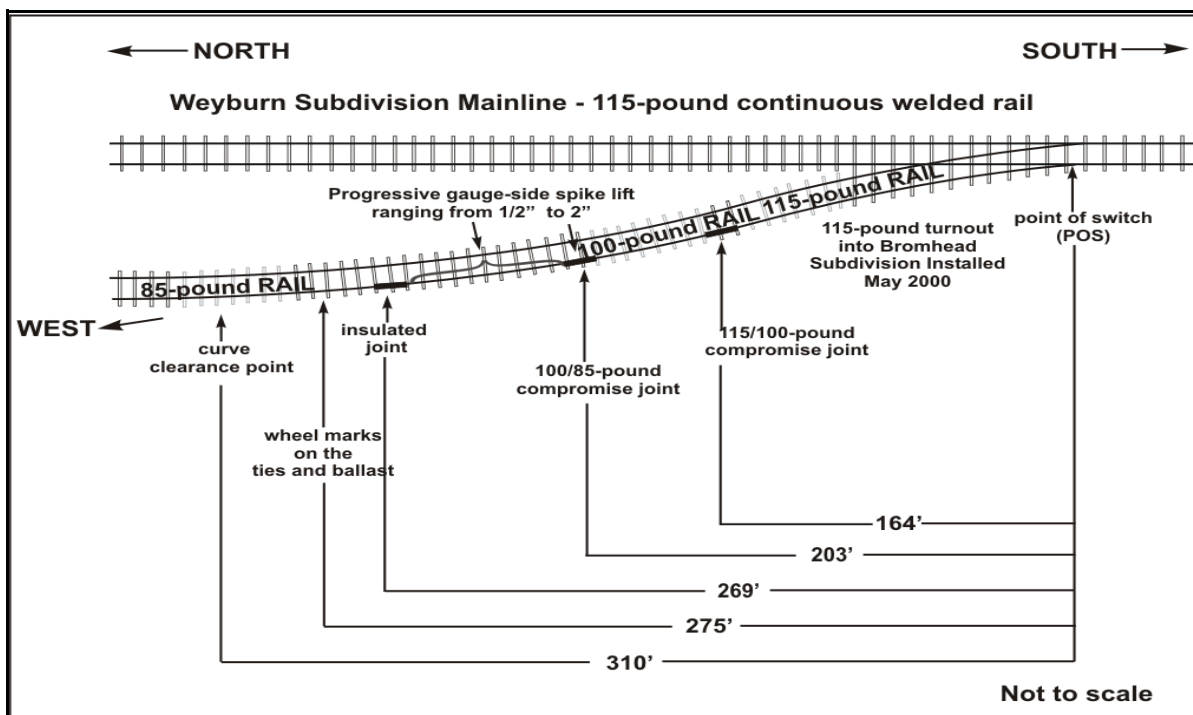
Figure 3. Observations and general track layout in the area of the derailment

The gauge-side spike lift (which originated immediately west of the 100/85-pound compromise joint on the south rail), the bent field-side track spike heads, and the canted south rail were all observed prior to the first wheel marks, indicating that rail roll-over was the derailment mechanism. The lack of obvious track defects, such as tie plate cutting or loose spikes, suggested that a higher-than-usual lateral load was exerted on the track structure and caused the south rail to roll over.

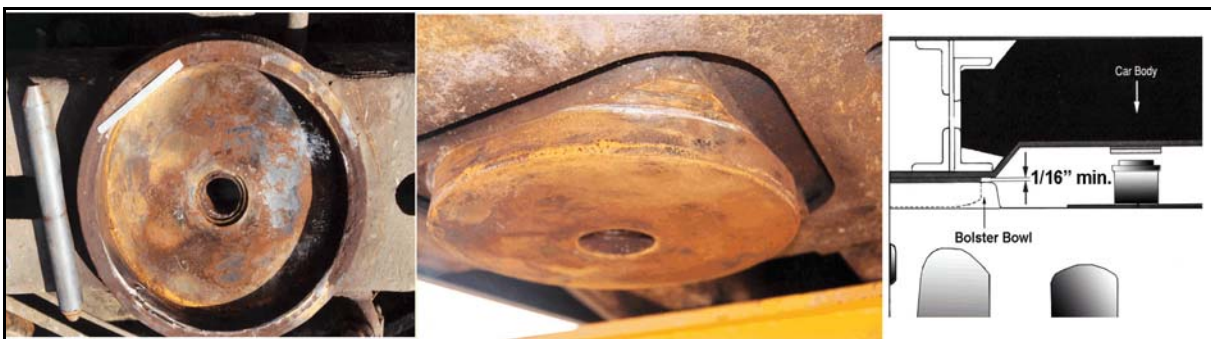
CPR and the TSB conducted a mechanical tear-down inspection of the first two derailed cars, ACFX 220149 and FURX 818699. While no defects were identified in car ACFX 220149, the inspection of car FURX 818699 revealed a number of defective and worn truck components. In particular, the B-end car body centre plate was dry, oxidized, and binding on the truck bolster rim. The contacting surfaces of the body centre plate were smeared and gouged. In addition, both side bearings were tight, and three of four bolster gibs, as well as the L-1 and R-1 bolster friction pockets, were worn to condemning limits (see Appendix A). The TSB identified five train accidents in the previous 18 years in which binding car body centre plates were contributory factors.

Photo 2. The truck bolster rim on car FURX 818699 was worn at four locations. The wear on the corners of the matching car body centre plate corresponded to the bolster rim wear. The sketch indicates the clearance between the two.

While negotiating a curve, lateral forces generated by a properly performing truck will not exceed the lateral restraint capacity of adequately secured rail. However, when freight car and truck defects that restrict truck rotation and facilitate truck warp are present, the wheel flange angle of attack is increased, and higher-than-usual truck-side lateral forces are generated in curves. Binding centre plates, tight side bearings, and truck components worn to condemning limits are defects that increase truck rotational resistance and warp. Since these defects were present on car FURX 818699, it can be concluded that the B-end truck induced higher-than-usual lateral forces on the south rail as the car negotiated the turnout curve.

The binding centre plate on the B-end of car FURX 818699 was a defect that had existed for some time. Although this condition required immediate attention, it remained undetected despite a number of inspections that had been performed on the car prior to the derailment. Such defects are supposed to be captured during safety inspections; however, as demonstrated by this occurrence, they are not always identified. The quality and thoroughness of the inspections may be hindered by a number of factors such as car configuration, work environment, and awareness of the inspector.

Acknowledging the human limitations on performing visual inspections, the rail industry is implementing automated inspection technologies. Canadian Pacific Railway (CPR) is currently reviewing options for installing up to two truck performance detectors on its network in the next few years. These detectors are designed to identify defects in freight car trucks similar to those that were present in car FURX 818699.

CPR developed and distributed a "Tech Tip" poster across its system to illustrate what to look for when inspecting freight car centre plates and side bearings. CPR instructed all certified car inspectors to review the poster.

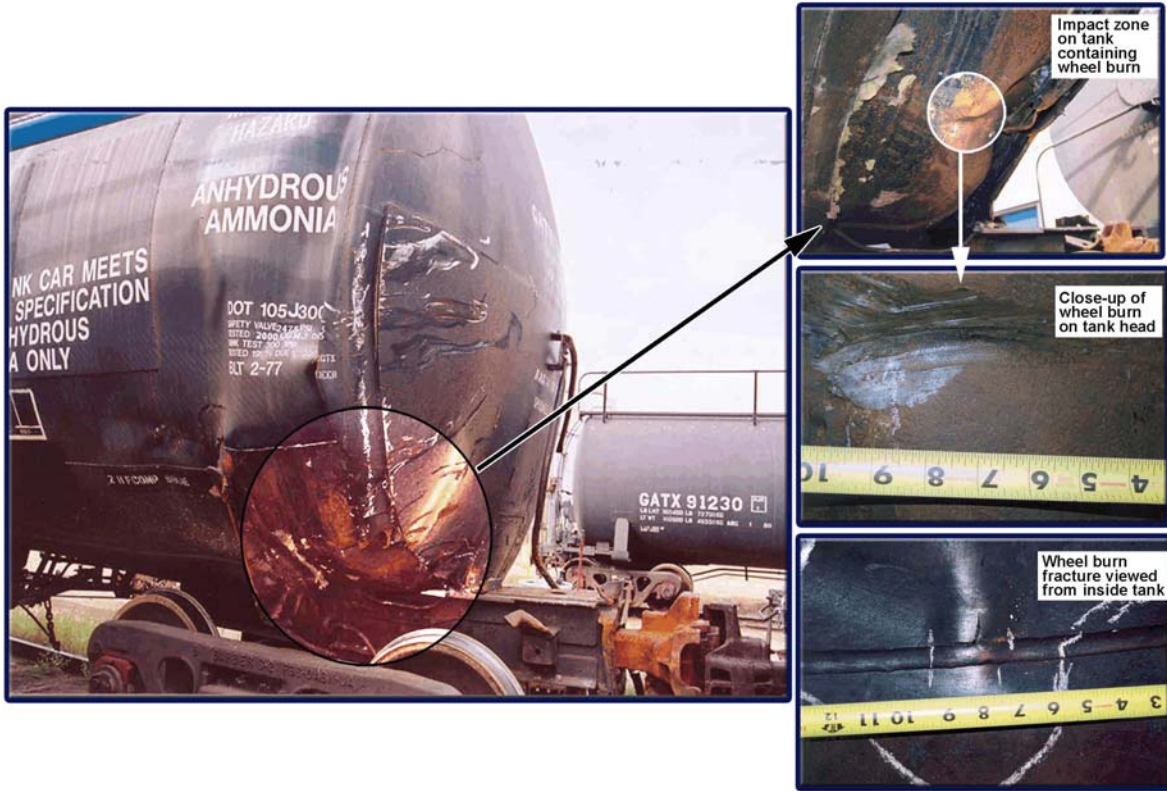
On 15 September 2004, car GATX 48058 was examined at the GATX facility in Moose Jaw. A two-foot diameter dent was observed in the B-end tank head. The lower portion of the dent contained a wheel flange burn that extended into the weld securing the tank head to the body of the tank. The burn measured about five inches long, two inches wide and one inch deep. At the root of the flange burn, a two-inch-long crack extended into the tank head weld area. On the inside of the tank, a one-inch longitudinal crack was visible extending up to the tank head weld. A second crack, perpendicular to the longitudinal crack, had propagated 2 ½ inches along the toe of the weld. The damaged area of the tank car was removed and sent to the TSB Engineering Laboratory for further analysis.

Photo 3. Zone affected by impact on B-end of tank car GATX 48058. Note wheel flange burn on tank exterior and a through crack on tank interior.

- The B-end of the tank car sustained a small through fracture as a result of an impact with the flange of a wheel during the derailment. No pre-existing primary or secondary fractures were observed.
- No metallurgical anomalies were observed in the tank head, weld, or shell material. The chemical and tensile properties of the tank car met or exceeded the minimum AAR specifications for TC 128 Grade B steel.
- The tank car head and shell were constructed with a very fine-grained steel (ASTM 10), which provides superior toughness and resists crack propagation.
- The Charpy impact value of the tank car head material was measured at 66.8 foot-pounds at -45.6°C. Testing in previous TSB investigations (R94D0033 and R96M0011) revealed Charpy impact values of 3 to 5 foot-pounds at temperatures between -30°C and -45.6°C, for tank cars constructed prior to 1989.

Tank car GATX 48058 sustained a relatively small fracture and released a minimal amount of product. However, analysis determined that the car was constructed from material that had properties superior to current AAR specifications. The high Charpy impact values and fine-grained microstructure of the tank car steel were characteristic of a material with high impact resistance and toughness. These properties likely played a role in the survival of tank car GATX 48058 and reduced the risk of a more serious tank breach.
