MARINE OCCURRENCE REPORT

SWAMPING AND FOUNDERING

**FISHING VESSEL "WHISKEY JACK"
OFF FAN ISLAND, BRITISH COLUMBIA**

REPORT NUMBER M93W0004

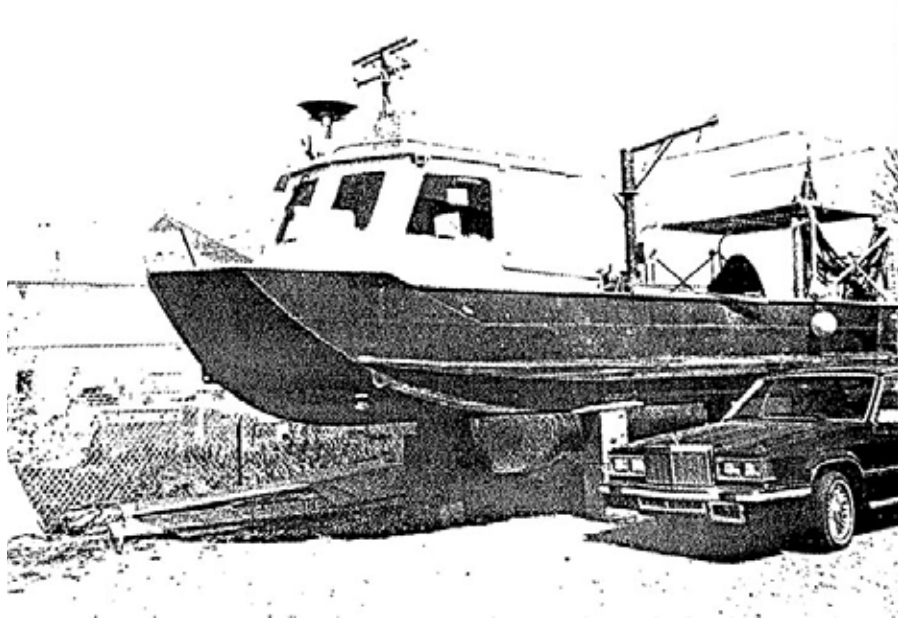
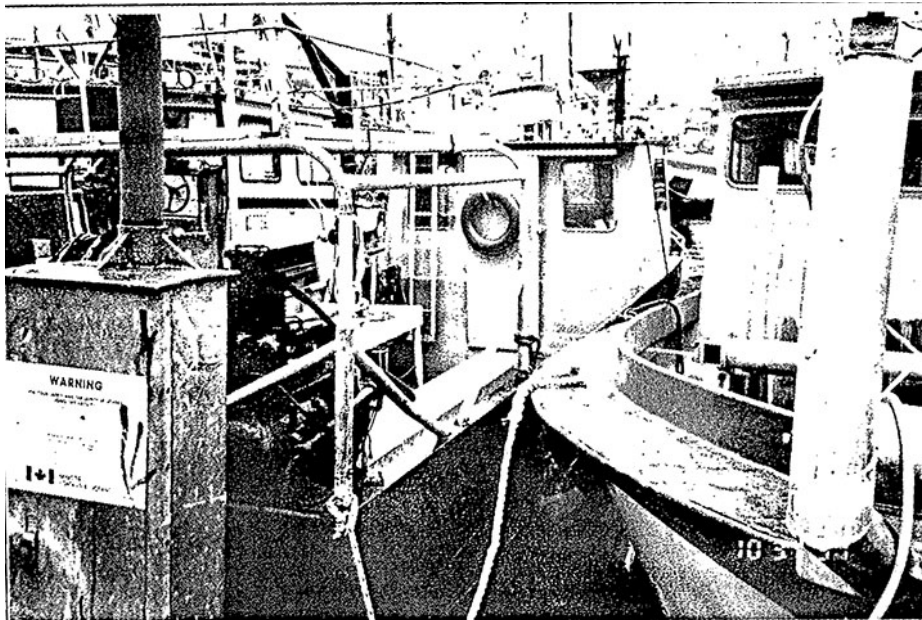
"WHISKEY JACK", January 1992

Free-surface effect of any liquid would have a detrimental effect on the intact stability characteristics of the vessel. However, photographs show that the engine compartment was much smaller than the full width of the well deck and, consequently, free-surface effect would be a relatively minor factor in the event of the engine compartment and/or well deck becoming partially flooded.
