MARINE OCCURRENCE REPORT

M96M0150

FERRY CABLE FAILURE

CABLE FERRY "F-39"

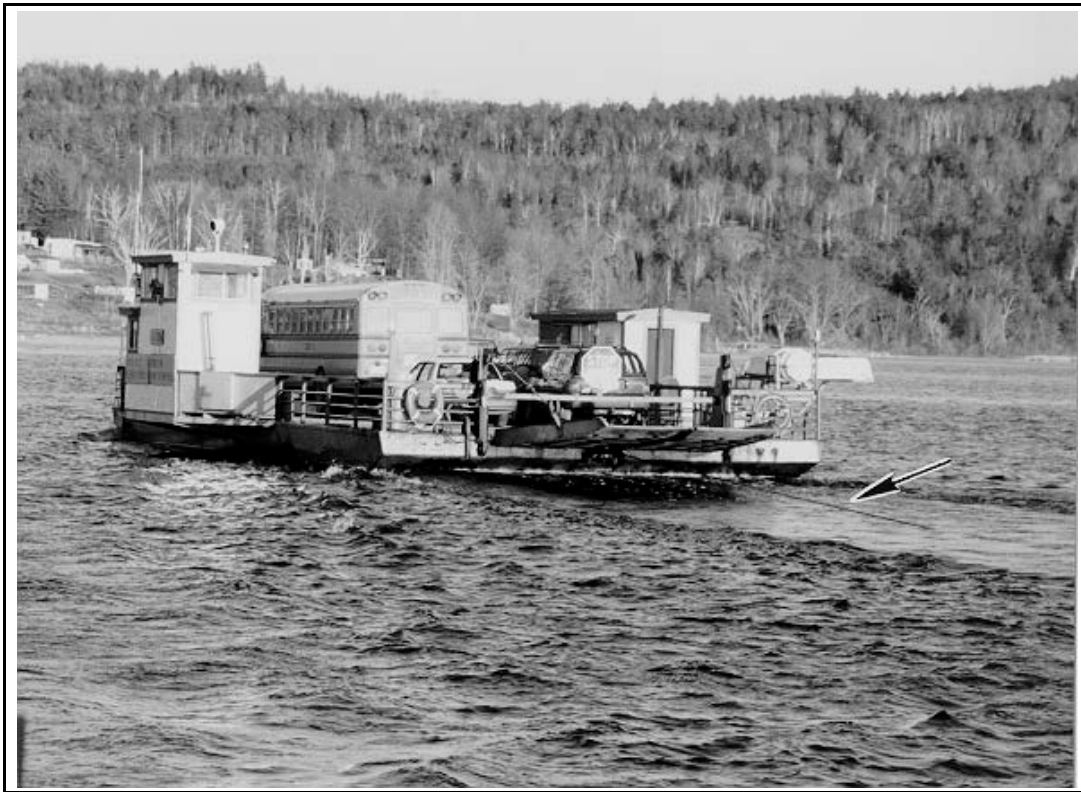
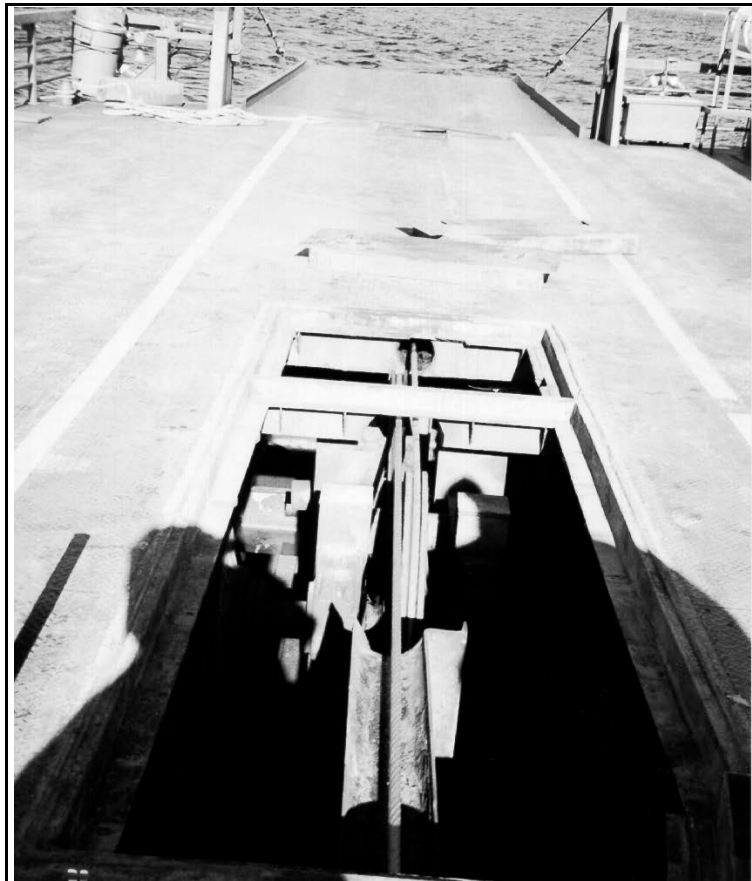
Appendix B - Photographs

Visual examination of the sections comprising the mating ends of the fractured cable revealed that the protective plastic coating had worn away over approximately one third of the diameter, with strands heavily corroded deep into the core of the cable. The outermost strands were worn completely through as a result of abrasion and others were broken as a result of corrosion. The fractured ends showed little deformation or “birdcaging” typical of tensile failure, indicating the cable was significantly weakened prior to failure. Further examination showed that the outer strands failed primarily in a brittle fashion as a result of corrosion while strands near the core exhibited “necking”, a ductile deformation consistent with tensile overstress failure.

The localized heavy wear and loss of the exterior plastic in the fracture area was considered consistent with contact between the cable and the river bottom. Drag due to the current was considered responsible for most of the wear as the cable is dragged across the bottom each time the direction of the current reverses.

The TSB Engineering Laboratory report (LP 159/96) concluded that the cable failed as a result of localized wear and corrosion of the exterior strands having reached such an extent that the remaining strands failed in overstress.

Following this occurrence, the TSB forwarded a copy of the laboratory analysis report on the damaged cable to the New Brunswick Department of Transportation (DOT). The TSB understands that the DOT has now conducted a study of the life span of ferry cables to determine average operational life in the prevailing conditions, with a view to optimizing a replacement schedule. (Several factors such as winter ice, high currents and high winds affect the life span of a ferry cable.) For the "F-39" cable ferry, it was determined that the replacement cycle should be less than 303 days, taking into consideration a replacement before winter.
