MARINE OCCURRENCE REPORT

M97W0197

GROUNDING

THE BULK CARRIER "RAVEN ARROW"  
JOHNSTONE STRAIT, BRITISH COLUMBIA  
24 SEPTEMBER 1997

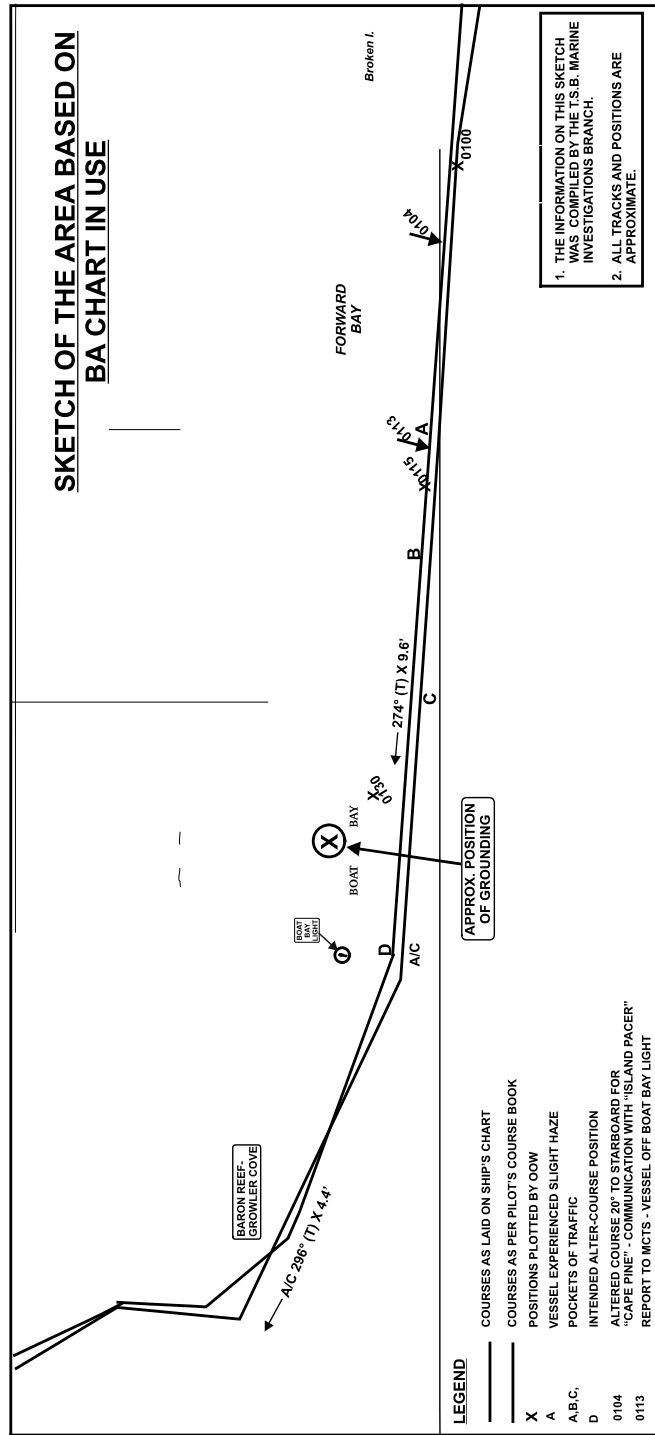
In the vicinity of Stimpson Reef the visibility was good as the vessel encountered traffic, including a few fishing vessels. On passing Broken Island, at the eastern end of West Cracroft Island, the vessel's course was altered to 274°, to head for a point some 0.5 nautical mile (M) off Boat Bay Light. At 0100, Broken Island Light bore 058°, distance 1.9 M, and around this time the vessel began to experience a slight haze. Targets were picked up on the vessel's radar on the 12-mile range. Approaching Forward Bay, the vessel entered fog. By 0120–0125 the visibility had decreased to about 150 m and the master was not informed. No dedicated look-out was posted.

The last position, as plotted on the chart by the OOW, was at 0115: 50°30.2' N, 126°26.32' W, some 5.5 M east of Boat Bay Light. Between the 0045 and 0115 positions the average speed of the vessel was 14.92 knots (kn). At approximately 0130 the pilot saw on the radar what he believed was the entrance to Blackney Passage and commenced a course alteration to starboard. He did not verify the vessel's position prior to the course alteration nor did he request the OOW to plot the vessel's position. Shortly after reaching the new heading of 320°, the pilot realized that the vessel was not at the alter-course position and ordered hard-a-starboard helm, in the hopes of bringing her around, but this was unsuccessful and the vessel grounded in position 50°31.4' N, 126°32.4' W, on a heading of 056°. The time of the grounding as recorded in the log books was 0133, while the course recorder trace showed that the grounding occurred at 0136.

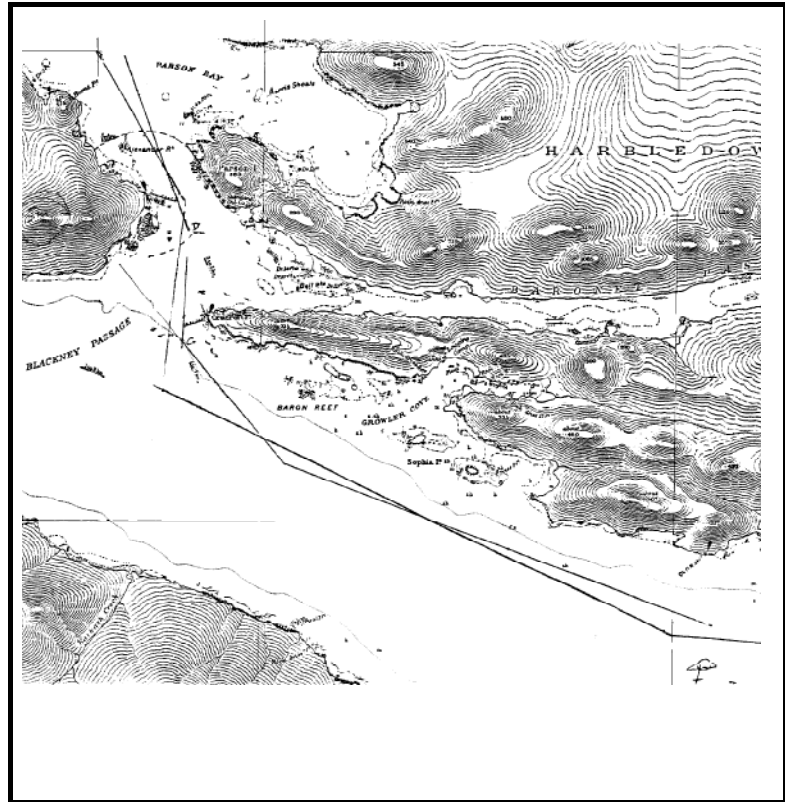
There were only minor differences between the courses laid by the ship's complement and those contained in the pilot's course book for the area covering Fanny Island to Cracroft Point. However, there was a significant difference in the plan to round Cracroft Point. On the vessel's proposed route an alteration of some 70 degrees was required, whereas the pilot intended to make two alterations, of some 30 degrees and 40 degrees respectively, over a mile apart (see Figure 2). The pilot had not informed the OOW of this plan nor had he indicated to the OOW the minimum safe distance from the shore he intended to keep.

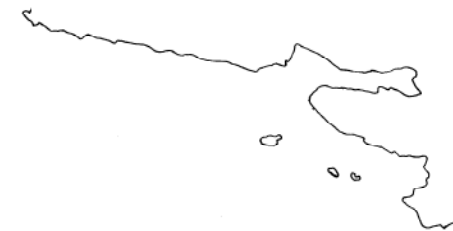
Proceeding westbound along the south shore of West Cracroft Island and before reaching the Baron Reef-Growler Cove area where the course alteration into Blackney Passage is effected, a vessel passes Forward Bay and Boat Bay. A review of the chart for the south shore of West Cracroft Island reveals similar shoreline indentations in the Forward Bay, Boat Bay and Baron Reef-Growler Cove areas (6 M and 4 M apart, respectively). To an observer on a vessel proceeding eastward or westward along the shore, a cursory radar observation could result in improper identification of the three areas.

- the unique characteristics that differentiated Forward Bay and Boat Bay. These include the absence of a navigational light on the headland west of Forward Bay; however, given the deteriorating visibility, an assumption was made that the light was obscured by fog;
- the mismatch between the 0113 position report to MCTS and the OOW's 0115 plotted position. The OOW did not detect the pilot's error in reporting the 0113 position to MCTS;
- the vessel would have had to average a speed of some 19 kn to have been off Boat Bay Light at 0113 instead of 0135. This is an unrealistic speed in the given circumstances. Neither the pilot nor the OOW used the vessel's estimated steaming time between course alteration points as a means to cross-check whether the vessel had reached the alter-course position.

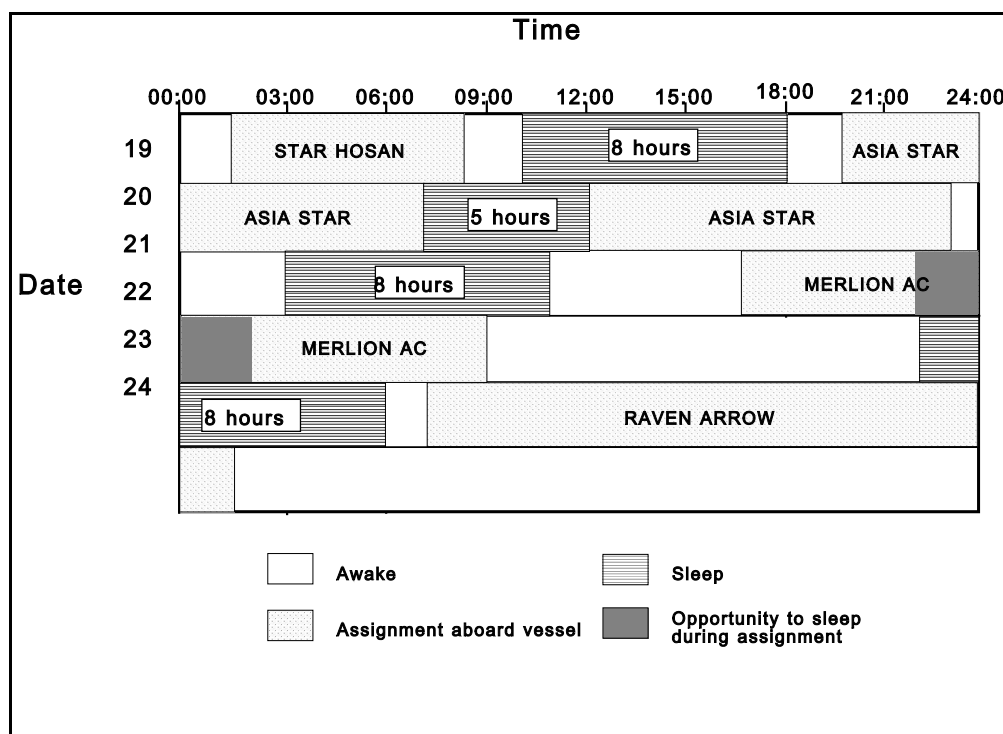
Figure 5 presents pilot No.1's schedule for the period September 19 to September 24. The irregularity of the pilot's schedule is evidenced by the fact that the pilot had worked three midnight shifts in six days, and that interspersed with these midnight shifts were an evening shift and a day shift. Over the six days, off-duty periods between the shifts vary in length from about 5 hours to about 21 hours. Studies of marine watchkeepers who work odd shifts have shown that shorter/poor-quality sleep and poorer performance are associated with irregular work/rest cycles.<sup>26</sup>
