MARINE INVESTIGATION REPORT

M99W0145

GROUNDING

BULK CARRIER "MANDARIN ARROW"

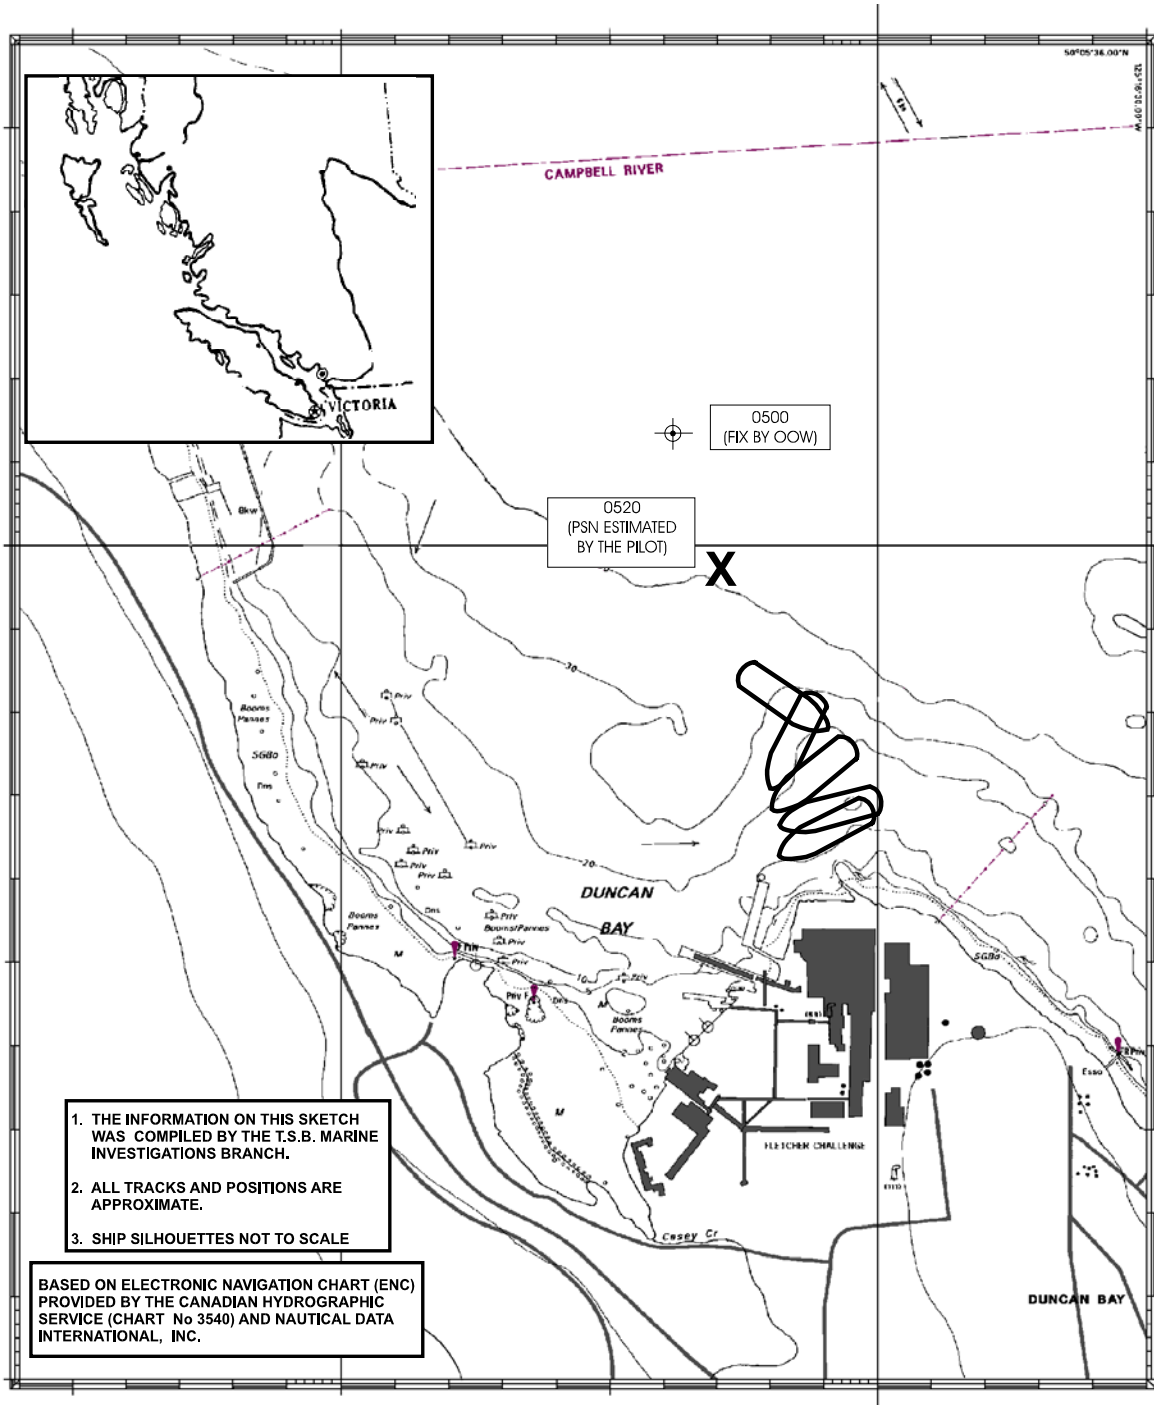
# Appendix A — Sketch of the Occurrence Area

Duncan Bay is a body of water in Johnstone Strait lying approximately four miles south of Seymour Narrows. It is bounded by Vancouver Island to the west and open to the northeast. Located in Duncan Bay is a large pulp and paper mill which owns and manages three wharves: a pulp wharf, a paper wharf, and a barge-loading facility. The pulp wharf, to which the “MANDARIN ARROW” was allocated, is 152 m long and extends into the bay at 15 degrees True (°T), almost parallel to the shore; it has a mooring dolphin located at its north end (see Appendix A).

Canadian Hydrographic Service (CHS) charts used on board the "MANDARIN ARROW"—CHS 3539 and CHS 3540—show several arrows delineating the currents during flooding and ebbing phases of the tide (see Appendix A). One arrow is placed just north of the pulp wharf in Duncan Bay. It shows the ebbing current in

an easterly direction. There is no matching arrow referring to the flooding current in the vicinity of the wharf, although all other references to the tidal currents on the chart are paired.
