MARINE INVESTIGATION REPORT

M00L0034

MAIN ENGINE FAILURE

GENERAL CARGO CARRIER *MILLENIUM YAMA*

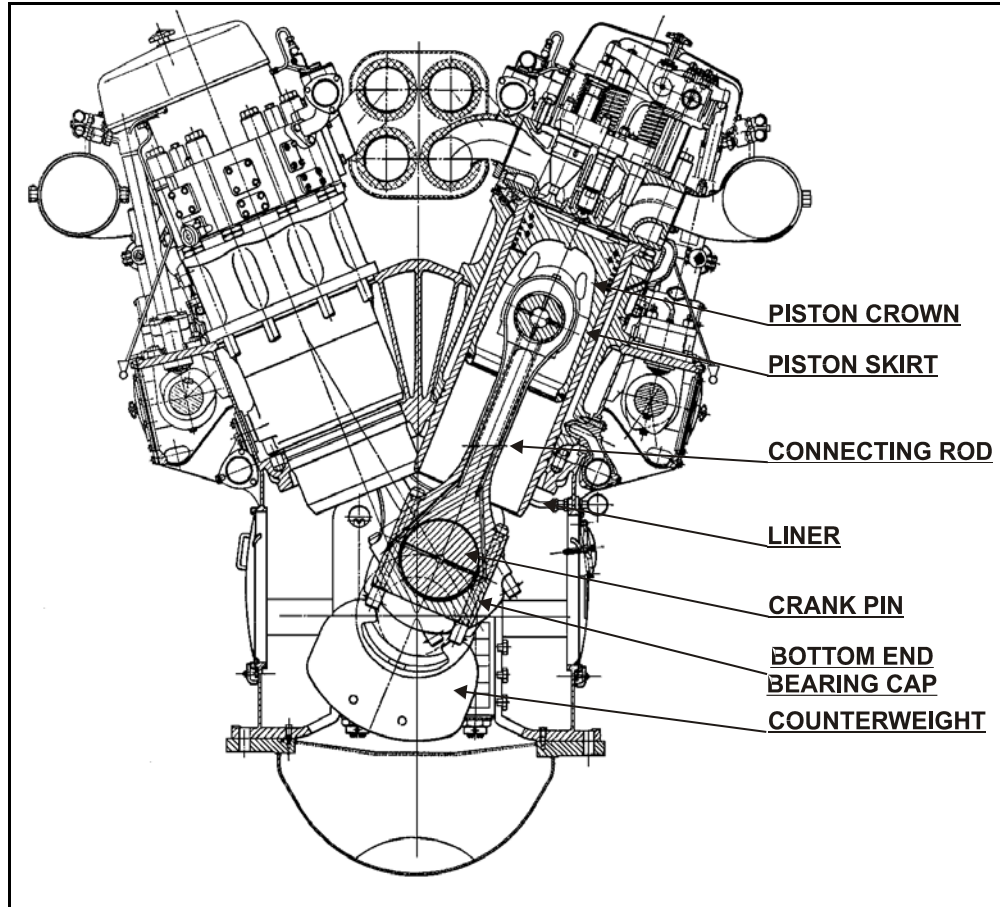
Inspection of the main engine revealed that the connecting rod (con-rod) had separated from piston No. 3.³ The piston crown had separated from the skirt, which was in pieces. The crankshaft was bent at the No. 4 main bearing. The exhaust valve and push rods for the exhaust and inlet valves in the No. 3 cylinder head were also bent. The No. 6 counterweight and the piston end of the No. 3 con-rod were jammed between the crank pin and

the bottom of the liner and the casing (see Figure 1).

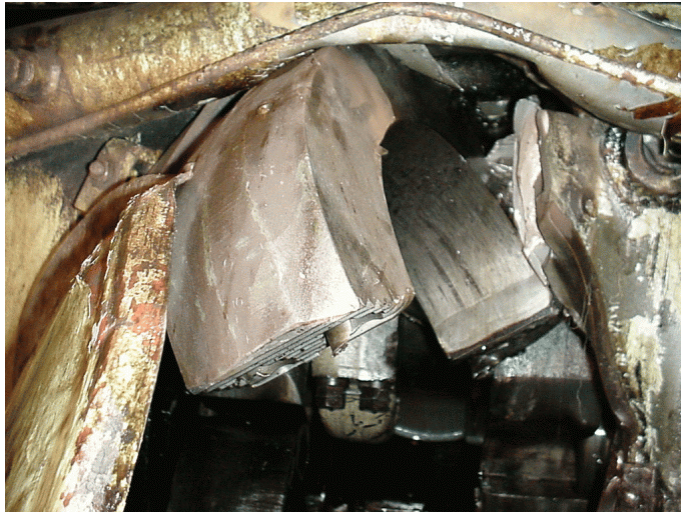
The bottom end of the No. 3 con-rod punched through the right side of the main engine, damaging the casing and inspection door at unit No. 9. The lube oil and coolant lines and the flexible coupling were also damaged (see Photo 2).

Debris from the liner, piston, bearing shell, con-rod, counterweight, con-rod cap, pin, bearing shell, and other parts were strewn about in the crank case in way of the failed unit.

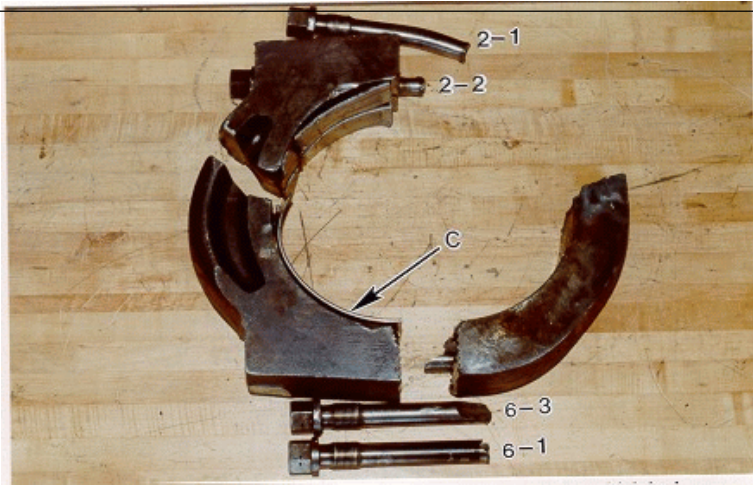
Photo 3. The four con-rod cap bolts, the two pieces of the broken cap, and part of the upper portion of the con-rod that was cut off with a torch. The letter C indicates the lower bearing shell that was broken in two. Bolts nos. 6-1 and 6-3 are not bent. Bolt No. 2-1 is deformed.

The Board determined that the con-rod cap became detached from the con-rod due to a fracture and not due to failure of the bolts. It was noted that the crack developed in the thinnest section of the con-rod cap⁷. It originated in a corrosion pit on the contact surface with the bearing shell, then propagated to over 95 percent of the cap surface through high cycle fatigue. The cap subsequently failed in overload in the smallest section. The break-up of the cap caused the four bolts to fracture.

In this occurrence, the con-rod cap fractured near its centre. This seldom occurs, since the central portion is generally subjected to very little stress. Stresses are normally concentrated in the upper portion of the con-rod.

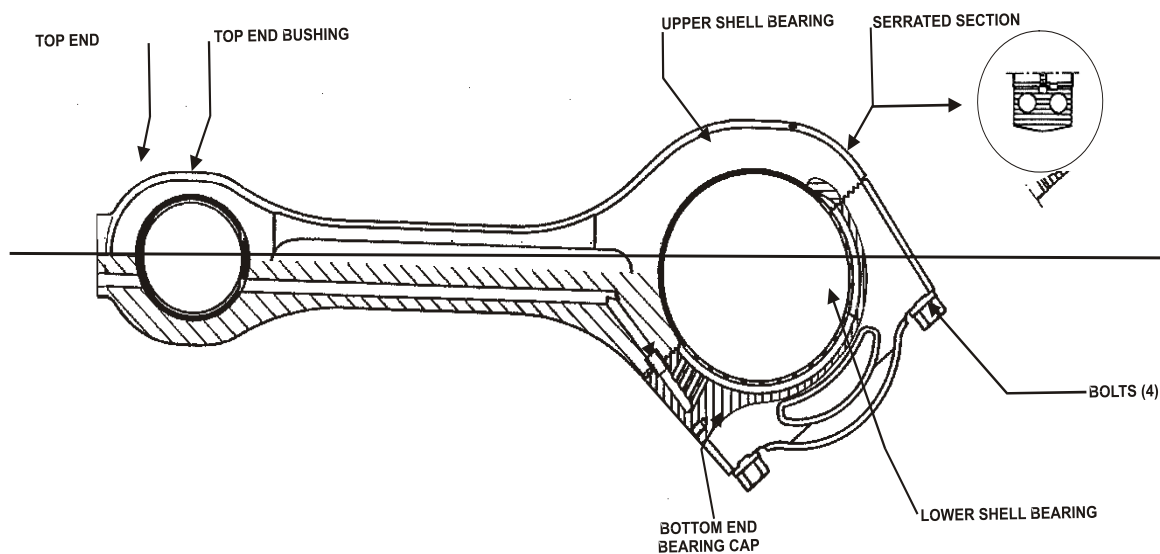
The manufacturer recommends that con-rods be inspected as follows, after 24,000 running hours:⁶

- Measure the inner diameter of the bush.
- Conduct a Dye Penetration Test of the con-rod cap serrated faces of the oblique bottom end joint. Any crack shall be submitted to an examination by the manufacturer, who will decide whether the con-rod cap is to be rejected.
- Perform a Magnetic Particle Crack-Detection Test on the con-rod bottom end screws or bolts. Failing that, carry out a Dye Penetration Test.
- Perform a dimensional inspection of the connecting rod bottom end bore.

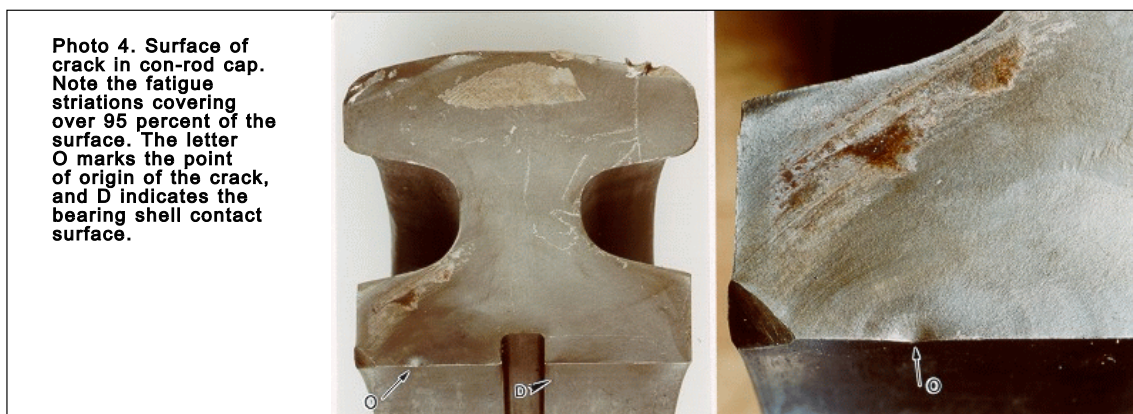
The main engine failure started with the No. 3 con-rod bottom end detaching from the crankshaft. This triggered a chain of parts separation. With no cap to hold it in place, the con-rod unseated from the crank pin and struck the counterweight. The impact sheared the pin securing the counterweight in its notches. As the crankshaft continued to rotate, it struck the counterweight and con-rod, jamming them against the lower edge of the No. 3 cylinder liner. The force transmitted by the con-rod top end to its gudgeon pin caused the piston skirt to break into several pieces. The impact of the con-rod bottom end striking the starboard casing wall punctured the casing, damaging the oil and fresh water lines.

In most cases of con-rod detachment, the bottom end cap separates from the upper part of the con-rod, which is caused by a failure of either the securing bolt or the cap. The bolts usually fail in fatigue caused by unequal torquing.
