MARINE INVESTIGATION REPORT

M00W0005

STRIKING OF A BRIDGE

THE TUGBOAT "SEA CAP XII" AND

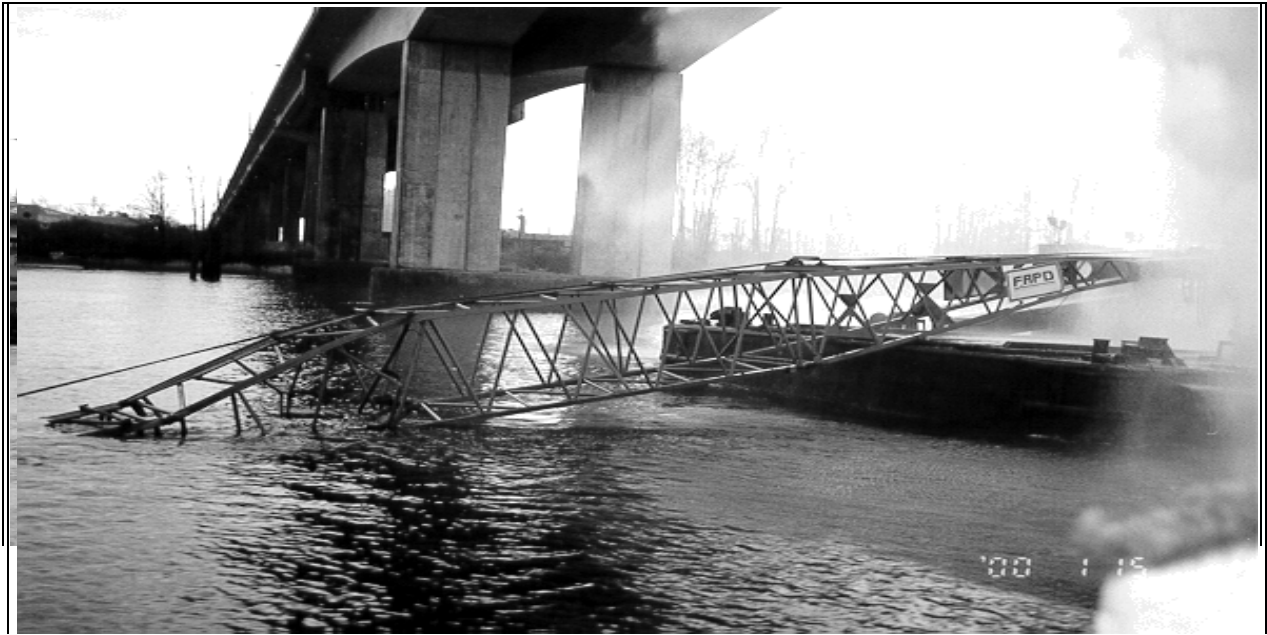
At 1345, the tug was passing under the Knight Street Bridge; the skipper had the con while the deck-hand was in the wheel-house with his back to the tow. When the tug was just west of the bridge the crew heard a crashing sound. When they looked back they saw the boom swaying and buckling. The top of the boom was scratching against the underside of the concrete span. Bits of concrete were falling onto the barge, followed by water from an overhead pipe. The skipper reduced propulsion to slacken the pull; however, the barge still had some momentum and the crane, with the top of the boom wedged under the bridge, shifted off the deck and sank astern of the barge.

The investigation established that the sheave on top of the boom first hit the side of the eastern concrete girder slightly above the highest point of the arch, whereupon it slid under the girder and hit the steel grate and the pipes. As a result of the striking, the boom was bent and twisted and the securing arrangements between the barge and the crane were severed. The crane’s machinery was water-damaged as a result of the subsequent sinking.
