MARINE INVESTIGATION REPORT

M00W0220

COLLISION

PASSENGER/VEHICLE FERRY *SPIRIT OF VANCOUVER ISLAND*

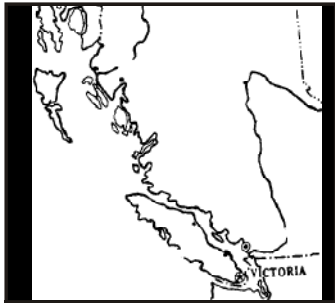
Within Colburne Passage, the vessels altered to port toward the buoyed channel which separates Piers Island from Vancouver Island. Reportedly, the *Star Ruby* continued past the multiple berths of the BCFC ferry terminal toward Gosse Passage, before resuming its position an estimated 100 m astern of the pleasure craft ahead (see Figure 1).
