MARINE INVESTIGATION REPORT  
M01C0033

TAKING ON WATER AND SINKING

AMPHIBIOUS VEHICLE *LADY DUCK*  
OTTAWA RIVER  
30 JUNE 2001

Report Number M01C0033

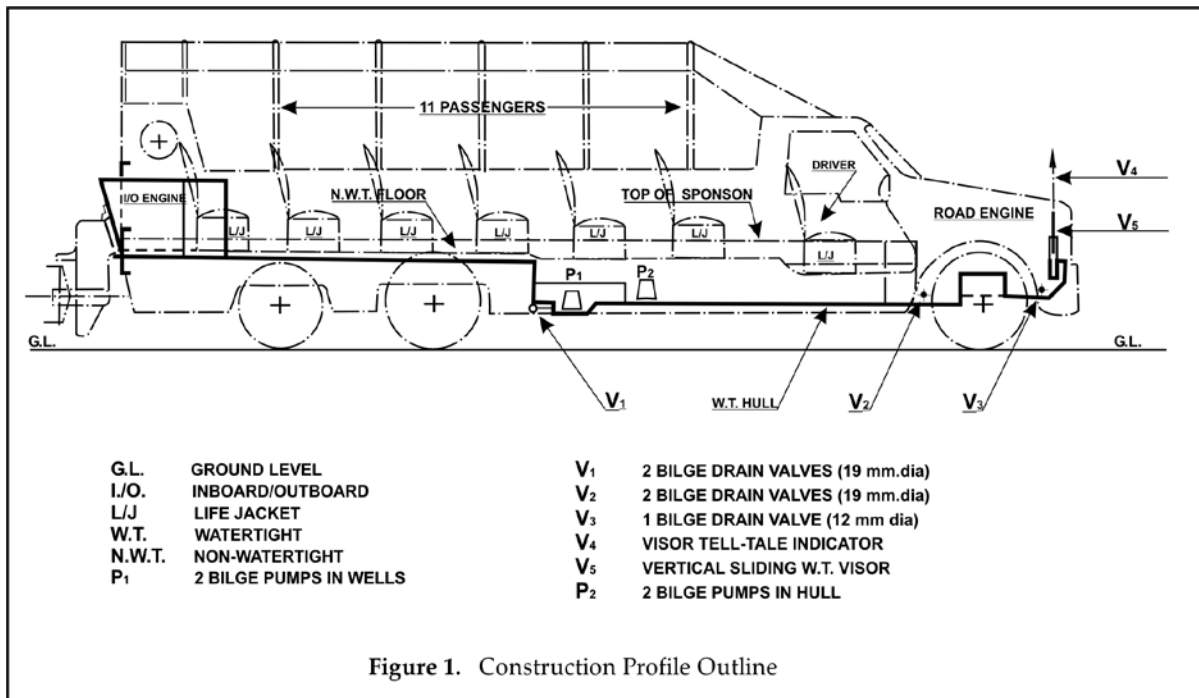
The vehicle is based on the conversion of a Ford F-350 truck chassis. The original gasoline engine is used for on-road operation; a gasoline-powered MerCruiser inboard/outboard engine at the rear is used for waterborne propulsion. Figure 1 shows the basic layout of the vehicle.

The drainage points are each comprised of hand-operated ball check valves (seacocks) with a swing-check nonreturn valve immediately inboard, both mounted on a common pipe spigot. Four of the drainage points are 19 mm in diameter; the fifth is 12 mm in diameter. They are located as shown in Figure 1.

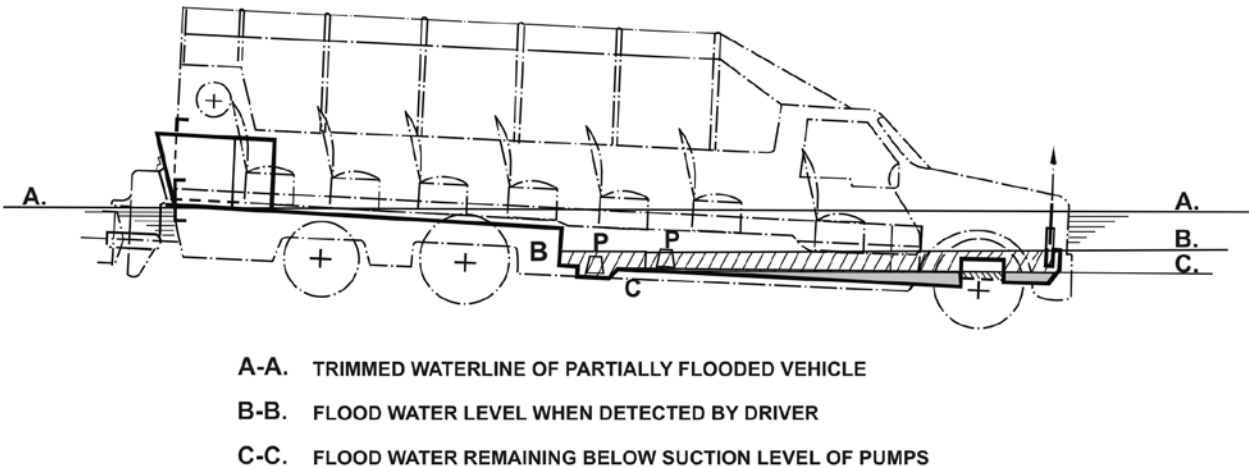
Figure 2. Trim of Partially Flooded Vehicle

When the vehicle was stopped or moving slowly ahead, there was a loss or reduction of the venturi suction effect of the water flowing by the ends of the open bilge drain valves. This resulted in an increased rate of flooding as more water entered the open seacocks and flowed past the secondary (but ineffective) swing-check valves.

The bilge pumps stemmed the inflow and reduced the total accumulation of floodwater while the vehicle was under way. However, the bilge pumps—located near the vehicle's midlength—could not discharge the floodwater that accumulated in the forward end of the trimmed vehicle because this water was below the level of the pumps' suction (Figure 2). While stationary or being slowly manoeuvred along the river bank toward the disused ramp, the vehicle continued to trim more by the front and to settle deeper in the water.

As attempts were being made to drive the *Lady Duck* out of the water, the front right wheel of the partially flooded vehicle grounded on the left edge of the ramp. The forward momentum and the grounding effect slightly raised the front right side of the vehicle, and the floodwater in the hull surged to the left side. This transfer of weight caused the vehicle to heel to the left and ship more water over that side. The additional shipped water downflooded into the hull and caused the *Lady Duck* to suddenly capsize and sink.
