**MARINE INVESTIGATION REPORT**  
**M03N0047**

**COLLISION**

**BETWEEN THE CANADIAN COAST GUARD SHIP**  
***SIR WILFRED GRENFELL***

**THE FISHING VESSEL *GENNY AND DOUG***  
**OUTSIDE ST. JOHN'S HARBOUR,**  
**NEWFOUNDLAND AND LABRADOR**

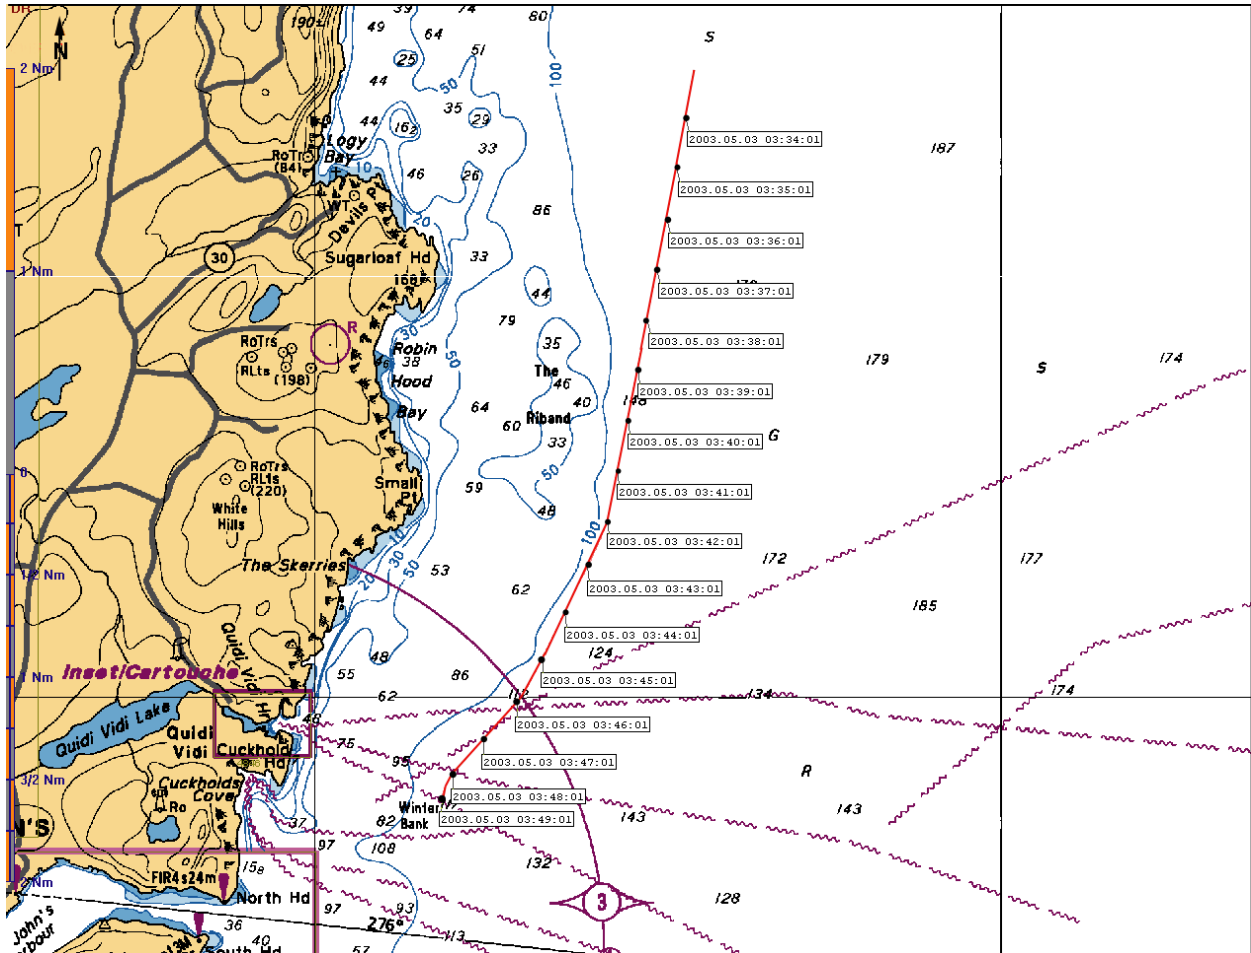
Figure 2. Track of the CCGS *Sir Wilfred Grenfell* prior to the collision (times shown in UTC)

The ECS is a navigational device that is integrated with the radar, the GPS and the Gyro compass. The vessel's progress can be monitored on an electronic chart with a radar overlay. This system also provides a recording and playback feature that can be used to recreate a vessel's course and speed with precision (see Figure 2).

The speed of the CCGS *Sir Wilfred Grenfell* prior to the collision, as obtained from the ECS recording, showed that the vessel was proceeding at a sustained speed of 15 knots until two minutes prior to the collision. At one minute before the collision, it was proceeding at a speed of 11 knots and, at the time of the collision, at about 6 knots.

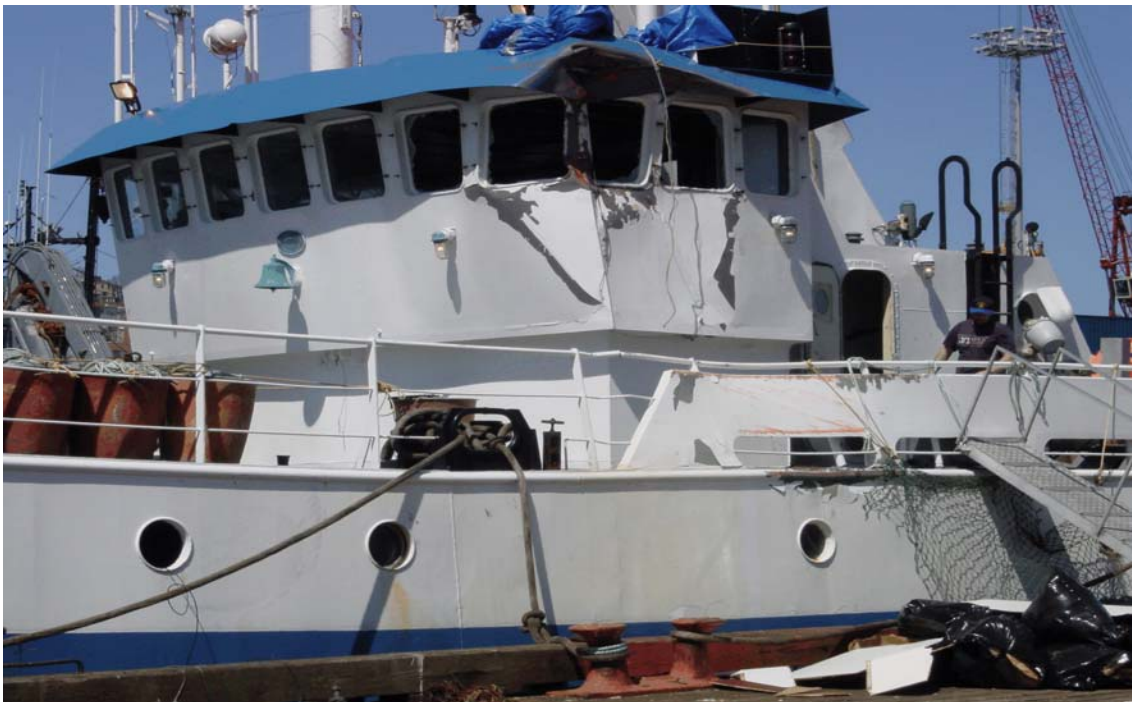
the waterline on the *Genny and Doug*. The collision caused extensive damage to the wheelhouse and lesser damage to the shell plating on the port side of the *Genny and Doug*. The CCGS *Sir Wilfred Grenfell* sustained a minimal amount of damage to her bow, comprising small dents and scratches. There was no injury and no pollution. The wind was from the southeast at 5 to 10 knots and the visibility was less than one-half mile.

**Photo 3.** The damaged superstructure of the *Genny and Doug*
