MARINE INVESTIGATION REPORT

M03W0073

ENGINE ROOM FIRE AND SUBSEQUENT FAILURE OF THE CO₂ DISTRIBUTION MANIFOLD

ROLL-ON/ROLL-OFF PASSENGER FERRY *QUEEN OF SURREY*
QUEEN CHARLOTTE CHANNEL, BRITISH COLUMBIA

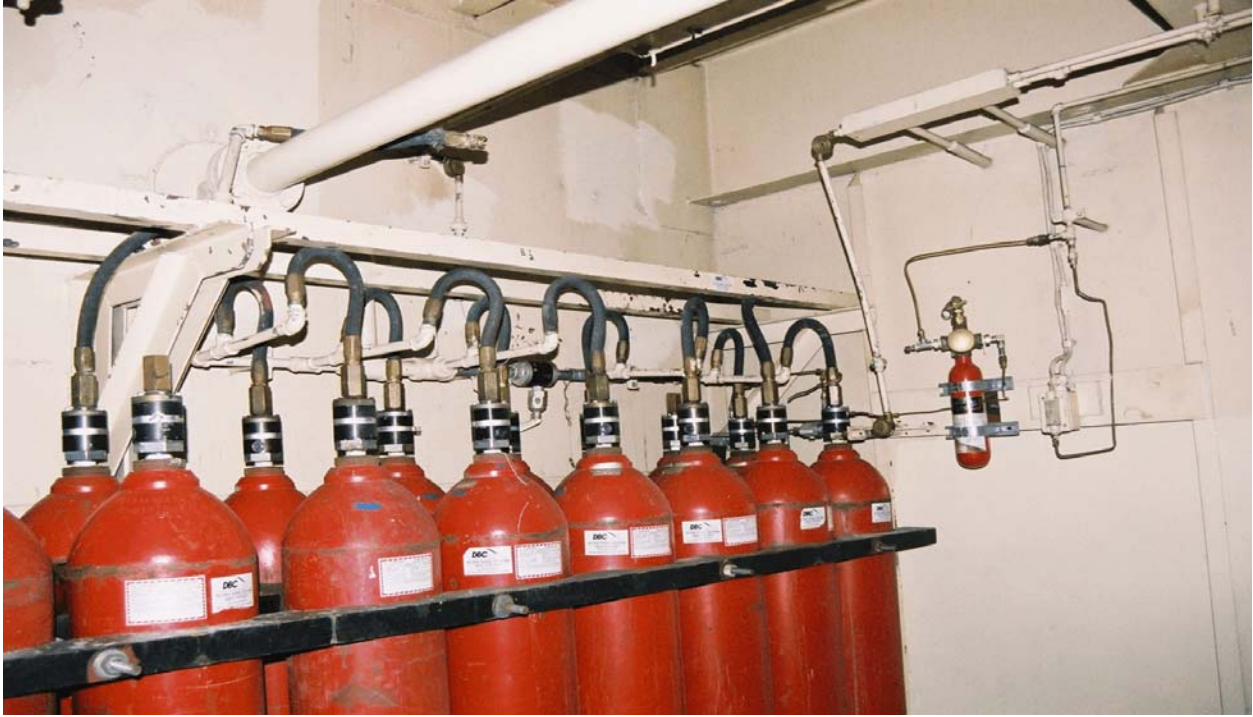
The CO₂ cylinders were arranged in three banks, rigidly clamped to the outboard, forward and inboard bulkheads of the CO₂ compartment. Each cylinder was connected to a distribution manifold by means of a flexible, reinforced, braided neoprene hose, which formed an inverted U between the top of the cylinder and the piping. The distribution manifold was made up in sections of sub-manifolds and branches, all constructed out of threaded, galvanized, schedule 40 steel pipe (or schedule 80, depending upon its diameter). An overhanging arrangement of steel frames and brackets was welded to the bulkheads, and it held the distribution piping by means of U clamps, which were passed around the pipes and bolted to the brackets (see Photo 2).

Photo 2. Bank of CO₂ cylinders and distribution manifold

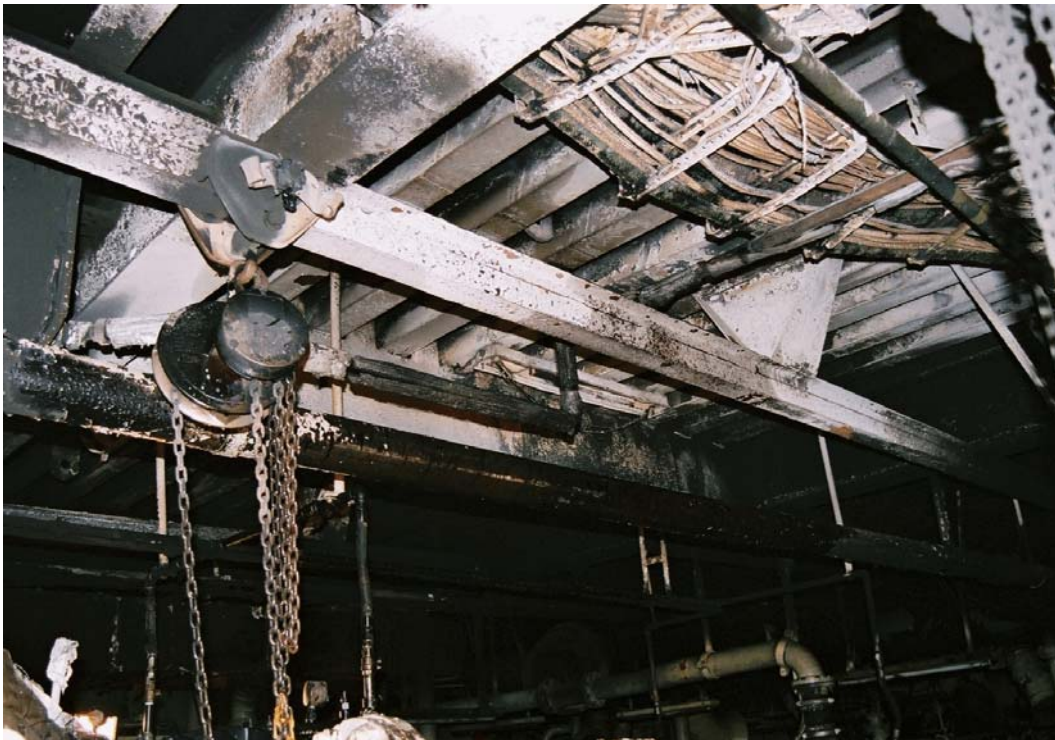
There was considerable fire and heat damage to the electrical cables that were laid out along the engine room deckhead, and large sections of these had to be renewed (see Photo 3).

Photo 3. Damage to engine room and electrical cables

The “clean burn” areas created by the high-intensity flames and the “shadowing” patterns created by the deposition of soot on the turbocharger air inlet casing, engine piping and cable trays located on the deckhead indicate the origin of the fire to be in between the turbocharger casing and the last cylinder on the engine’s A bank (see photos 3 and 5).

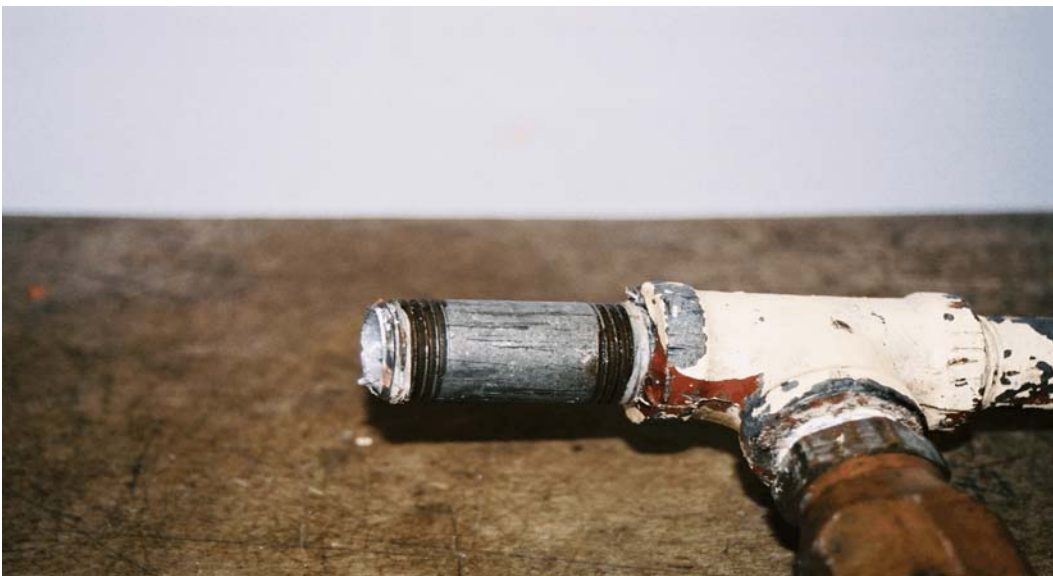
- the free ends of the flexible hoses had flailed around and caused some impact damage to the insulation on the after bulkhead of the CO₂ compartment; and
- manifold segments had fractured and sheared off at five different points (see Photo 4).

Photo 4. A fractured manifold pipe segment

The fractured pipe segments were sent to the TSB Engineering Laboratory for analysis.⁹ The examination under a scanning electron microscope confirmed that failure was due to fatigue pre-cracking, initiated at the thread root and probably as a result of excessive vibrations.

The threads on the pipes were found to have been “cut,” not rolled, probably with a die. As a result, the profiles of the threads were not smooth and had many sharp “notches” that became points of stress concentration, and this is where the pre-cracks, which led to the eventual multi-point failure of the manifold, initially developed.¹⁹

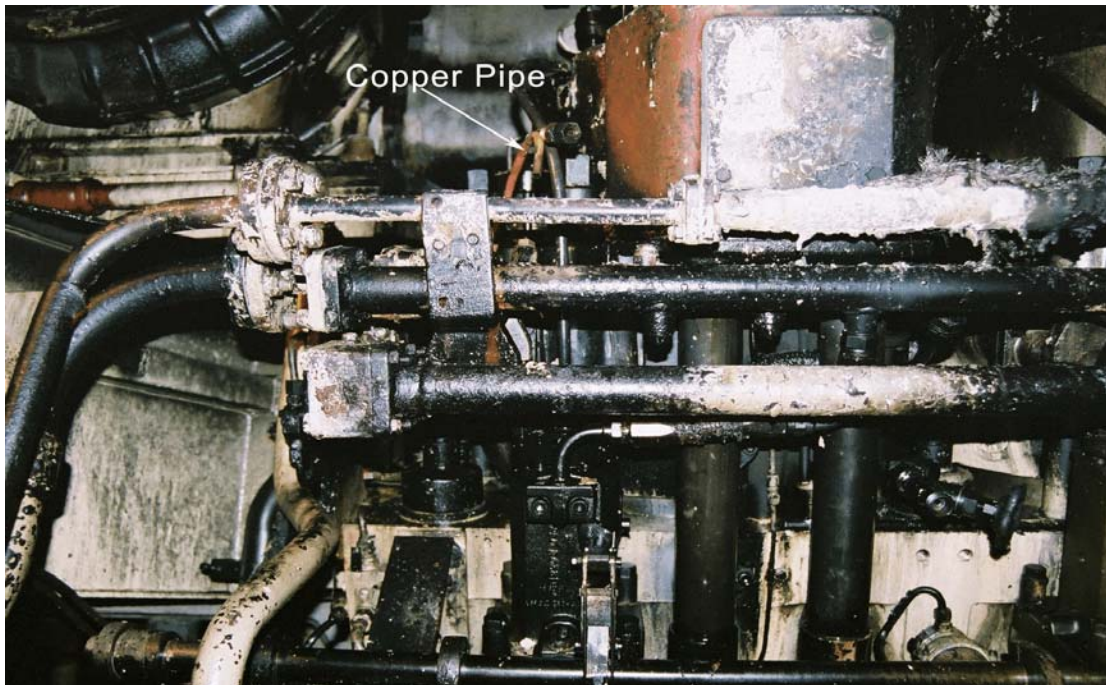
In this case, the pressure gauge connection pointed upwards towards the turbocharger gas inlet casing and the engine room deckhead (see Photo 5). This allowed the leaking fuel to come into contact with the heat source. Other take-offs from the fuel supply rail pointed downward, towards the engine foundation.

Photo 5. Spatial orientation of the fuel oil pressure gauge connection

Thus, the improper orientation of the pressure gauge connection take-off point directed pressurized diesel oil from the fractured pressure gauge pipe to spray onto the hot engine exhaust manifold.

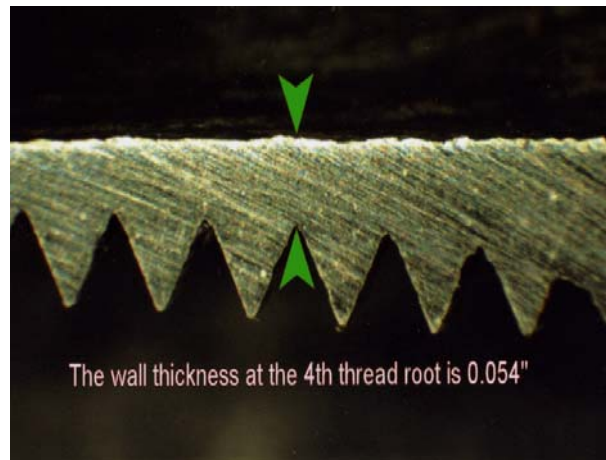
The process of cutting threads on the pipe reduced its wall thickness in way of the thread root. In order to gauge this, two 19 mm (3/4 inch) diameter, schedule 40 pipe segments were cut transversely, and the wall thicknesses at the root of the first thread outside the coupling pieces were measured. These were found to be 1.62 mm (0.064 inch) and 1.37 mm (0.054 inch) (see Photo 6).

Photo 6. Section through a schedule 40 pipe

A steel schedule 40 pipe of 19 mm (3/4 inch) diameter has a wall thickness of 2.87 mm and a bursting pressure of 59 400 kPa. Any reduction in the wall thickness has the effect of proportionately reducing its bursting pressure; thus, if the wall thickness at the thread root is half that of the non-threaded pipe wall, the longitudinal and circumferential stresses in this region will be twice as high, while the bursting pressure will drop to half.
