MARINE INVESTIGATION REPORT

M04W0006

COLLISION

**BETWEEN THE ROLL-ON/ROLL-OFF
VEHICLE/PASSENGER FERRY *QUEEN OF SURREY*
AND ASSIST TUG *CHARLES H. CATES V*
HORSESHOE BAY, BRITISH COLUMBIA
11 JANUARY 2004**

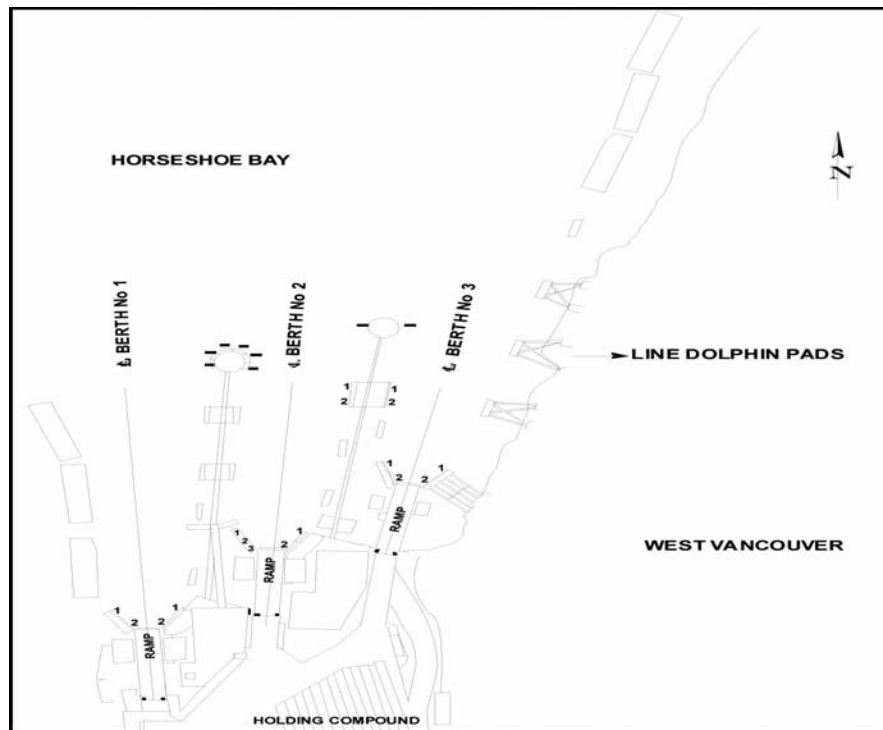
Figure 2. BCFC berths at Horseshoe Bay

The *Queen of Surrey* secured starboard side to the No. 3 berth (see Figure 2) in what appeared to be a smooth docking; no impact was felt either during its approach to the berth or while docking. Upon arrival, and after consulting with the chief engineer, the master decided to retain the services of the tug for the next docking at Horseshoe Bay scheduled for 0900. On contacting the *Cates V* to relay this request, the tug skipper informed the ferry that the *Cates V* had sustained damage to its bridge windows and the wheelhouse, and that it would be necessary to order another tug.

Unknown to the bridge team on the *Queen of Surrey*, the *Cates V* had been positioned on a westerly heading, between two of the line dolphin pads located on the shoreline. As the ferry drew alongside the berth, its stern swung to port, pushing the tug and trapping it between the ferry's rubbing strake and the line dolphin pads.

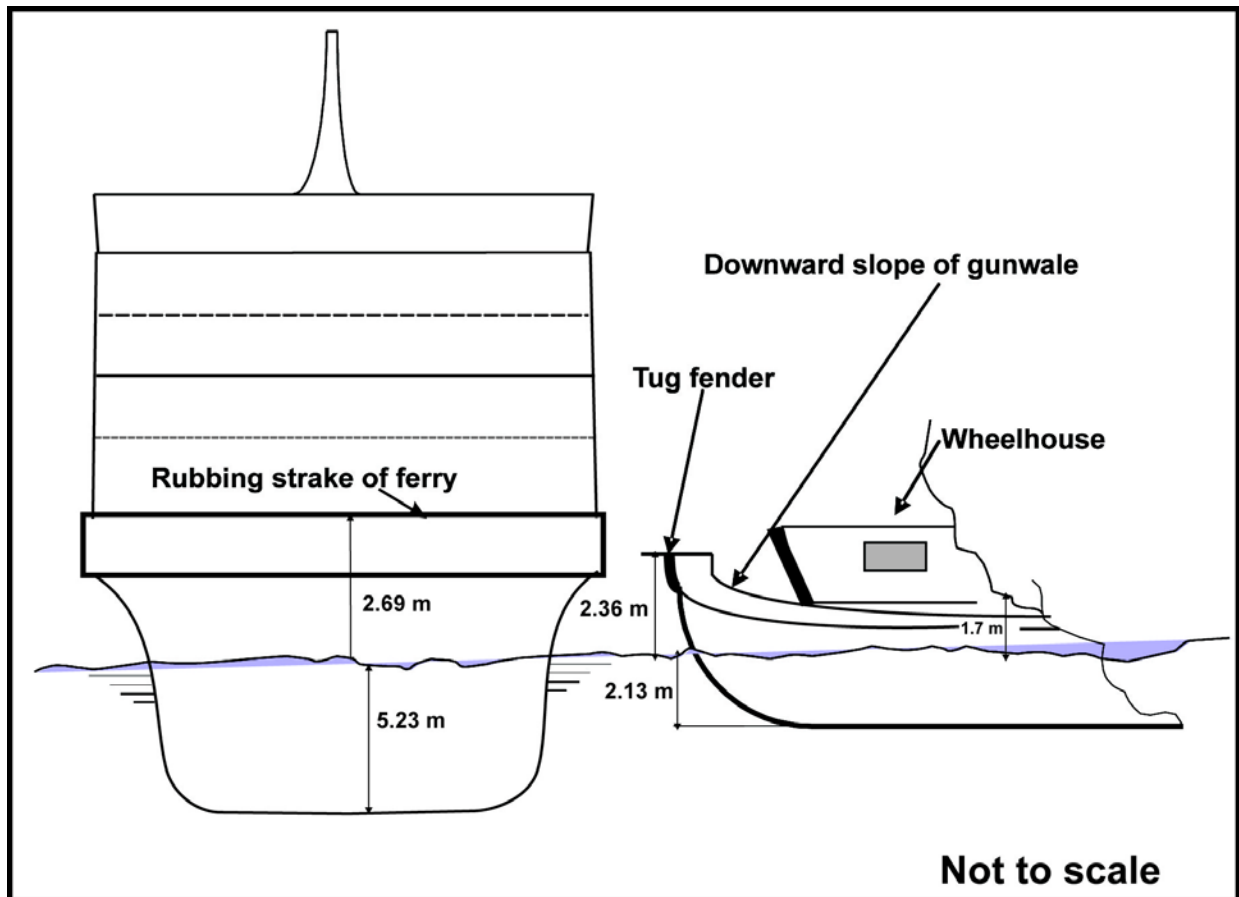
Figure 3. Vessel profiles

The 0.46 m rubbing strake that protrudes along the sides of the *Queen of Surrey's* main deck is 7.92 m above the keel. The hull form below this protrusion falls away sharply, sloping inwards towards the centre of the keel. At a mean draft of 5.23 m, the freeboard⁶ of the vessel is 2.69 m.

The *Cates V* usually operates at a draught of 2.13 m forward and 2.24 m aft. At these draughts, the top of the forward fender arrangement of the vessel is 2.36 m above the waterline. The amidships gunwale is 1.70 m above the waterline, and the stern gunwale is at a height of 1.52 m above the waterline.

As illustrated in Figure 3, the location of the rubbing strake on the *Queen of Surrey*, the freeboard of the tug, and the sloping of the gunwale render the superstructure of the tug vulnerable to damage while alongside the ferry.

Given the relative heights of the rubbing strake, the tug's freeboard, and the slope of the tug's gunwale, the *Cates V* can only push the ferry from the side by positioning its bow at right angles to the ferry. The protection provided by the raised gunwale and high fenders at the tug's bow is lost in any other position because of the pronounced downward slope of the gunwale. There was no protocol for the profile of the tug to be matched to that of the vessel it was assigned to assist.

While the tug was manoeuvring into position, it was inadvertently pushed to port and off its heading by the ferry's propeller wash and then pushed further by the ferry's port quarter, which unexpectedly swung out towards the tug. This caused the tug to assume an angle where the rubbing strake of the ferry came into contact with the wheelhouse structure, crushing it and pushing the tug between the ferry and the line dolphin pads.
