**MARINE INVESTIGATION REPORT**  
**M06C0058**

**STRIKING OF LOCK ARRESTER CABLE**

**PUSHER TUG *PETITE FORTE* AND BARGE *ST. MARYS CEMENT***  
**LOCK 4, WELLAND CANAL**  
**ST. CATHARINES, ONTARIO**  
**02 OCTOBER 2006**

Report Number M06C0058

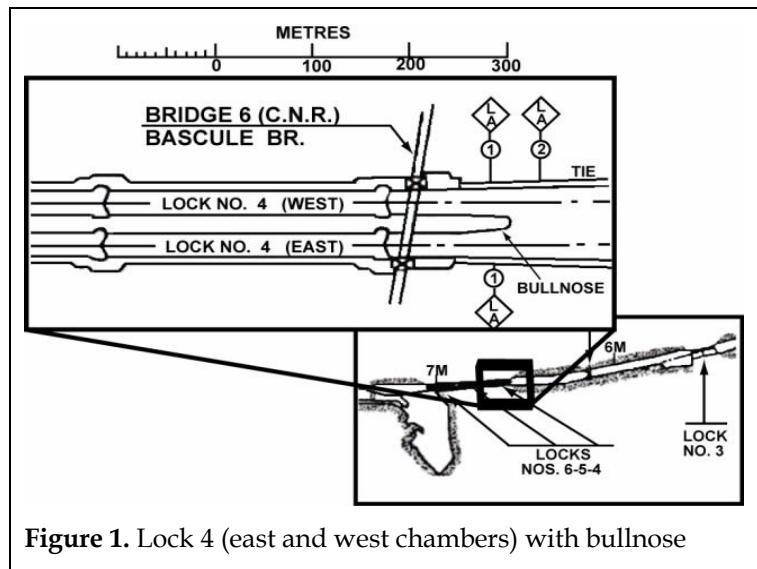
**Figure 1.** Lock 4 (east and west chambers) with bullnose

The term, although not specifically defined, applies to an approximate area from the lock chamber gates up to and including the tip of the bullnose, but not usually beyond the point L/A2 (Limit of Approach 2), which is approximately 25 to 30 m beyond the bullnose (see Figure 1). In practice and for the Lock 4 area, the term is generally taken to mean that a vessel's bow be positioned outside of the open lock gate doors and near or slightly forward of the tip of the bullnose. The position for the head of the lock will change from lock to lock according to lock construction variations and Seaway traffic control instructions.

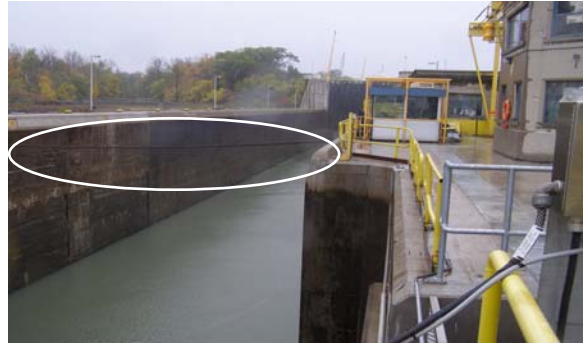
**Photo 5.** Daylight view of Lock 4's east chamber, with ship-arrester cable lowered in place (circled on the photo)

Photo 5, taken in daylight, shows the arrester cable as difficult to see against the background of Lock 4. In darkness, when the area was lit by shore-side floodlights, the difficulty increased particularly since the cable was cast in partial shadow. The shore-side lighting and restricted view from the lower wheelhouse made the arrester cable difficult to detect.

Following this occurrence, the St. Lawrence Seaway Management Corporation instructed lock operators that vessels are to be informed when the arrester cable has been lowered or when the lock preparation cycle has begun.

Additionally, the St. Lawrence Seaway Management Corporation has since covered arrester cables with a fluorescent yellow wrap to make them more visible for spotting purposes.

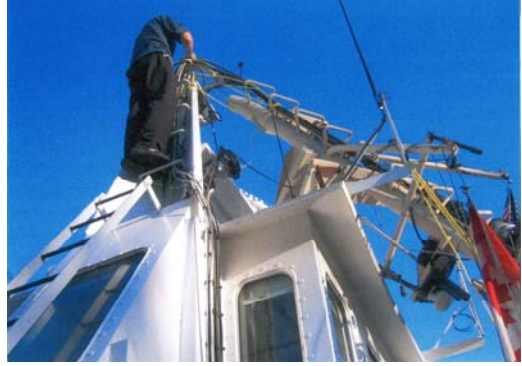
At 0615, while drifting astern with the water surge, the tug's mast struck the ship-arrester cable. The impact buckled the mast and disabled most of the electronic navigation and communication equipment. The arrester cable's connecting link attachments, as well as the mechanical/spring buffer system, were also damaged.

The *Petite Forte* suffered damage to its main mast, which was sheared-off at the deck. All the electronic navigation and communication equipment was rendered non-operational including the following: radars, DGPS unit, navigational lights, anchor release antennae, and radio antennae (see Photo 6).

**Photo 6.** Damaged mast and radar assembly on *Petite Forte*
