**MARINE INVESTIGATION REPORT**  
**M07L0040**

**GROUNDING**

**CHEMICAL/PRODUCTS TANKER *SICHEM ANELINE***  
**PORT OF MONTRÉAL, QUEBEC**  
**11 APRIL 2007**

Report Number M07L0040

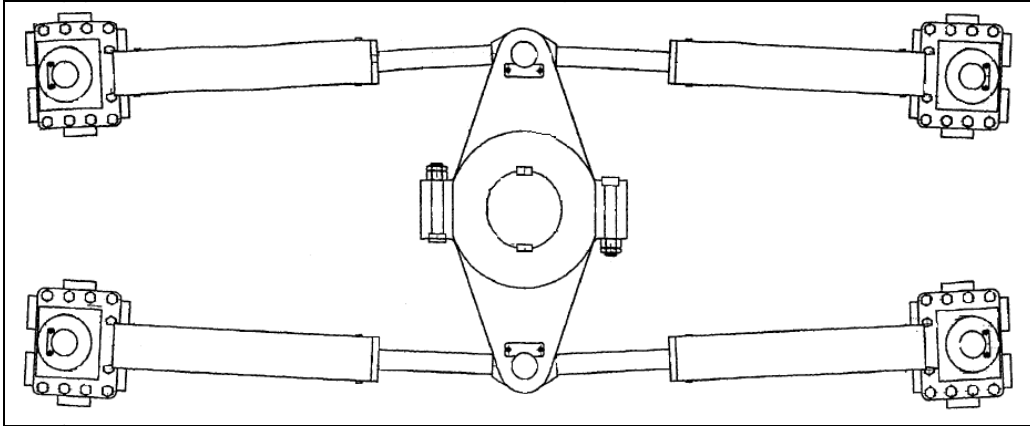
**Figure 1.** Steering gear arrangement

The electrohydraulic steering gear on the *Sichem Aneline* was manufactured by Fluidmecanica S.A. of Vigo, Spain. Four rams are hydraulically connected to twin power unit arrangements (see Figure 1).

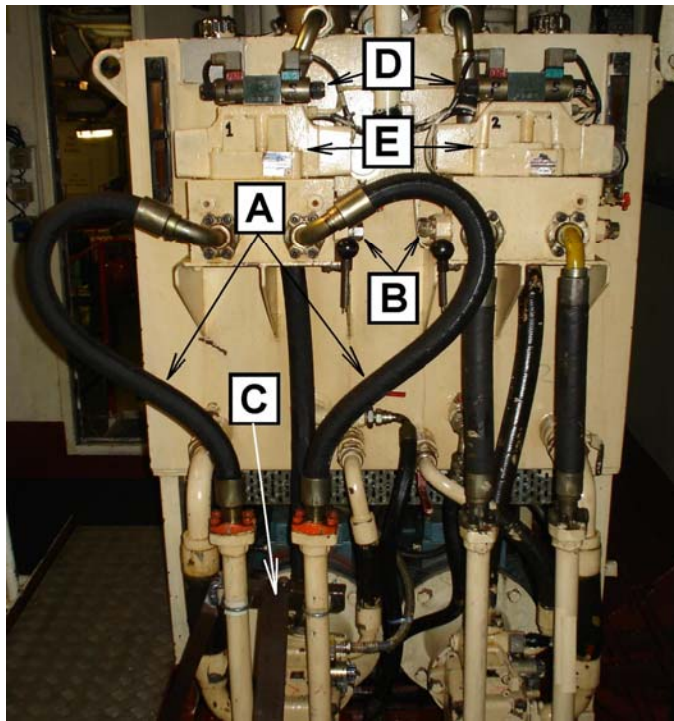
**Photo 2.** Valve block and hose arrangement

Each power unit has an electric motor and hydraulic vane pump, as well as a control system (block valve assembly including, among others, the pilot valve: see "D" in Photo 2), directional valve (see "E" in Photo 2), and its associated counterbalancing valves (see "B" in Photo 2).

- oil leaking from all eight counterbalancing valves (four on each unit);
- missing and damaged O-rings on counterbalancing valves;
- dried and cracked O-rings in No. 2 pilot valve;
- oil filters contained considerable debris, some of which appeared to be white pieces of teflon similar to material used in the O-rings;
- inoperative unloader valve on No. 2 unit;<sup>4</sup>
- main output hoses of incorrect length on No. 1 unit (see "A" in Photo 2);
- recently welded support bars in way of main output hoses on No. 1 unit so as to reduce the lateral forces that these hoses were subjected to due to incorrect length and 180-degree deviation (see "C" in Photo 2); and
- running times of units No. 1 and No. 2 were indicated as 21 693 and 14 310 hours, respectively.

In this instance, no notes or conditions of class were issued to record the fact that the hydraulic hoses fitted to the No. 1 power unit were longer than necessary and not fitted within the confines of the conduit for which they were designed. To help withstand the lateral forces acting on the hose under operational conditions, the hoses were clamped to a stabilizing bar fabricated by crew members.

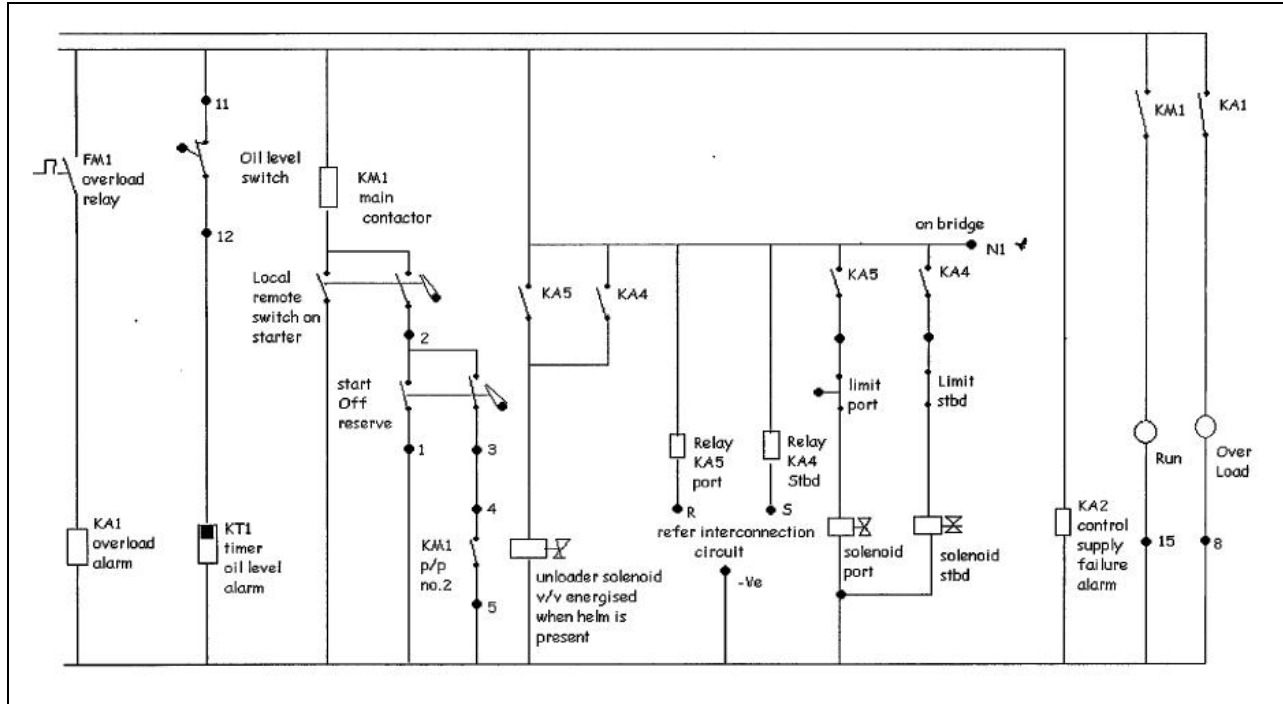
## Appendix B – Starter Box Wiring Diagram

and the steering gear that subsequently caused the malfunction of relays KA4 and KA5. The manufacturer corrected this malfunction on the *Gran Canaria Car* by re-wiring the starter boxes of the power pack units such that relays KA4 and KA5 were bypassed.<sup>6</sup>

Although the cause of the steering gear malfunction still cannot be determined, it is likely that an electrical anomaly occurred somewhere between and including the steering control stand and the power unit starter boxes in the steering flat. Action taken by the steering gear manufacturer on this vessel (see the *Safety Action* section of this report) and on the *Gran Canaria Car* indicates that there may be intermittent problems with relays KA4 and KA5 located in the power unit starter boxes.
