MARINE INVESTIGATION REPORT

M07N0117

CAPSIZING AND LOSS OF LIFE

SMALL FISHING VESSEL *SEA URCHIN*
NEWMAN SOUND, NEWFOUNDLAND AND LABRADOR
04 NOVEMBER 2007

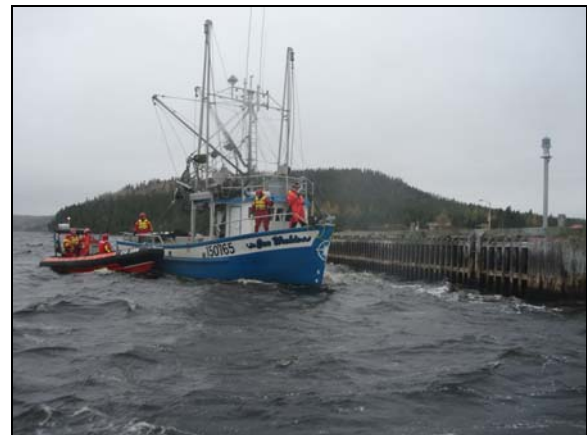
Photo 1. The *Sea Urchin* on the day of the occurrence
