MARINE INVESTIGATION REPORT

M08W0189

CAPSIZING AND SUBSEQUENT SINKING

SMALL FISHING VESSEL *LOVE AND ANARCHY*

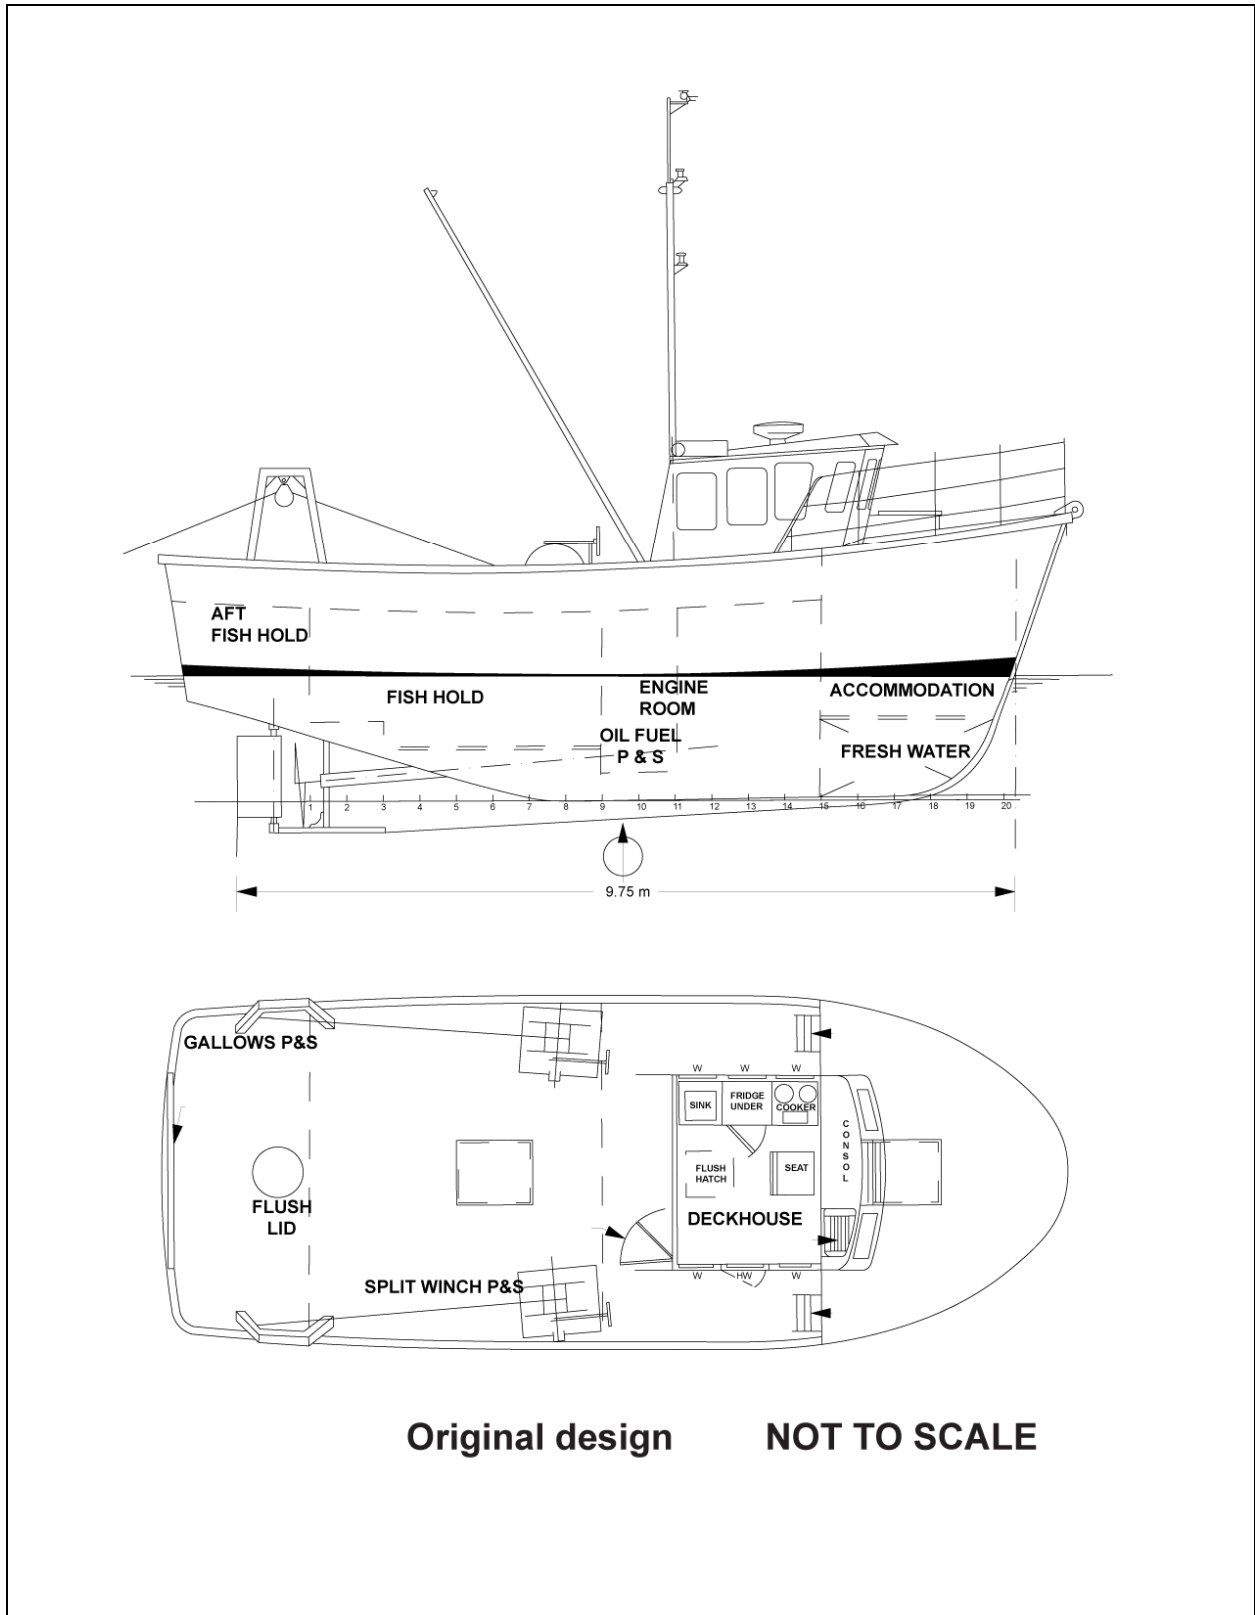
Appendix A-1 – Vessel General Arrangement

The *Love and Anarchy* was built as a small fishing vessel of closed construction with a welded steel hull. The aluminum deckhouse, the crew accommodation, and engine room space were located forward of amidships. Below the main working deck, three transverse watertight bulkheads subdivided the hull into crew accommodation, engine room, four insulated fish holds, and the lazarette (see Appendix A-1).

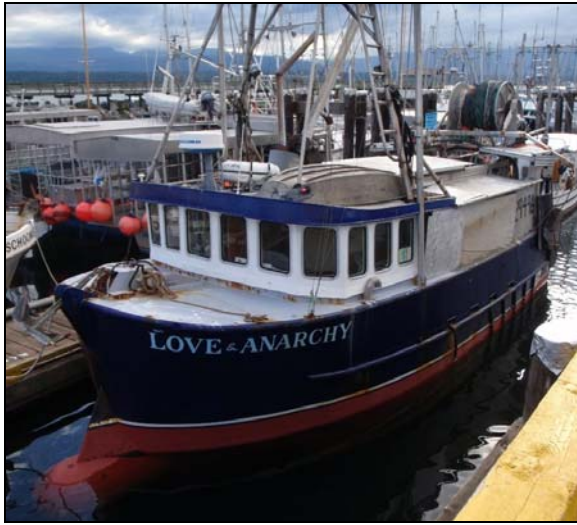
Photo 2. Front view showing aluminum canopy over working deck

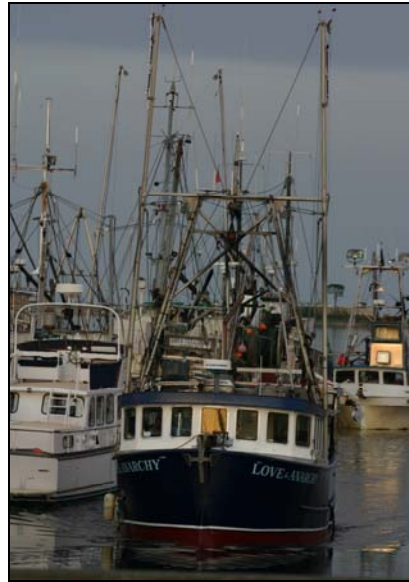
The vessel had a permanent port list (see Appendix C, Photo 3), which had been apparent since at least 1995.

- First, the vessel had a permanent port list, the cause of which was unknown.
- This was complicated by the development of the second, unexplained port list, and the owner's inability to correct it on 04 September 2008. This would suggest either an ingress of water below the waterline, or else a shift of weight on the vessel. Nonetheless, when the vessel lay at anchor broadside to the waves, water was being shipped on deck; the water then entered the fish holds through hatch covers that were not watertight. This resulted in free-surface effects – which is caused by liquids moving in fish holds, tanks, and on deck – and led to a further, virtual rise in the vessel's centre of gravity.

Photo 3. Bow view showing port list

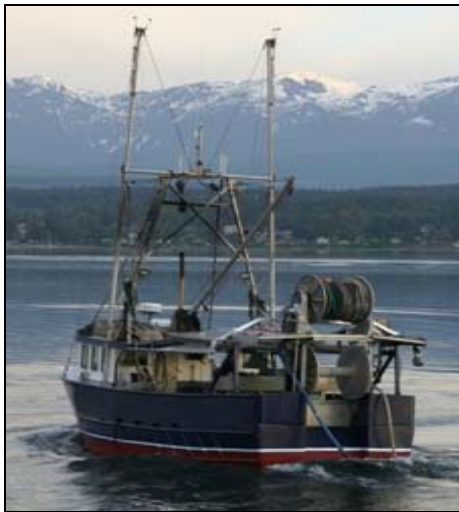
The vessel had undergone several modifications, including some to meet the Department of Fisheries and Oceans (DFO) licence length restrictions, and others to accommodate multiple fisheries. For example, among other changes, the addition of a second trawl drum above the original, combined with the removal of 0.76 m from the bow and the addition of 0.61 m to the stern, changed the vessel's original waterplane area and displacement. Combined with the stowage of fish in totes on deck, as opposed to in the holds, these changes¹⁹ likely resulted in a raised centre of gravity.

Photo 4. Stern view showing additional trawl, A-frame rigging, trawl stanchion
