MARINE INVESTIGATION REPORT
M09L0074

CAPSIZING WITH LOSS OF LIFE

SMALL FISHING VESSEL *LE MARSOUIN I*
OFF RIVIÈRE-AU-RENARD, QUEBEC
18 MAY 2009

Report Number M09L0074

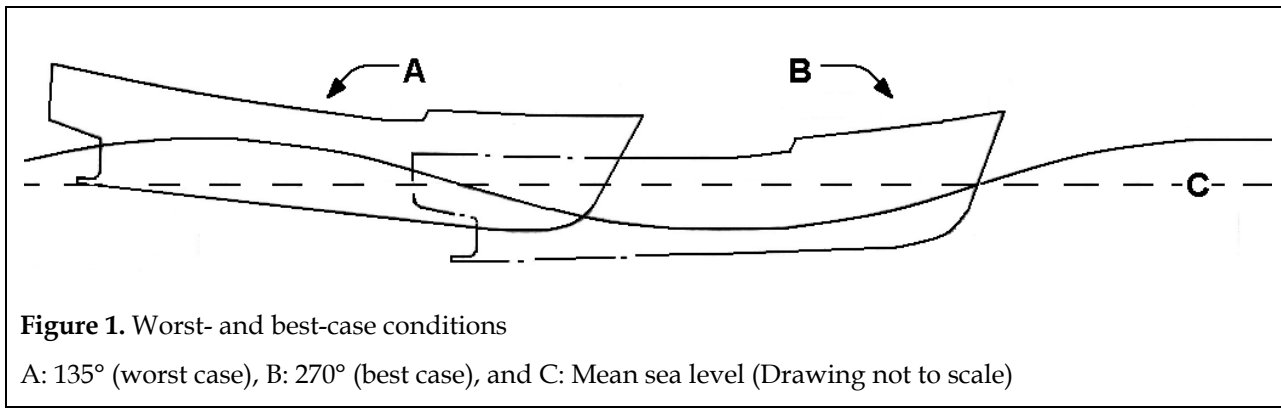
GZ curves were produced for various positions of a wave crest along the hull (see Figure 1). These assumed an average wave height of 0.9 m (3 ft) and a 45° angle of encounter (from the longitudinal axis after end). These were then compared against a condition where there were no waves. Results show that stability in waves was less than when no waves were present, except for a wave phase of 270°. At this phase, the righting lever amounts to 71% of the STAB 4 minimum, and the range of positive stability is 54°. The worst-case condition occurs at the wave phase 135°, wherein the area under the GZ curve represents just 6% of the STAB 4 minimum and the range of positive stability is only 20°. This corresponds to an angle of vanishing stability of 40° (see Appendix D – Graph 2).

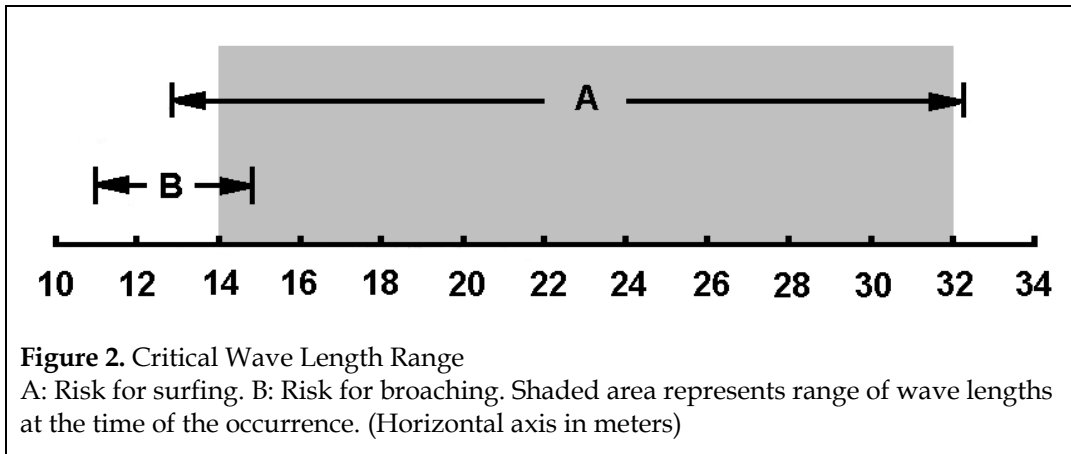
When the wave length is between 1 to 2.5 times a vessel's waterline length, there is an increased risk of surfing. Figure 2 shows that, in this occurrence, the wave length was within this critical range and, to a much lesser extent, also within the critical range for broaching.

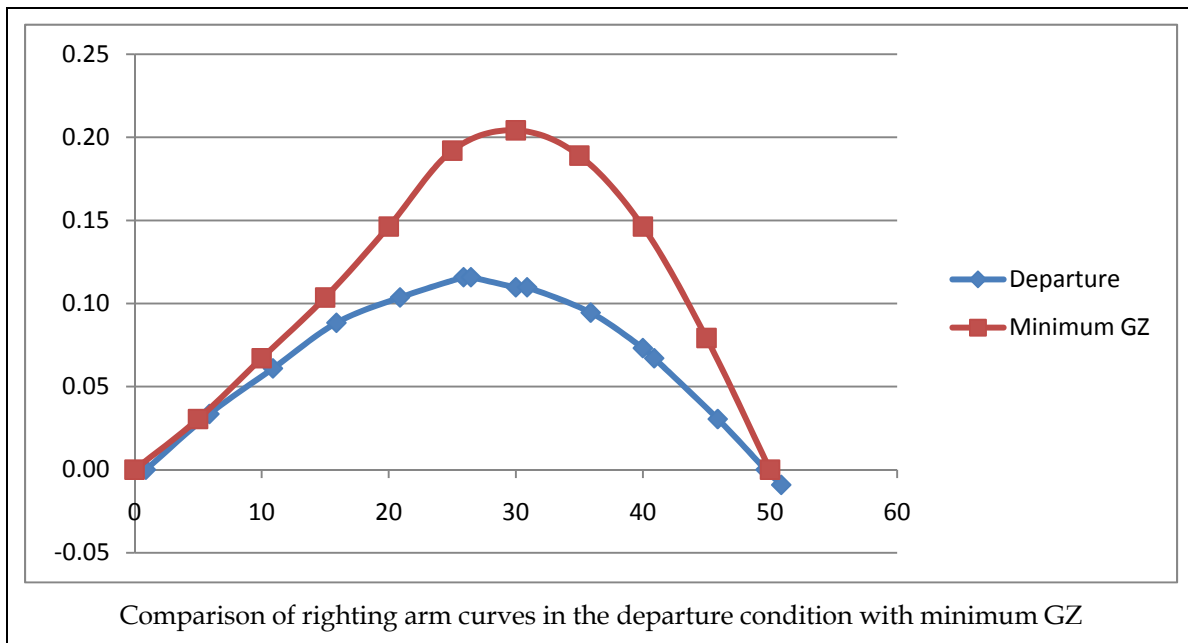
Graph 1. Curves of statical stability as a function of the departure condition and the standard of reference

In the departure condition after unloading the crab and with no wave action (i.e., dockside in calm water), the vessel's stability did not meet the majority of the STAB 4 criteria. For instance, the area under the righting arm (GZ) curve at 30° of heel was only 70% of the STAB 4 minimum; at 40°, it was 61%. The initial stability was also slightly further reduced on starboard side as the vessel had a slight list on that side (see Table 1 and Appendix D – Graph 1).

A comparison of the GZ curves in the departure condition for the vessel with the minimum STAB 4 reference criteria provides a clear indication of how limited the vessel’s stability was at the time of capsizing: the area under the “departure” line is much smaller than that under the “minimum GZ” line.

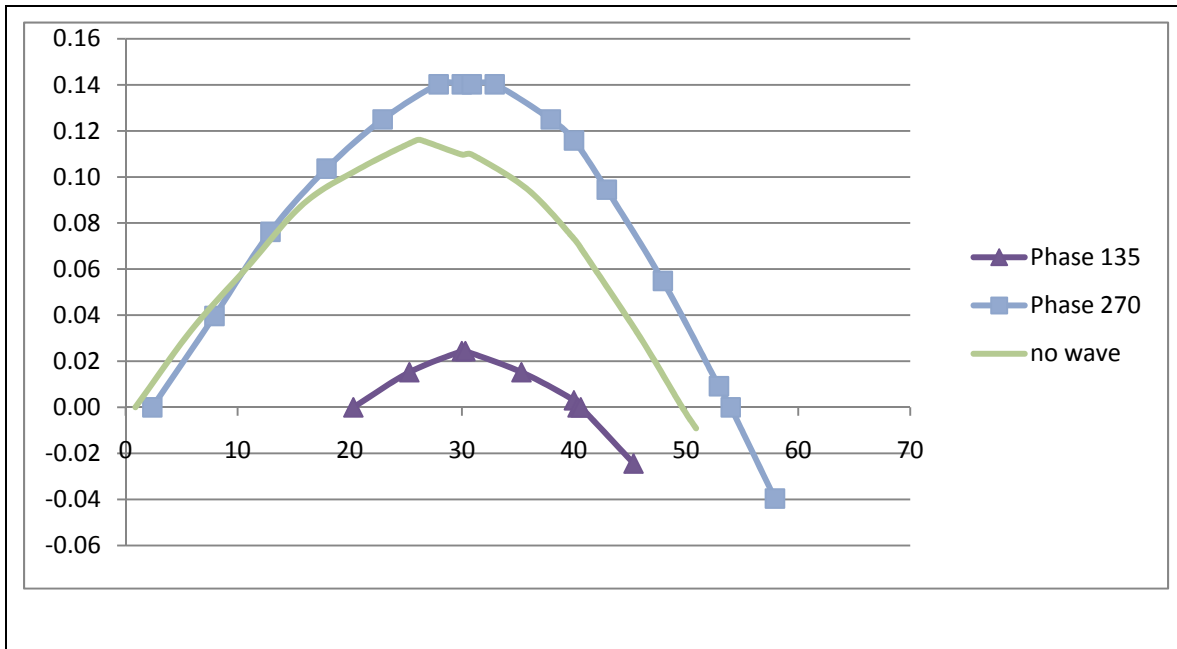
Graph 2. Curves of statical stability as a function of the position of the wave crest along the hull (angles of phase)

The vessel is most stable at phase 270° (curve with the highest peak and the largest area) and least stable at phase 135°.

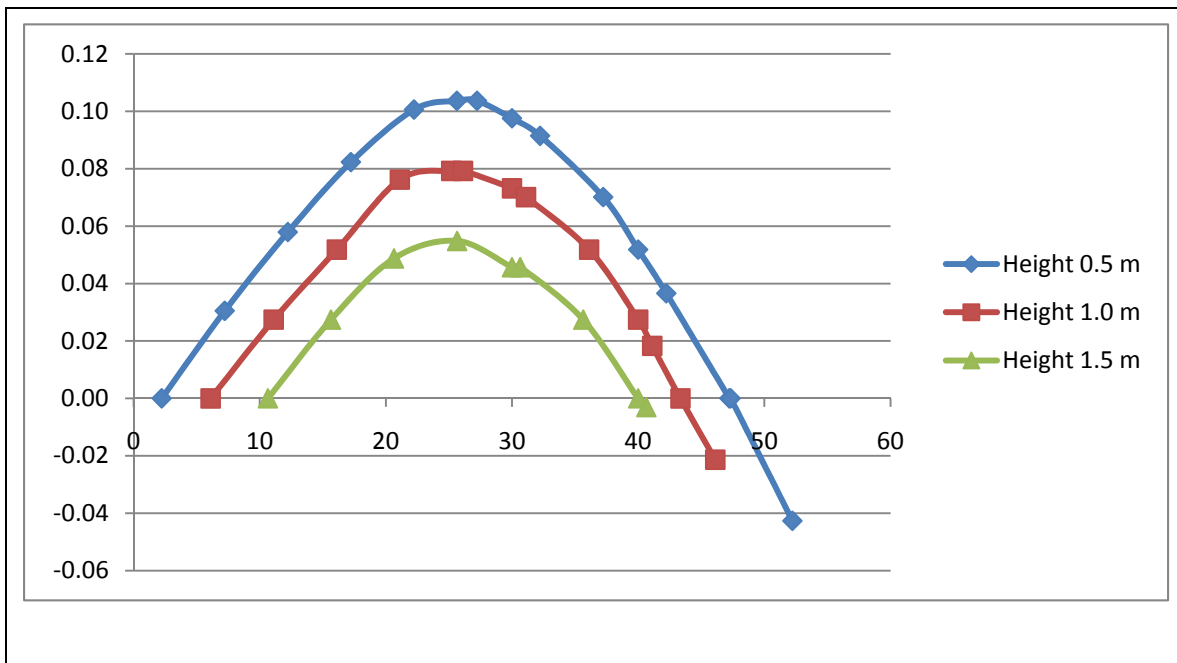
Graph 3. Curves of statical stability as a function of various wave heights

GZ curves were also produced for three different wave heights (0.5 m, 1.0 m, 1.5 m). Results show that the area under the GZ curve was 60%, 40%, and 24%, respectively, of the STAB 4 minimum between 0° and 30° of heel (see Appendix D – Graph 3).

The righting lever curves indicate that the higher the wave, the less stable the vessel (area under the 1.5 m curve is the smallest). A comparison of the GZ curves revealed that this variable had a significant impact on the reserve stability of this vessel.

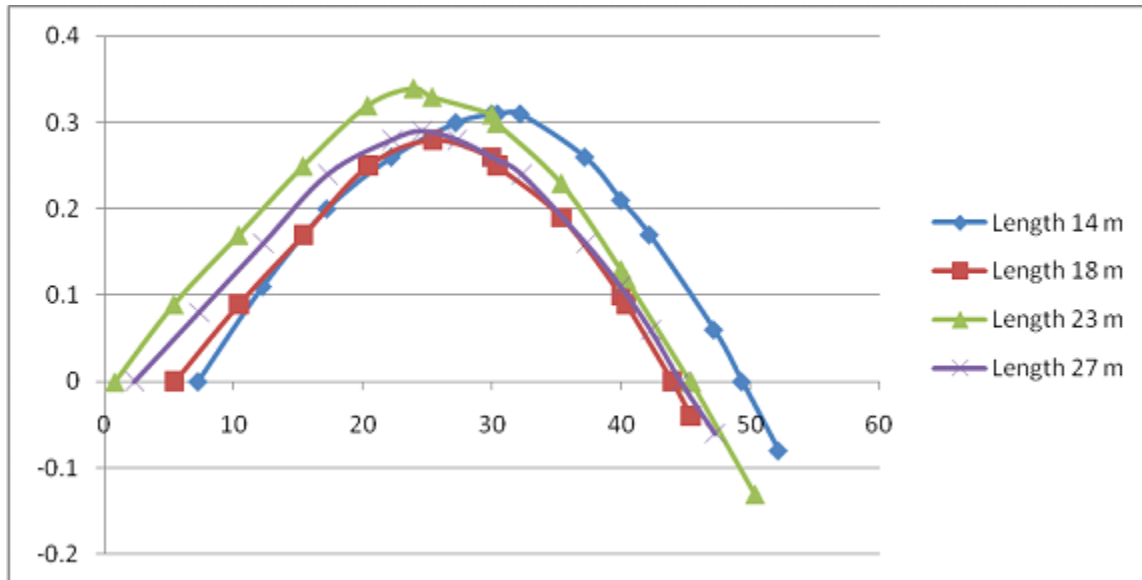
Graph 4. Curves of statical stability as a function of various wave height /lengths

Note the similarity of the righting arm curves for various ratios of wave height to wavelength.

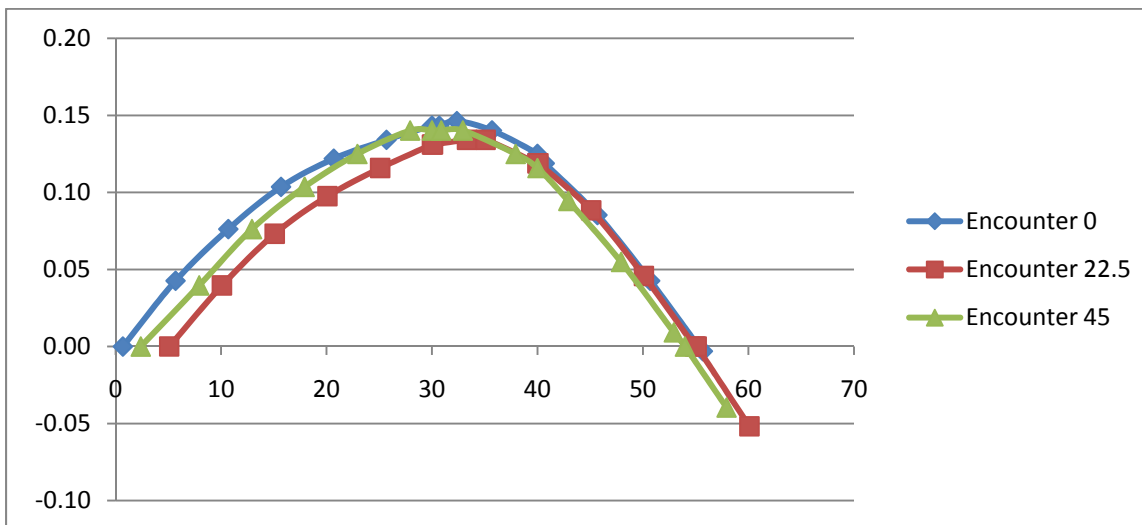
Graph 5. Curves of statical stability as a function of various angles of encounter with the vessel's bow

Using the best-case condition of wave phase 270°, GZ curves were produced for three different angles of encounter: broad on the stern to quartering seas (i.e., between 0°, 22.5°, and 45° from the longitudinal axis after end). A comparison between these GZ curves for these angles indicated no significant variation (see Appendix D – Graph 5).

The righting lever curves for various angles of encounter are similar in height and area, indicating that the wave's angle of encounter had little bearing on vessel stability.

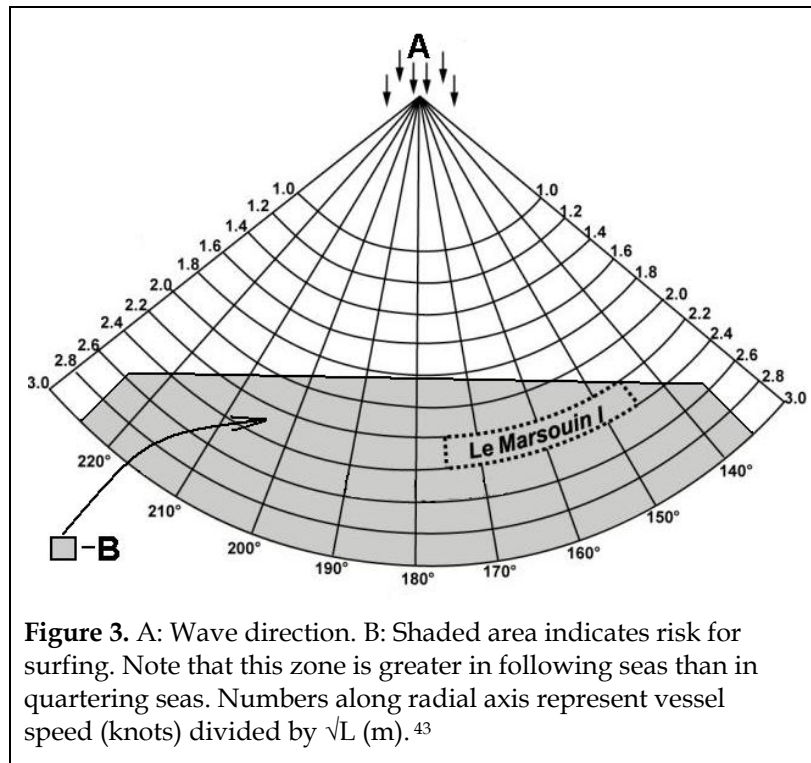
Figure 3. A: Wave direction. B: Shaded area indicates risk for surfing. Note that this zone is greater in following seas than in quartering seas. Numbers along radial axis represent vessel speed (knots) divided by \sqrt{L} (m).⁴³
