**MARINE INVESTIGATION REPORT  
M10F0003**

**KNOCKDOWN AND CAPSIZING**

**SAIL TRAINING YACHT *CONCORDIA*  
300 MILES SSE OFF RIO DE JANEIRO, BRAZIL  
17 FEBRUARY 2010**

Report Number M10F0003

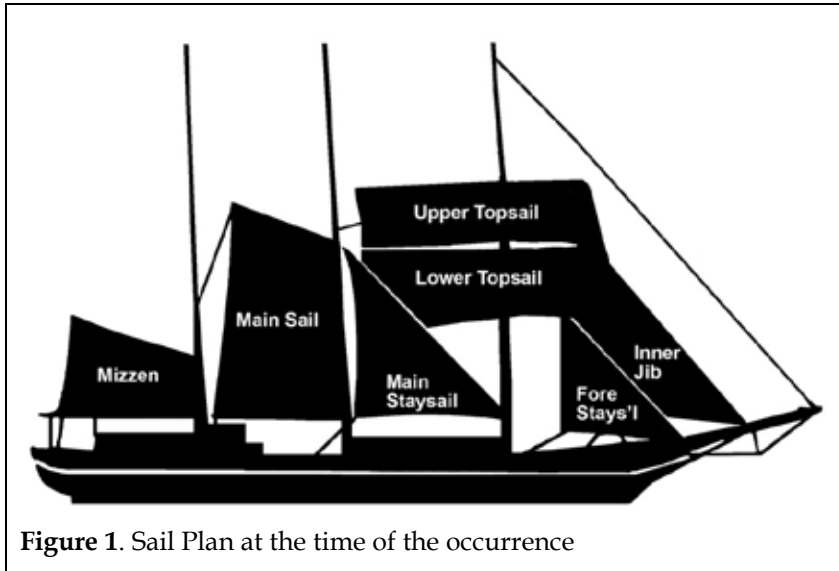
Figure 1. Sail Plan at the time of the occurrence

On the morning of 17 February 2010, in anticipation of the expected weather, the master shortened sail, culminating in the following sail plan at the end of his watch (1200): inner jib, fore staysail, upper and lower topsails, main staysail, main, and reefed mizzen sails (see Figure 1).<sup>12</sup> The 2/O, whose watch was from 12 to 4,

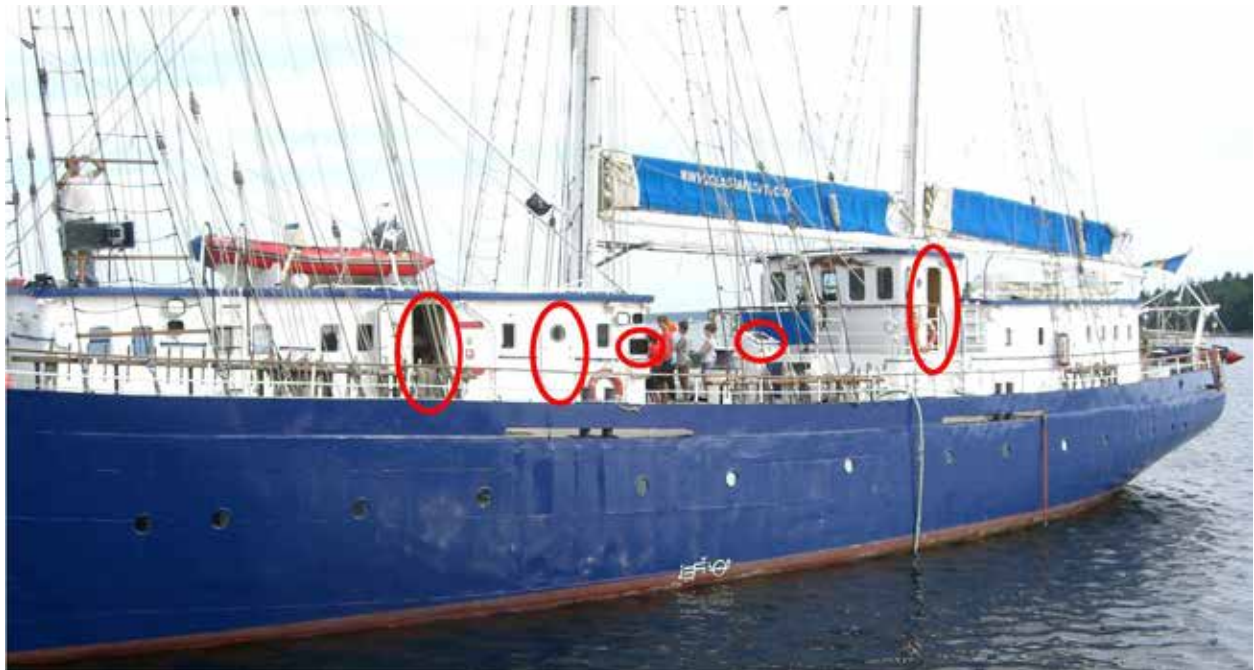
**Photo 3.** Some critical port side openings

Description	Angle of Immersion
Galley Door (forward deckhouse, port side)	56.5°
Mess Door (forward deckhouse, port side)	58.4°
Sanitary Exhaust Vent (forward deckhouse, port side) <sup>Note</sup>	65.0°
Radio Room Window (aft deckhouse, port side)	68.6°
Wheelhouse Door (aft deckhouse, port side)	74.2°
Chart room interior door	87.9°
Engine Exhaust (top of mizzen mast) <sup>Note</sup>	91.7°
Engine Room Skylight (forward of wheelhouse, offset to starboard) <sup>Note</sup>	100.5°
Mess Stairway (inside forward deckhouse) <sup>Note</sup>	116.5°

Note: Immersion of these openings would lead to downflooding of the hull.

Circled from forward to aft: mess room door, galley door, sanitary exhaust vent, engine room skylight and wheelhouse door.

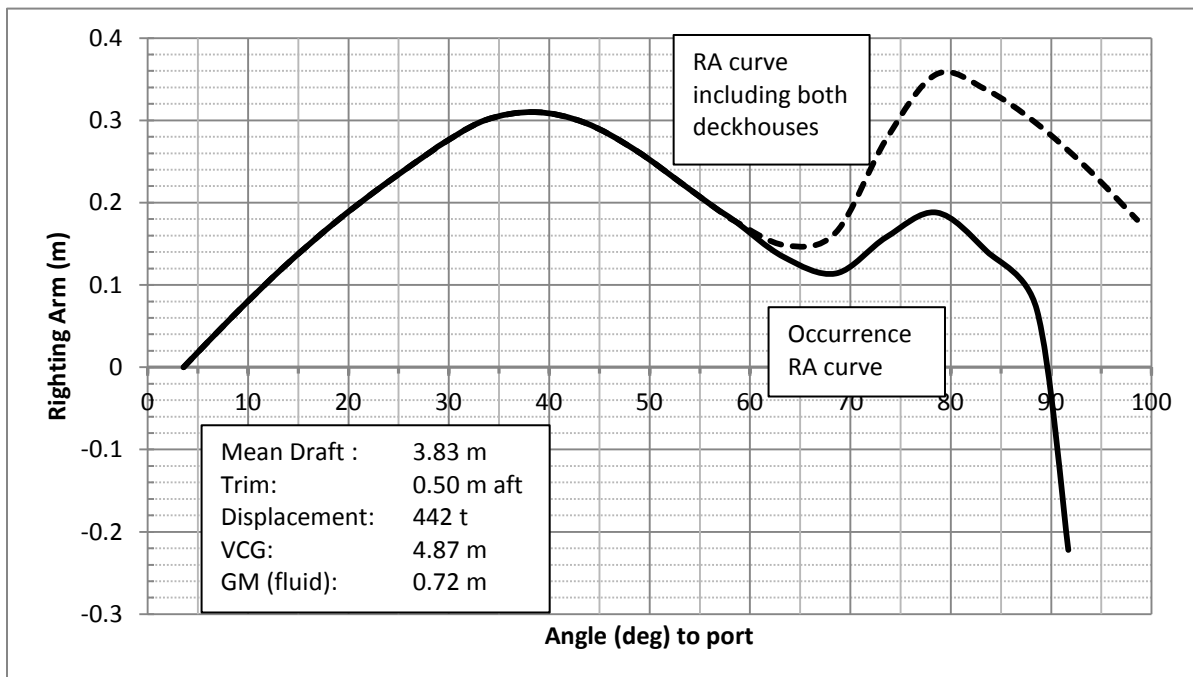
**Figure 5.** Occurrence righting arm (RA) curve<sup>63</sup> showing the effect of lost buoyancy from the deckhouses

The RA curves presented in *Concordia's* stability booklet are based on the assumption that the weathertight doors in the 2 deckhouses are secured closed, and thus that the deckhouses contribute to the vessel's buoyancy. The resulting effect on the vessel's righting ability can be seen as a second 'bump' in the RA curve beyond angles of around 60° (see Figure 5).

As mentioned previously, the deckhouse doors on the port side were open at the time of the occurrence. The resulting effect on the vessel's righting ability was modelled by eliminating the buoyancy contribution of the relevant deckhouse beyond those angles which would immerse its door(s) as shown in Table 3—the forward deckhouse was discounted after about 58 degrees and the aft deckhouse after about 88 degrees. The RA curve at the time the occurrence was thereby derived and is shown in Figure 5 below.

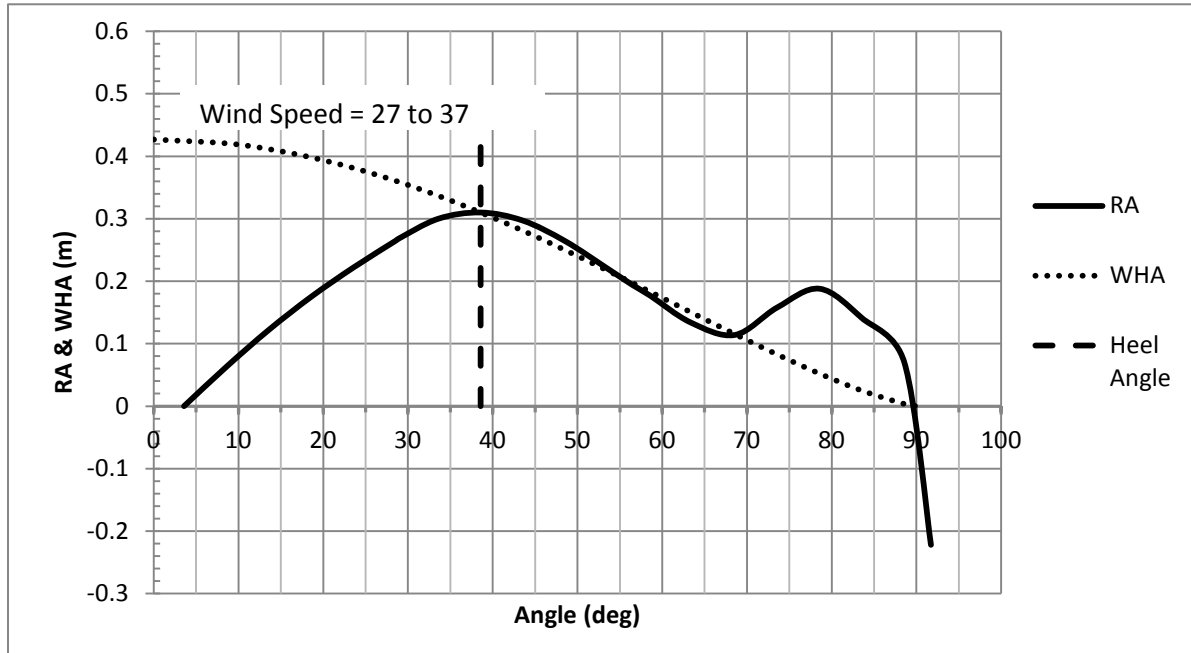
Figure 6. Occurrence righting arm (RA) / wind heeling arm (WHA) curves

It can also be seen in Appendix G that to induce wind heel angles beyond 70° or so, the necessary apparent wind speeds increase significantly to the point where winds in excess of 60 knots would be required to knock the vessel down to an angle in the range of 80°.

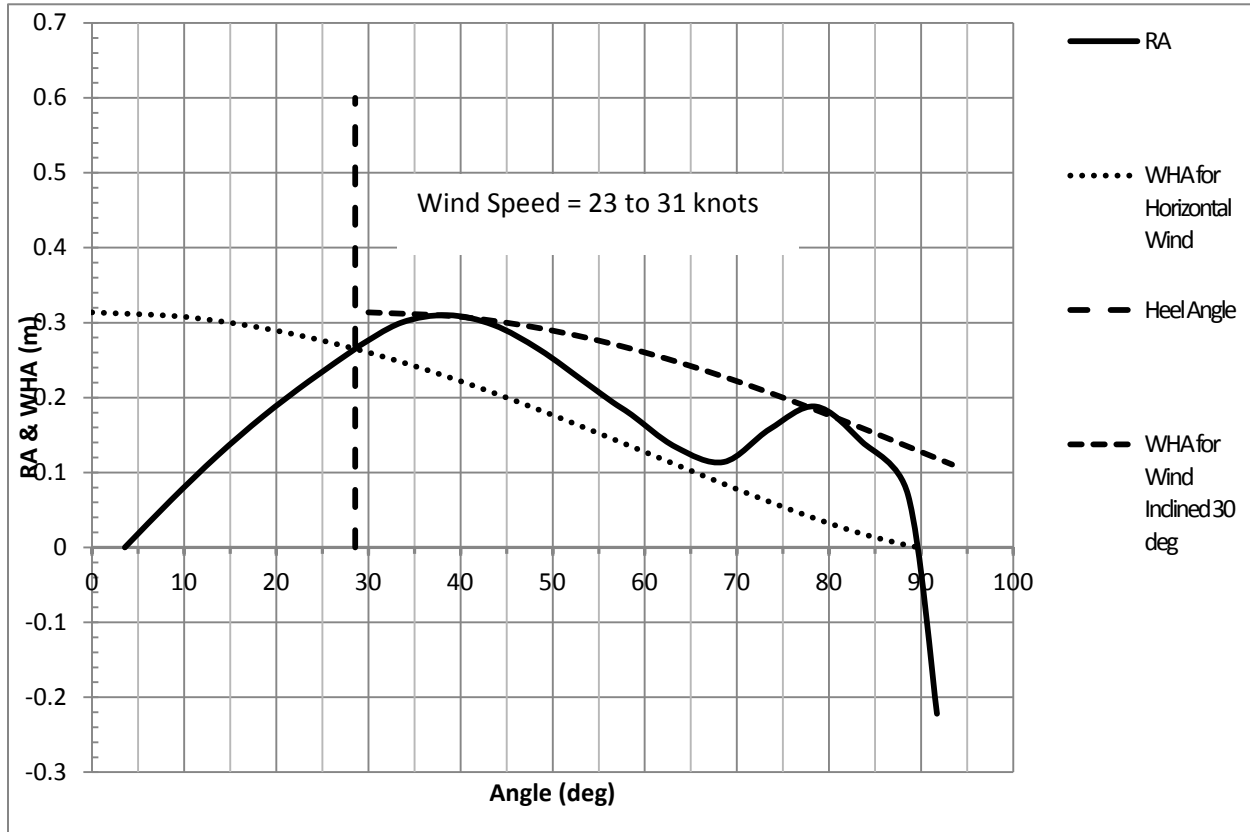
Figure 7. Wind heeling arm curve for wind inclined 30 ° from the horizontal

Figure 7 demonstrates this effect on the *Concordia's* righting ability. First, it is assumed that the vessel is heeled to an angle around 28° due to a horizontal wind. According to the relationship between apparent wind speed and heel angle shown in Appendix G, horizontal winds of between 23 and 31 knots would be sufficient to induce this heel angle. Then, the heeling arm curve is shifted 30° to the right, assuming the winds have shifted to 30° from the horizontal. As can be seen in Figure 7, the vessel's righting ability would be completely overcome by this combination of wind speed and inclination.

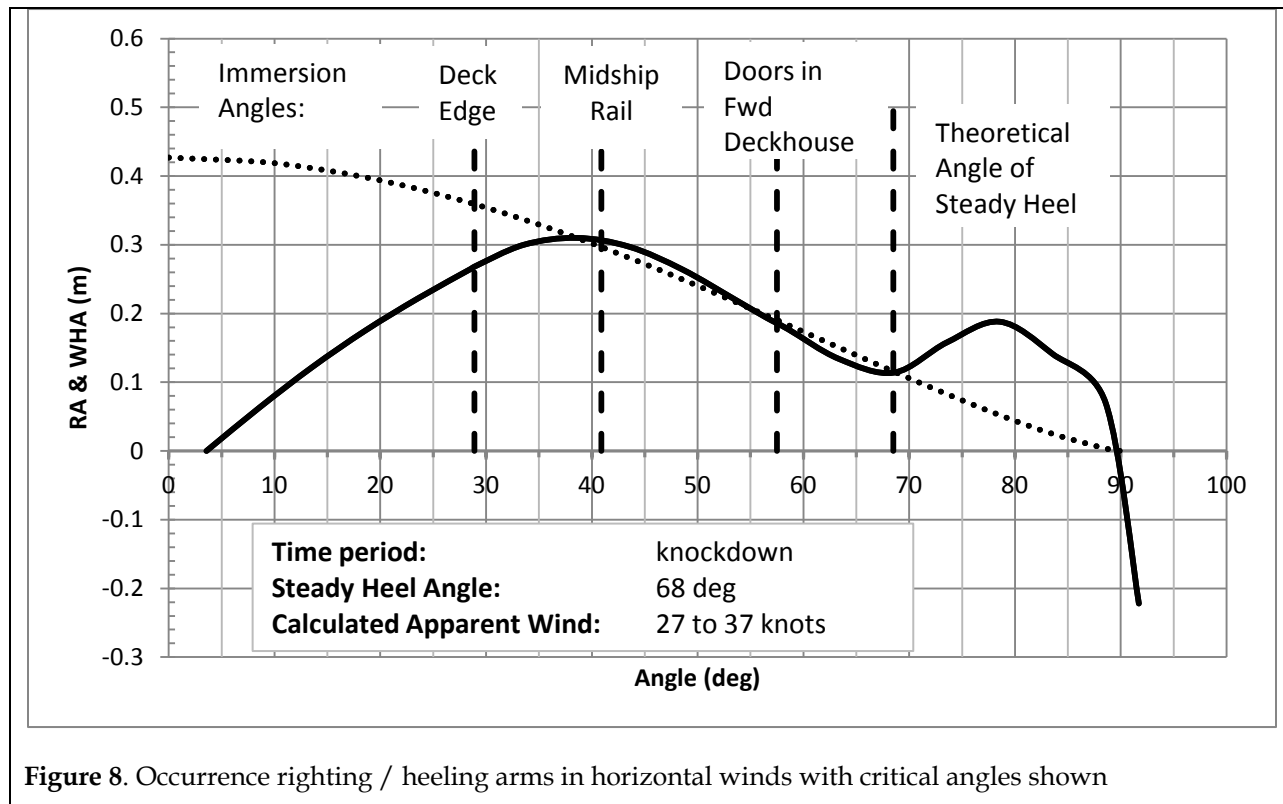
vessel to heel to an angle of about 38°. No further increase in wind speed would then have been necessary; having reached this critical point, the vessel would continue to heel to an angle approaching 70° (see Figure 8). This represents an increase in wind speed of only between 4 and 14 knots over the previous observation.

As Figure 8 indicates, although the vessel would theoretically take up a steady heel angle of almost 70° in such winds, water would have begun entering at various critical points before that angle was reached—first, via the open doors in the forward deckhouse (56.5°), then shortly thereafter via the sanitary exhaust vent, which was just aft of that (65°). With all of the doors on the port or lee side, as well as the ventilators and engine room skylight in the open position at the time of the knockdown, there was nothing to prevent or mitigate the downflooding that followed, progressing until the vessel ultimately lost all stability, rolled over, and capsized. The vessel's ability to recover would have been further hindered by the weight of water entrained in the sails as they submerged, in addition to the possible shifting of weights/equipment.

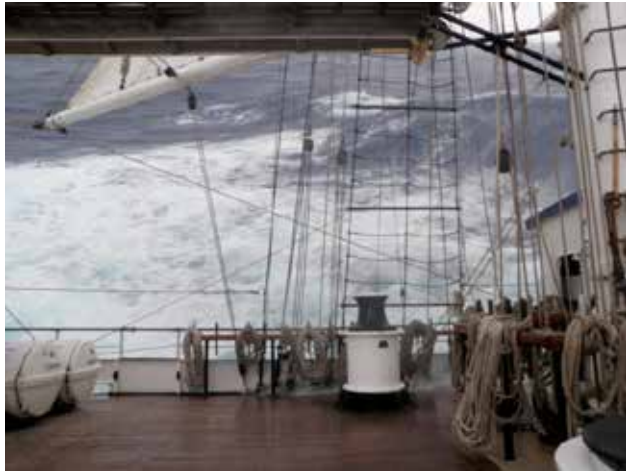
**Photo 4.** Port deck edge immersed at 29°

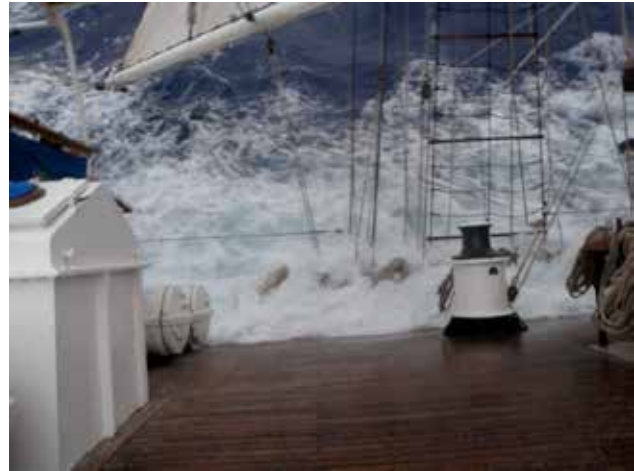
**Photo 5.** Port rail immersed at 41°
