**MARINE INVESTIGATION REPORT  
M14A0289**

**CAPSIZING AND SUBSEQUENT LOSS OF LIFE**

**SMALL FISHING VESSEL SEA SERPENT 25  
OFF LITTLE PORT HEAD, NEWFOUNDLAND AND LABRADOR**

**26 JUNE 2014**

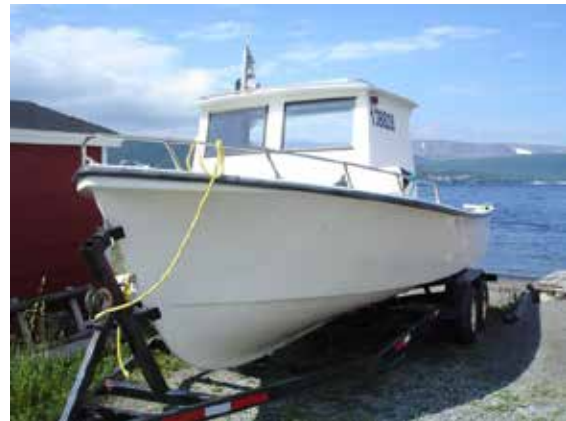
**Photo 1. Sea Serpent 25**

The Sea Serpent 25<sup>2</sup> was a multi-purpose fishing vessel constructed of moulded glass-reinforced plastic (Photo 1). It had an open deckhouse and cuddy forward, and two 50-horsepower outboard motors aft.

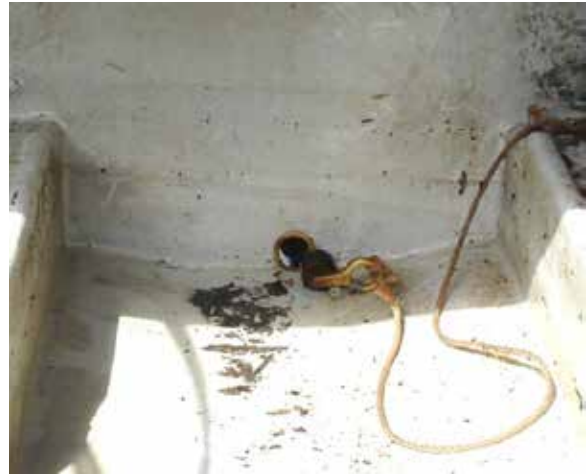
Photo 2. Drain hole and removable plug

A 3-centimeter drain hole with a removable plug was located in the stern plate (Photo 2). The drain hole was on the vessel's centreline and was just above the deck, but below the waterline. To drain any water that had accumulated on board, the practice was to accelerate the vessel until it was planing<sup>3</sup> and then remove the plug; the water would then drain out the drain hole. Buckets were kept on board that could be used as bailers if necessary.

During normal fishing operations on the Sea Serpent 25, water accumulated on the vessel after hauling and setting traps. The procedure used to remove this incidental seawater was to increase the vessel's speed to an extent that the vessel was planing, remove the plug, and allow the water to drain through the open drain hole. In this occurrence, it is likely that the plug, which was difficult to access, was not re-inserted after this procedure, or was not re-inserted properly to create a watertight seal. Although the crew had observed a small amount of water coming into the engine well, the well was fitted on the stern plate with drain holes that were designed to drain that water overboard. There were no other through-hull openings, there was no hull damage, and the seas were slight at 0.5 m. Therefore, the drain hole is the most likely source of the water ingress in this occurrence.

1. The vessel began taking on water in slight sea conditions, most likely due to water entering the vessel through the drain hole because the drain plug had not been inserted, or had not been inserted properly.
2. The vessel had no automatic means for discharging water, and the crew did not notice the increase in water level until it was too late for their bailing efforts to be effective.
3. The vessel lost power after water covered the exposed battery, which then short-circuited.
4. The vessel settled further into the water before rolling to starboard and capsizing.
5. No distress message or signal was sent by the crew and the overturned vessel was discovered by chance several hours later by a Department of Fisheries and Oceans vessel on patrol; 3 crew members were rescued and 1 deceased crew member was recovered.

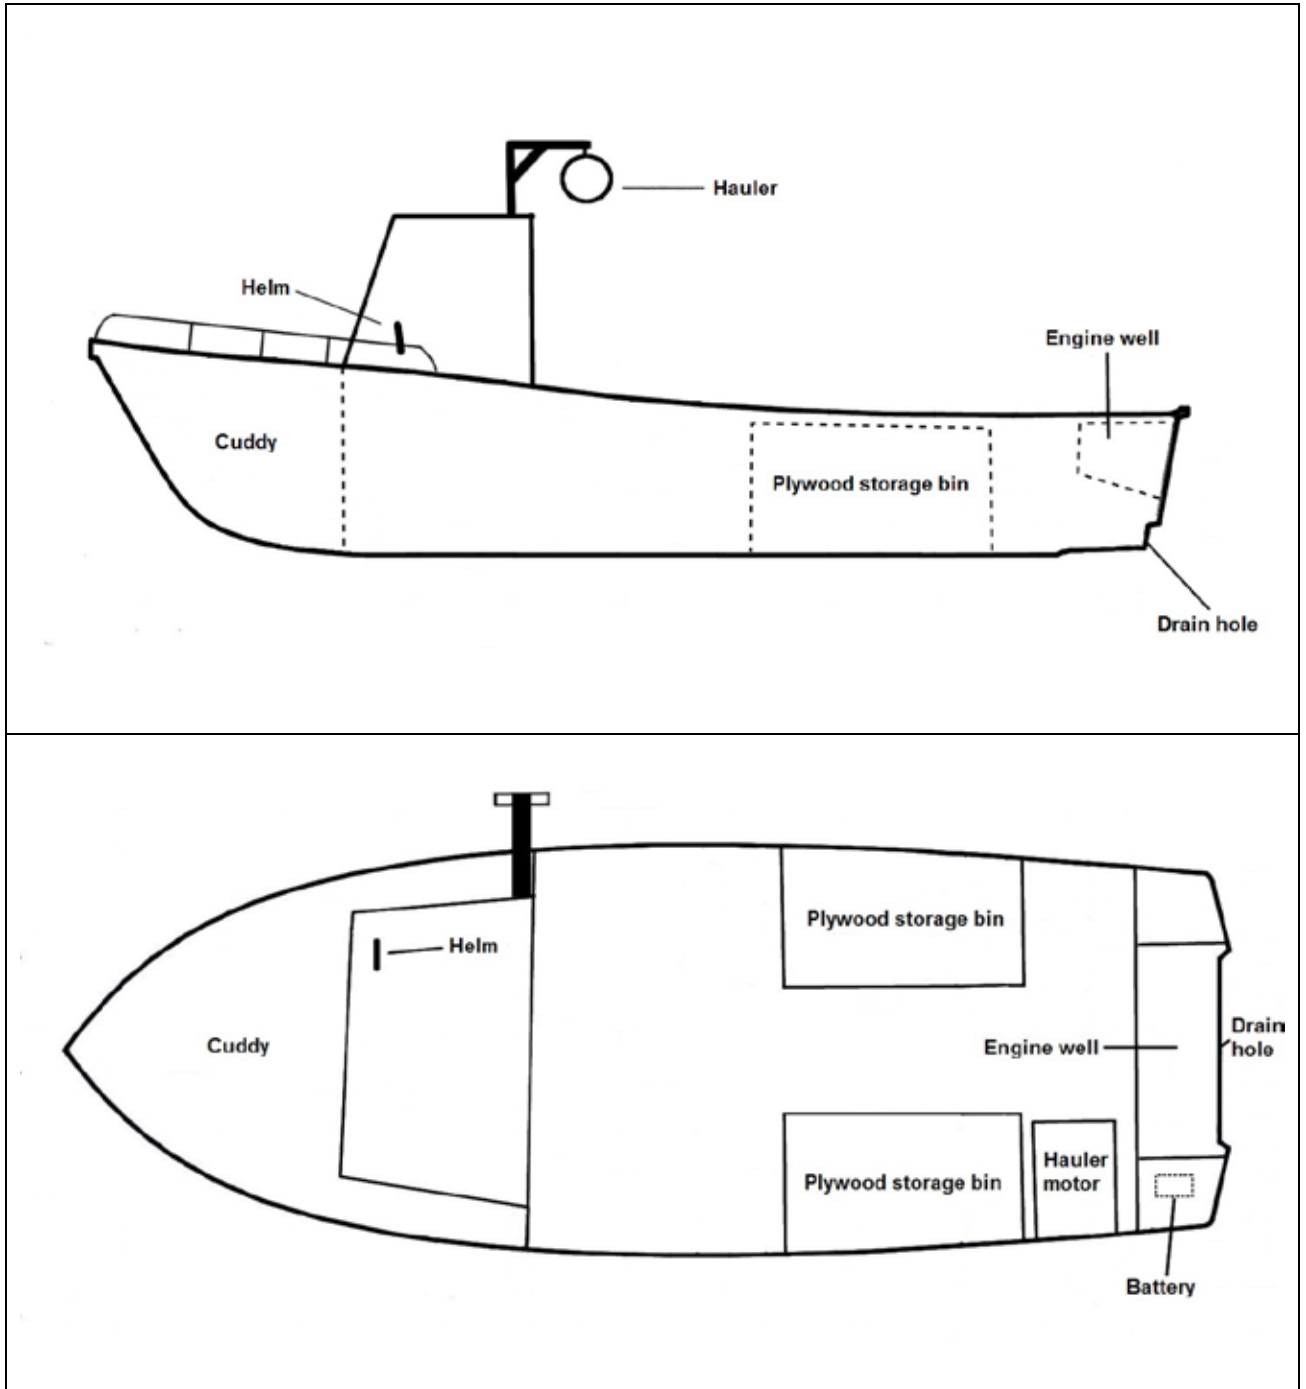
## Appendix A – Sea Serpent 25 profile and deck arrangement

The hull was of open construction, and there were 2 plywood bins, 1 fitted on either side of the vessel, that were used to stow the catch. When hauling or setting crab traps, a piece of wood was placed on top of the bins and was used as a platform for the traps. A watertight deck was fitted a few centimetres above the keel and provided a flat surface to stand on. An engine well in the stern plate provided support for the outboard motors. The battery, which was not covered, rested on the port quarter of the deck under the engine well (Appendix A).
