MARINE INVESTIGATION REPORT
M15C0006

GROUNDING

SELF-DISCHARGING BULK CARRIER *ATLANTIC ERIE*
CHENAL DU HAVRE DE LA GRANDE ENTRÉE
ÎLES DE LA MADELEINE, QUEBEC
11 JANUARY 2015

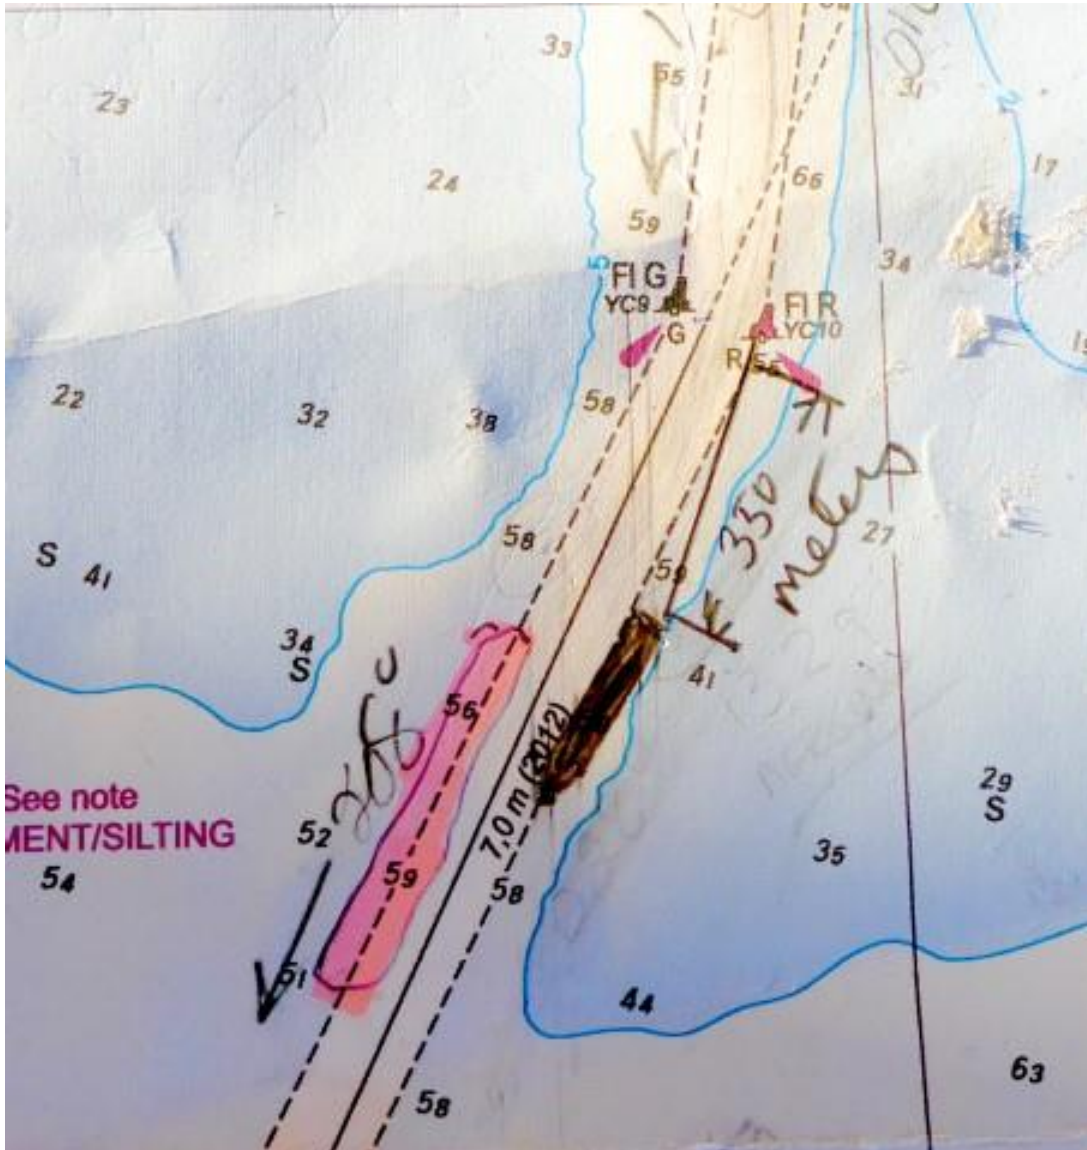
Appendix C – Notations on chart no. 4954

This photograph of chart no. 4954 carried on board the *Atlantic Erie* shows the shallow area marked in pink. The vessel's aground position, marked in black, was added by the crew following the occurrence.
