MARINE INVESTIGATION REPORT
M15C0094

PASSENGER OVERBOARD AND SUBSEQUENT LOSS OF LIFE
PASSENGER VESSEL *NORTHERN SPIRIT I*
TORONTO, ONTARIO
13 JUNE 2015

Passenger overboard and subsequent loss of life

Passenger vessel *Northern Spirit I*

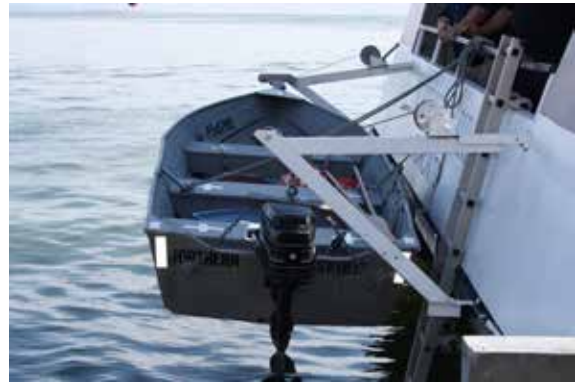
Photo 2. Position of the emergency boat on the stern

The *Northern Spirit I* is fitted with an emergency boat that is stowed in launching davits at the stern of the vessel on the main deck (Photo 2).

Emergency boat

The *Northern Spirit I* was brought under the Canadian Ships Registry in 1989 and was required to carry a Class II lifeboat under davits by the regulations in effect at that time. The owners of the vessel applied to Transport Canada Marine Safety and Security (TCMSS) for an exemption from this particular regulatory requirement. The TCMSS Board²¹ decided to exempt the *Northern Spirit I* from carrying the required lifeboat under 2 conditions: the vessel must carry one 5-person approved emergency boat with a means of launching, and the vessel must carry inflatable rescue platforms with aggregate capacity to accommodate 600 persons.²² On the muster list on board the *Northern Spirit I* at the time of the occurrence, however, the emergency boat was identified as a lifeboat. As well, this same emergency boat was identified as a rescue boat in the life saving equipment plan.

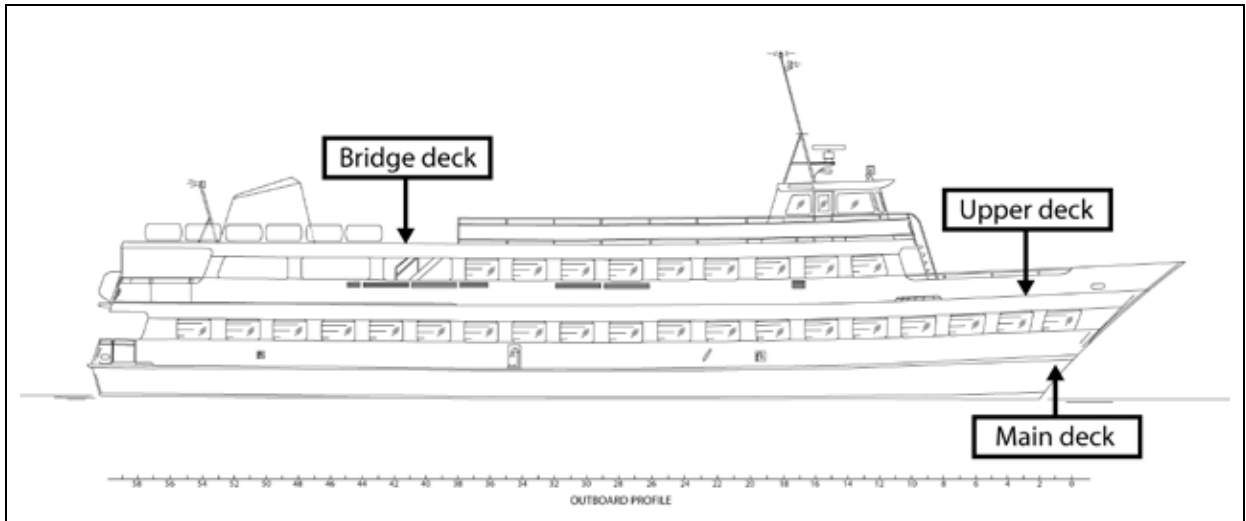
Appendix B – Vessel plan view

The *Northern Spirit I* has a main deck, an upper deck, and a bridge deck (Appendix B). The bridge is located forward on the bridge deck and is equipped with a magnetic compass, an echo sounder, a global positioning system (GPS), and a very high frequency (VHF) radiotelephone.
