Marine Occurrence Report

of the "CELINE METZ"
Gulf of St. Lawrence
01 December 1991

Report Number M91L3033

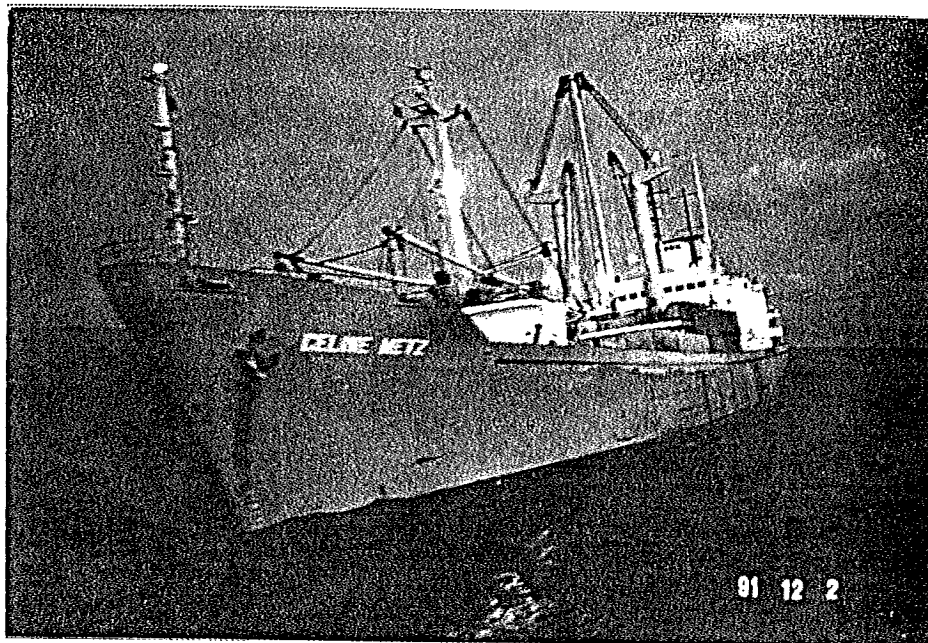
The "CELINE METZ" loaded some 6,400 tonnes (t) of general cargo, including a small parcel of timber deck cargo and some containers on deck, in Montreal, Quebec, and Québec, Quebec, for discharge at Las Palmas, Canary Islands, and other transatlantic destinations. After dropping the pilot off at Les Escoumins, Quebec, on the morning of 30 November 1991, the vessel anchored for some 10 hours near Île-du-Bic, Quebec, to secure the containers. The following morning, 01 December, the "CELINE METZ" was outward bound in the Gulf of St. Lawrence, rolling moderately in a heavy stern sea. At about 1045³, as the vessel was some 50 miles east of the Gaspé peninsula, she rolled heavily, some 30° to starboard, only partially righted herself and remained listed 11° to starboard.

The "CELINE METZ" listed because the unsecured under-deck cargo had shifted.

'CELINE METZ' AT ANCHOR AT BAIE COMEAU, LISTED STARBOARD.
<<CELINE METZ>> INCLINÉ SUR TRIBORD MOUILLÉ À BAIE COMEAU.

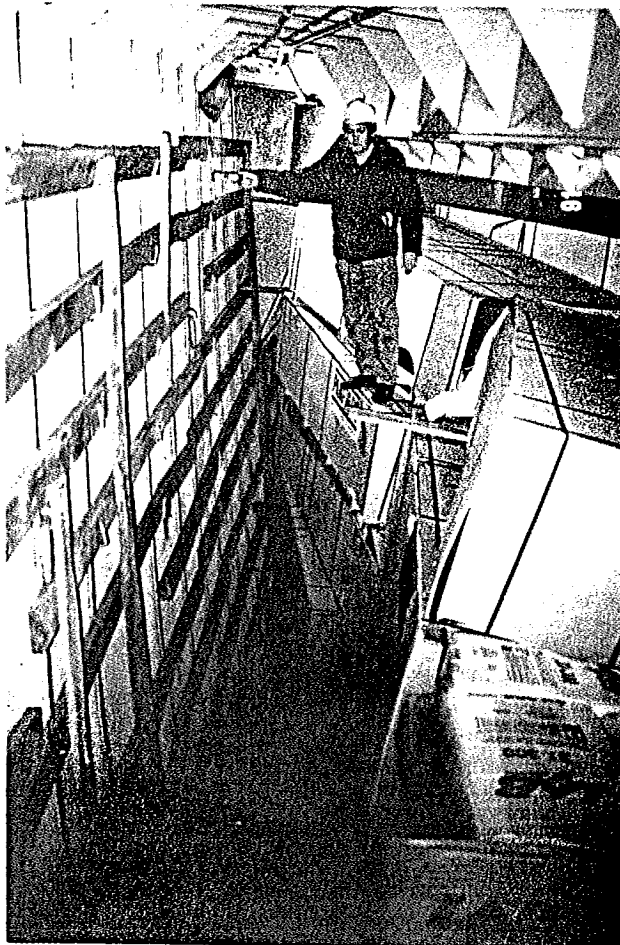
All compartments, except the No. 5 lower hold, which was inaccessible, were inspected on 02 December, after the vessel had acquired the initial 11° list. The packages in the lower holds and 'tween-decks were found jammed together and leaning to starboard, leaving a space on the port side, along the ship's side, which varied from 0.5 m to 1.5 m in width. The lumber and containers on the deck had not shifted.

SHOWING CARGO ON THE
PORT SIDE IN ONE OF
THE HOLDS OF THE
'CELINE METZ'.

VUE DES MARCHANDISES
DANS UNE DES CALES DU
<<CELINE METZ>>, CÔTÉ
BÂBORD.

While the "CELINE METZ" was at Matane, cargo was unloaded, reloaded and re-stowed, secured with wooden shoring and tomming. She departed for Halifax, Nova Scotia, on 12 December to load some 300 t of fuel, which the Matane port warden had directed the vessel to take on before the transatlantic passage to increase the weight in the double bottoms and to improve her stability.

The Department of Transport extend the role of Canadian Coast Guard port wardens to include the survey of the stowage and securing arrangements of under-deck cargo, as well as all types of deck cargo, on vessels departing Canadian ports.
