MARINE INVESTIGATION REPORT

M97N0073

THE FISHING VESSEL "RYANE & SISTERS"
GRAND BANKS OF NEWFOUNDLAND

26 MAY 1997

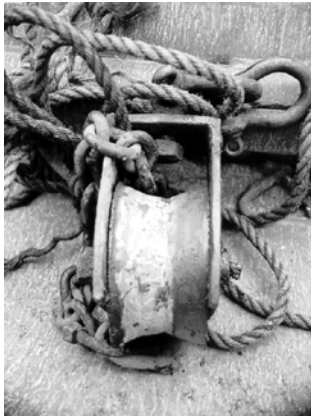
Photograph Number 3

The topping block was a second-hand towing/trawl block normally used to guide warp cable over the stern for dragging fishing gear. It had been installed as a topping block several trips previously. The surface of the sheave had been built up with weld and the groove was improperly shaped to support and guide the lifting cable. There were signs of concentrated wear over one side of the wide roller-type sheave groove and indications were that the cable had at times moved over the edge of the sheave to rub on the cheek of the block (see Appendix A, Photos 3 and 4).

The block was not the proper type for use with a 1.27 cm lifting cable under heavy load. The undersized block diameter imposed an excessive bending moment on the cable causing severe deformation, cable crushing, and accelerated wear which greatly reduced its lifespan.

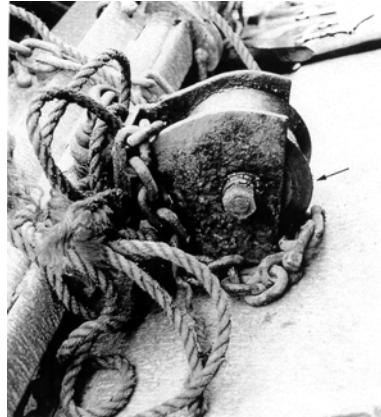
Photograph Number 4

Contributing to the failure of the cable was the use of an improper type of single sheave block whose rough condition, undersized diameter, and inappropriate sheave geometry caused accelerated wear and premature cable damage.

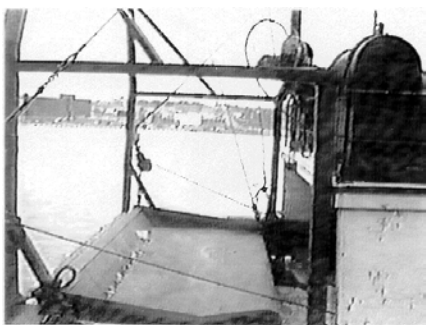
Photograph Number 5

The dump table consists of a wooden platform bolted to a steel frame and enclosed with steel plating. It extends athwartships 4.9 m over the work deck, with a hinged attachment at the stern bulwark. The forward edge of the table measures 2.3 m from its hinges to the lifting lug and rests horizontally on steel legs to provide an underside clearance of 0.53 m above the deck. The weight of the table structure in a clean state is estimated to be 1.25 t (see Appendix A, Photo. 5).
