MARINE INVESTIGATION REPORT

M97W0194

FIRE IN ACCOMMODATION

SMALL FISHING VESSEL "WESTERN VIKING"

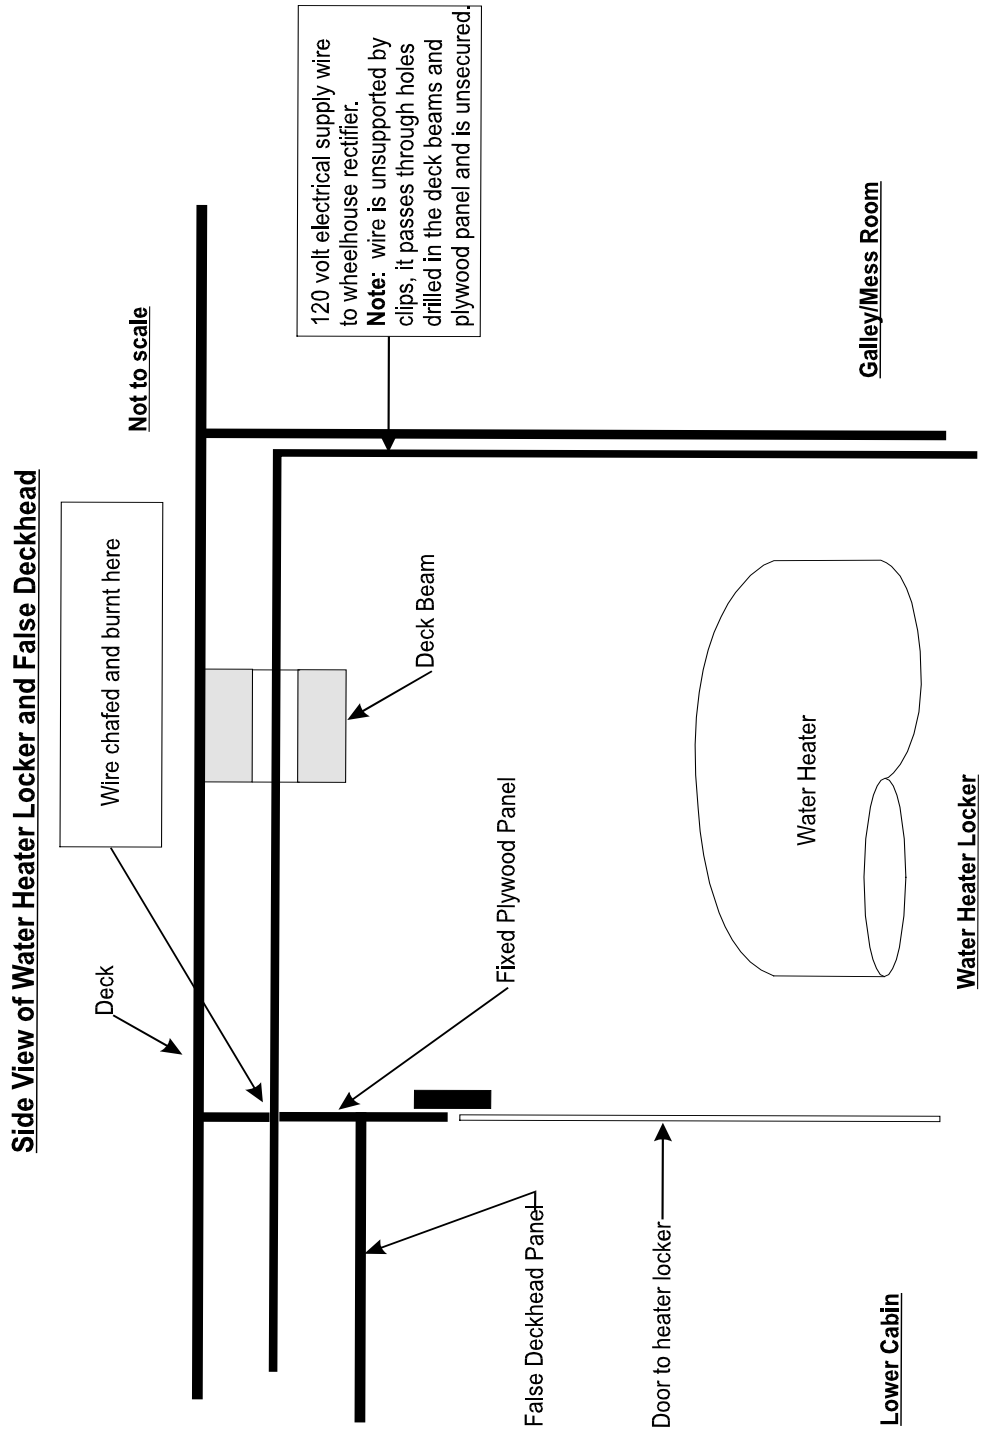
Appendix A - Sketch of Water Heater Locker and False Deckhead

When the heavily charred beams in the lower cabin cross passage were inspected closely, several electrical cables in that part of the false deckhead were found to have no insulation left. One heavy-duty, two-core, electrical cable ran up the back of the water heater locker and across the cabin deckhead, inside the false deckhead panelling. This cable showed signs of having shorted out and burned where it passed through a plywood panel as it exited the water heater locker. The cable had separated as it had burned.

The cable was traced from a breaker in the forward end of the engine-room, marked "120 volt ac power to the wheelhouse dc rectifier," across the engine-room deckhead and into the water heater locker. It ran up the bulkhead behind the water heater, through a hole drilled in the deck beam and exited the locker through another hole in a fixed plywood panel into the space between the deckhead and the false deckhead panels. Each deck beam through the cabin had been drilled and the cables fed through the holes without securing clips, in the same manner as house wiring is run through frames. Transport Canada *Ship Safety Electrical Standards*,

The insulation of the electrical cable supplying power to the wheel-house dc rectifier was abraded where it passed through a thin vertical panel at the top of the locker in which the hot water heater was located. The panel had been drilled and the wire fed through without any support, or any securing which would have prevented the cable from chafing with the vessel’s movement and vibration. When the insulation chafed through, the two-core cable shorted out and the copper wire burned, setting fire to the wood beams inside the false deckhead panelling. The chafing occurred in a location in which it would not be immediately obvious to personnel on board the vessel. Further, a properly rated circuit breaker installed in a suitably installed electrical distribution

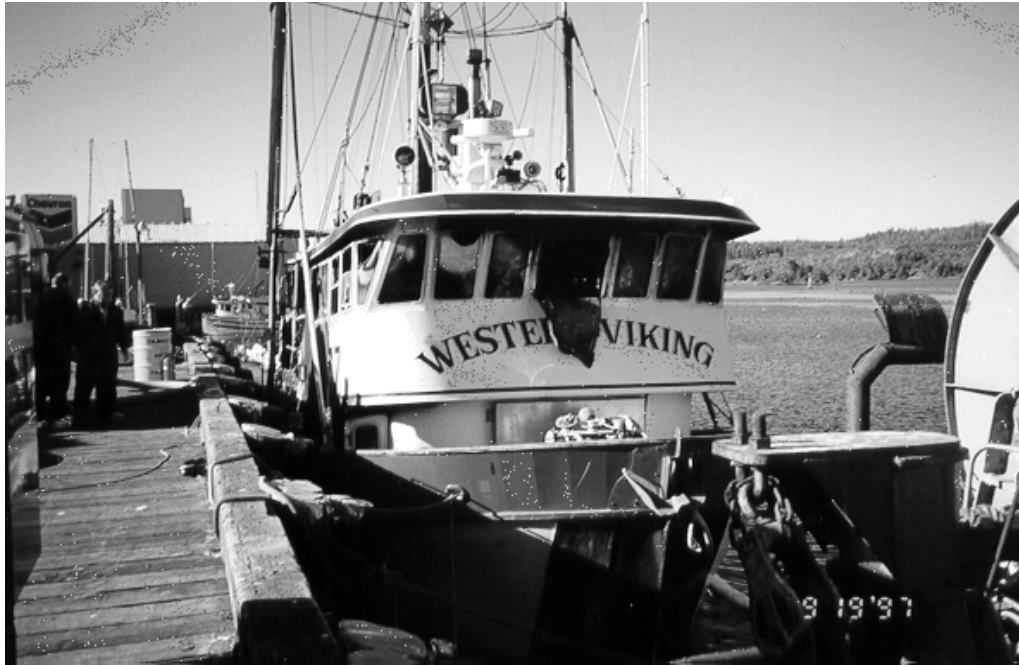
Vessel at Ucluelet government wharf after the fire

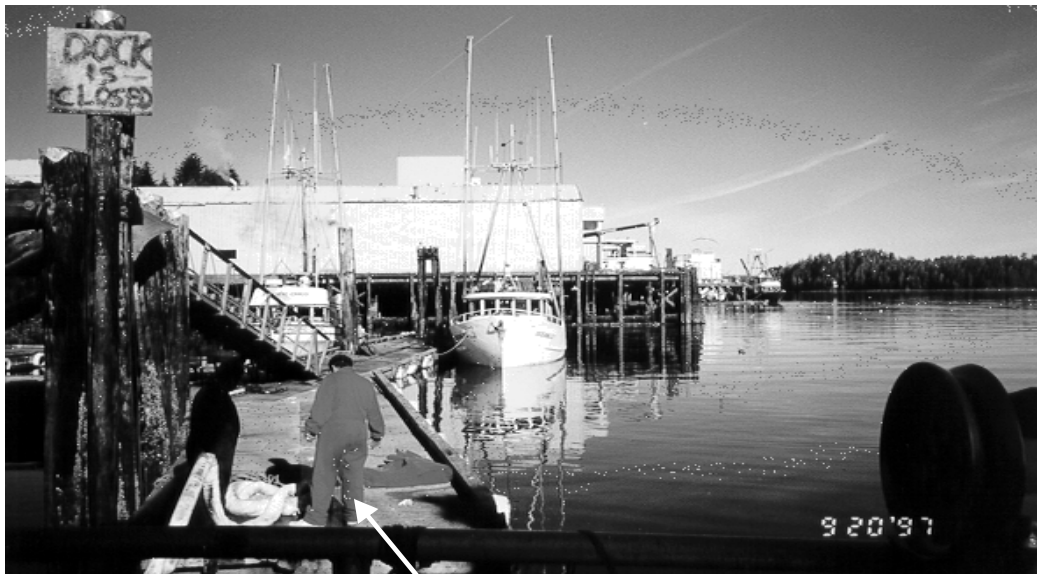
Wharf where vessel was moored at time of fire
