MARINE INVESTIGATION REPORT  
M98C0015

BOTTOM CONTACT

BULK CARRIER "GRANT CARRIER"  
NEAR THE SAINT-LOUIS BRIDGE  
ON THE ST. LAWRENCE SEAWAY, QUEBEC

11 JUNE 1998

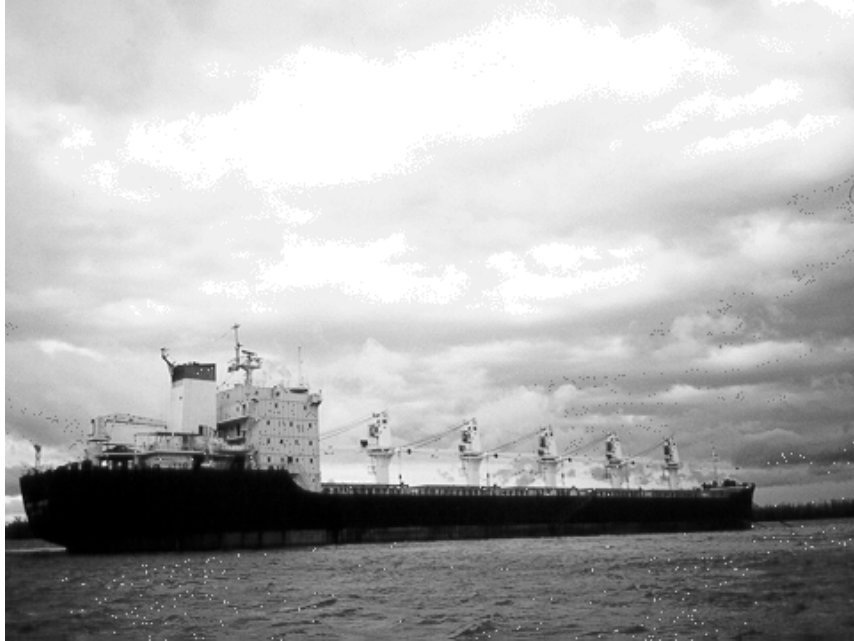
**THE GRANT CARRIER**

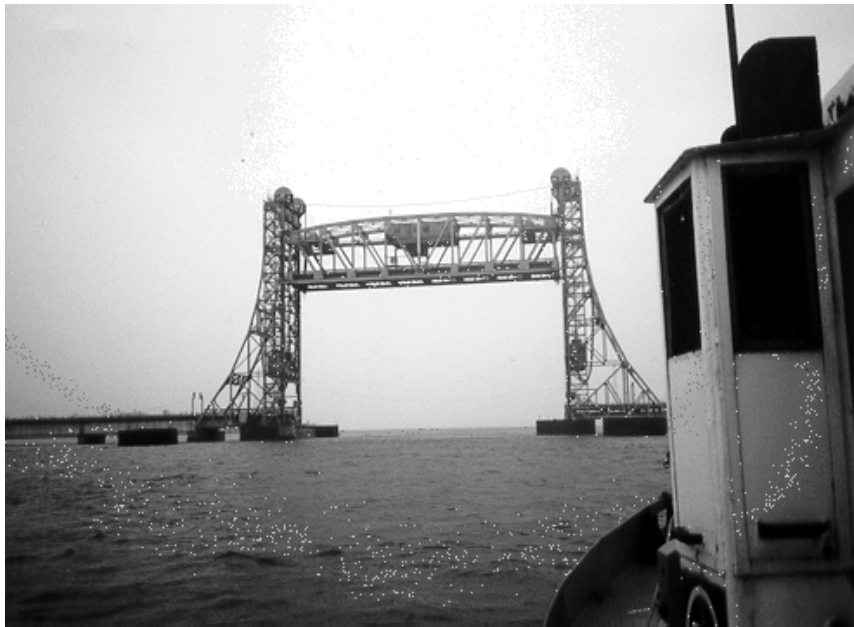
**THE SAINT-LOUIS BRIDGE IN THE UP POSITION**

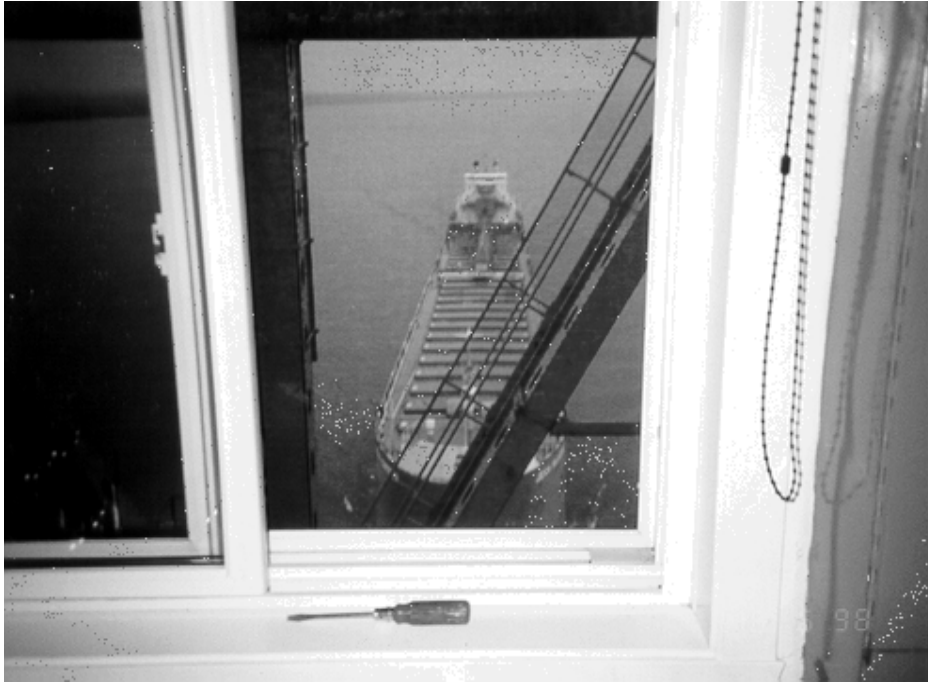
**VESSEL ABOUT TO PASS UNDER THE BRIDGE FROM THE BRIDGE OPERATORS VIEW POINT**

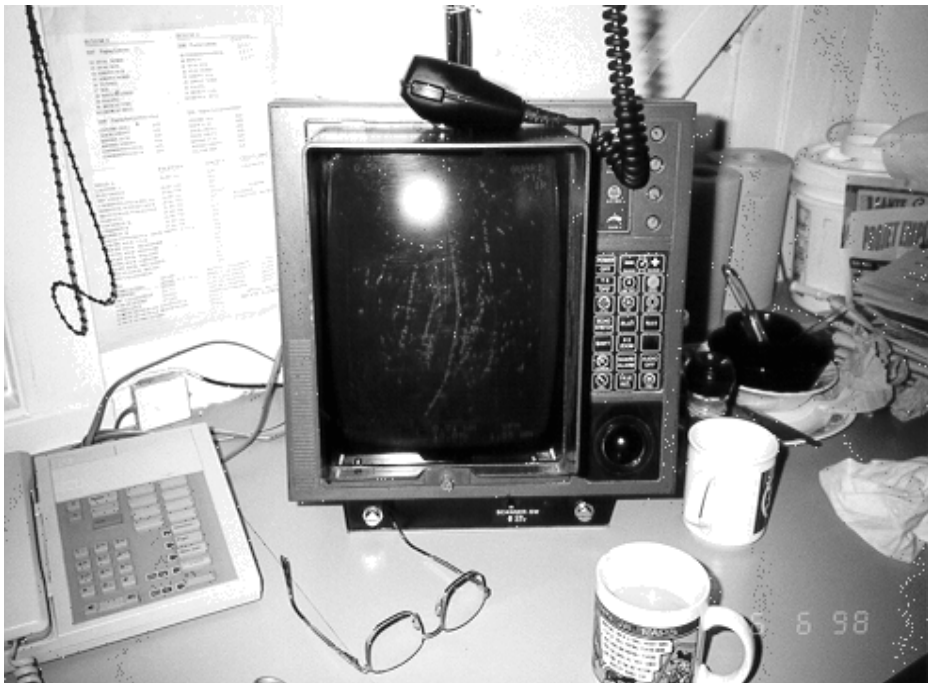
**RADAR SCREEN IN THE BRIDGE OPERATORS OFFICE**
