MARINE INVESTIGATION REPORT

M99C0003

GROUNDING

THE BULK CARRIER "PATERSON"

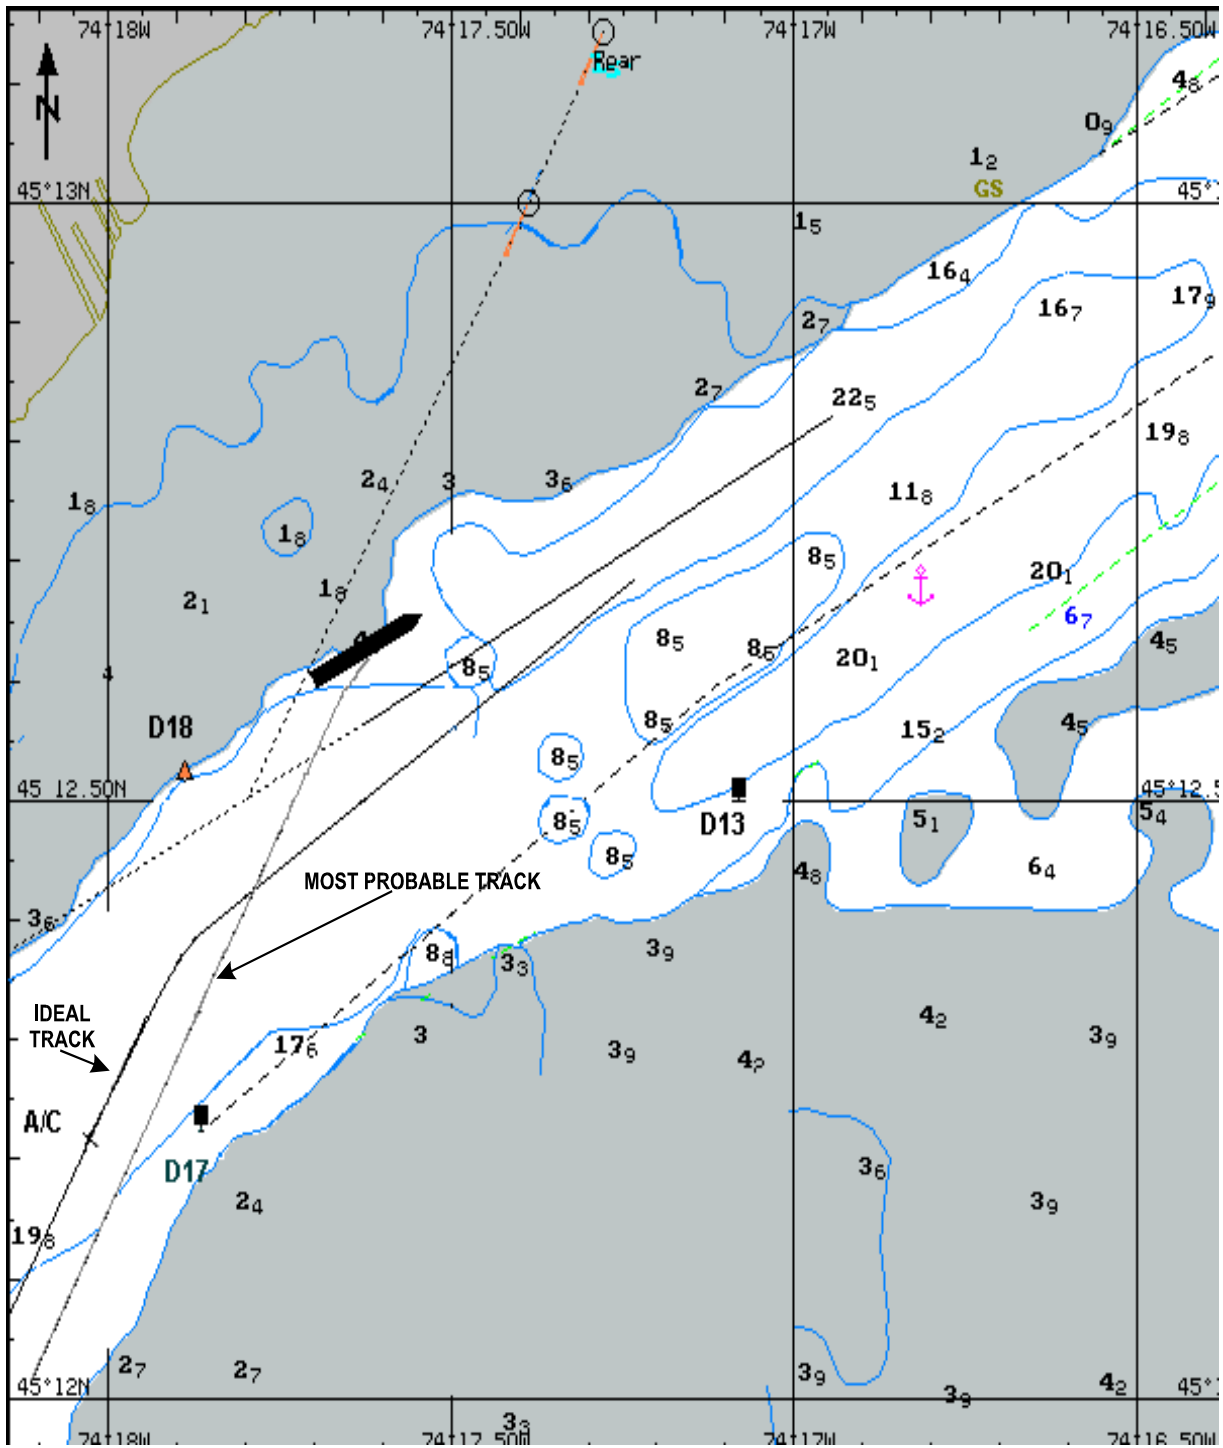
*Appendix C - Ideal Track vs. Most Probable Track*

11. The turn was delayed beyond the point where, irrespective of the helm used, the vessel could have remained within the navigable channel.
12. The electronic chart system in use did not reflect the appropriate up-to-date corrections, although this is not considered to have been a factor in the occurrence.

The “PATERSON” ran aground because a critical course alteration was delayed beyond a point which would have allowed the vessel to stay within the confines of a navigable channel. The vessel was under the conduct of a ship’s officer, who single-handedly conducted the navigation of the vessel in these confined pilotage waters, and the navigation system in use was prone to single-point failure.
