MARINE INVESTIGATION REPORT

M99W0087

BOTTOM CONTACT

BULK CARRIER "ALAM SELAMAT"  
FRASER RIVER, BRITISH COLUMBIA  
16 JUNE 1999

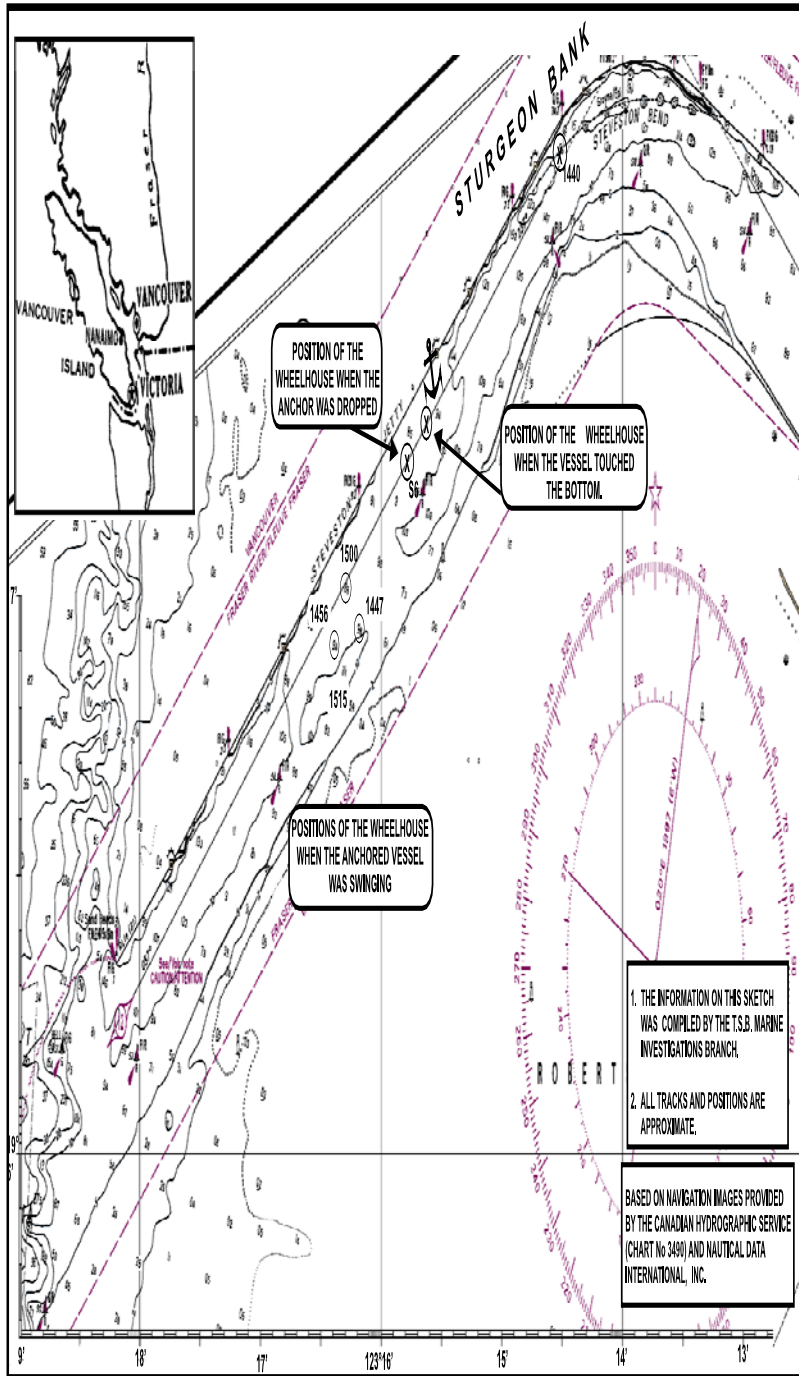
# Appendix A - Sketch of the Occurrence Area

At 1445, in a position approximately 200 m north of S-6 buoy, a strong vibration was felt by the persons in the wheel-house and the vessel started sheering to starboard, towards Steveston Jetty. The pilot ordered hard-to-port rudder, slow ahead engine, and for the port anchor to be deployed and held fast when it touched the bottom.

There was no indication that the draught of the “ALAM SELAMAT” increased after leaving Fraser-Surrey docks, nor that she deviated from her track; the vessel was proceeding along the line defined by the ranges when she ran aground. As was ascertained after the occurrence, there was a shallow spot with a depth of 6.0 m (above chart datum) in the position where the vessel reportedly made contact with the bottom.
