MARINE INVESTIGATION REPORT

M00N0098

GROUNDING

TANKER *MOKAMI*

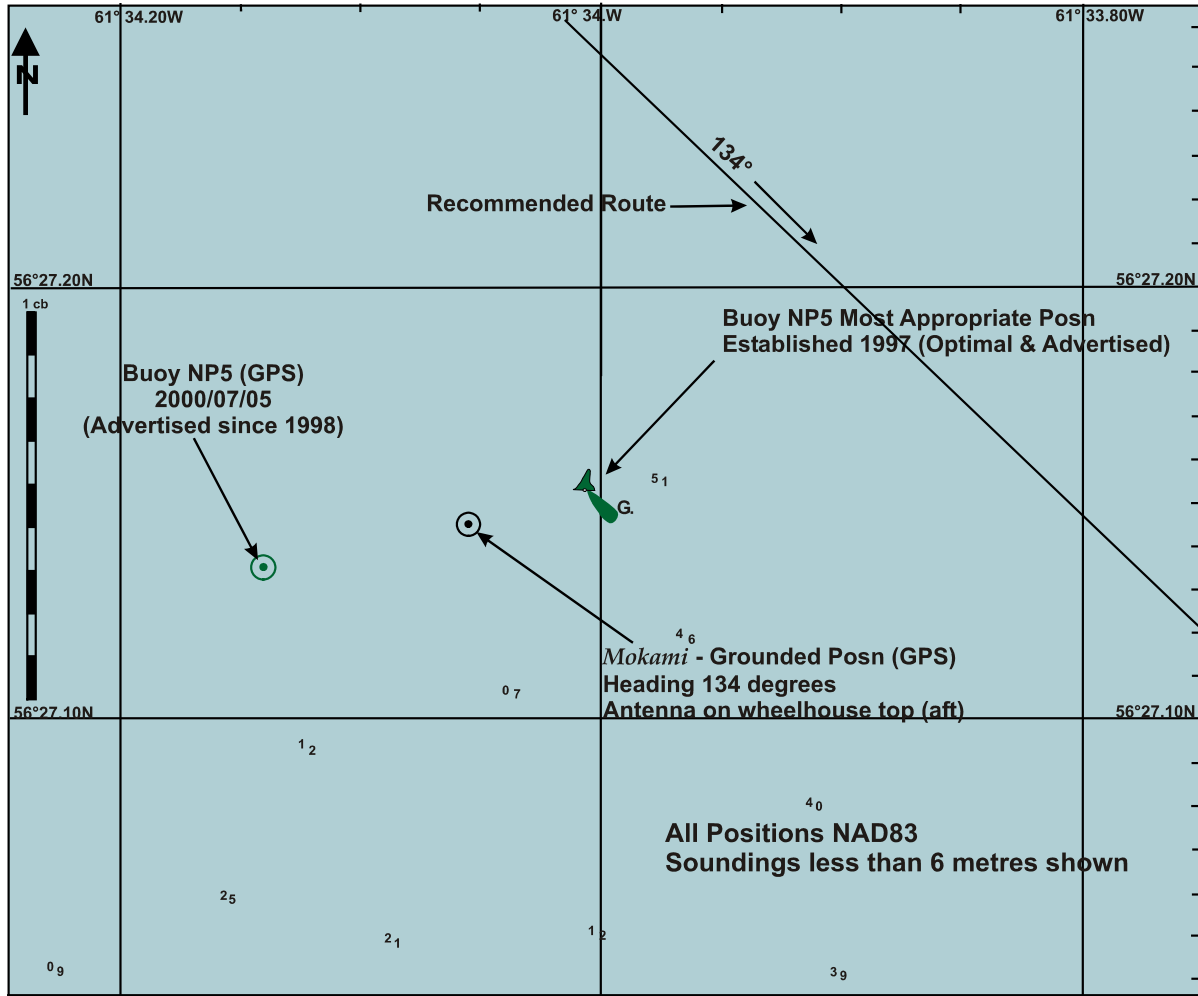
With the buoy NP5 abeam 130 m distant and Rain Islet at 5.5 cables, the OOW ordered course alteration in increments to 105°, 110°, 120° before steadying on a course of 134° as per the recommended track. At about this time, the vessel ran aground at 1549, approximately 200 m NE of buoy NP5 (see Figure 2). The vessel

- 18/07/1997: According to standard practices, buoy NP5 was established in optimal position⁷ by Canadian Coast Guard ship *CCGS J.E. Bernier* following on-site assessment. It was positioned on the northeast corner of a bank extending northeasterly from Palungitak Island at 56° 27' .050 N, 061° 34' .180 W referred to the orphan datum existing on CHS chart No. 4748 -- Bridges Passage Inset.⁸ A BSR was submitted to the regional MNS program office. The "advertised position" of the buoy was the "optimal position" (see Figure 2). This position as plotted is corrected to NAD 83.

- The navigation team relied on buoy NP 5, which was on its advertised position, 160 m west of the optimal position established in 1997. The team relied on the buoy to alter the vessel's course to the exclusion of other visual/ electronic cues, in spite of various navigational publications warning mariners that buoys can be out of position and that caution should be exercised in using buoys as an aid to navigation.¹¹
