MARINE INVESTIGATION REPORT

M00W0044

CAPSIZING

THE FISHING VESSEL "LORI CATHLYNN"

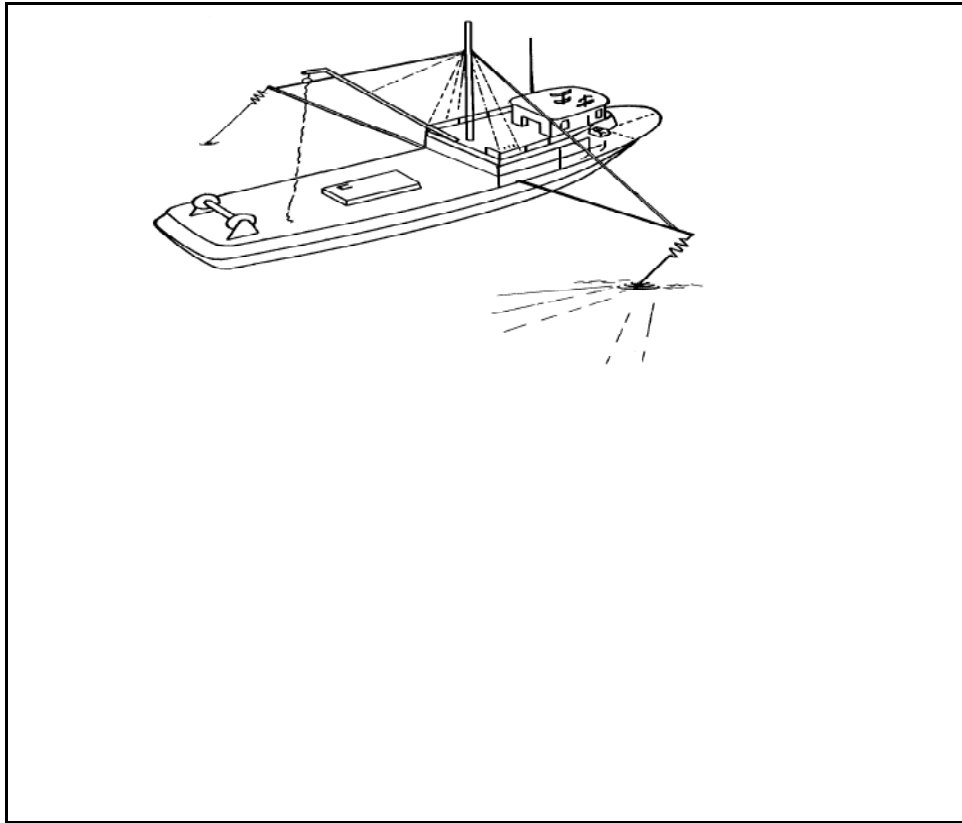
Roll-dampening paravanes were fitted to the "LORI CATHLYNN" on port and starboard outriggers attached to the bulwarks. The paravanes were in use at the time of the occurrence. Post-occurrence inspection of the vessel showed that the cable to the starboard paravane stabilizer was ruptured at the eyelet's extremity. The paravane could not be found on the vessel. It could not be ascertained if it was lost at the time of the occurrence or while towing the upturned vessel the following day.

When both paravanes are deployed, they are lowered into the water—port and starboard—from the extended outriggers. When dragged through the water, each paravane exerts a downward force by the diving effect of its fin. This balanced downward pulling force at the end of each outrigger makes the moving vessel more resistant to heeling forces, and dampens roll (see Figure 2).

The use of roll-dampening paravanes is not without risk. The safe functioning of the submerged delta-shape is largely dependent on the towing speed and on their complementary operation—to port and starboard—such that the righting moment caused by the downward force generated on one side is synchronized with the upward roll of the vessel on that same side. If the port and starboard synchronization is disturbed or lost, an athwartships moment can be applied to the vessel when she is rolling toward the paravane generating the most downward force, and the vessel's roll may actually be increased on that side. The synchronous and complementary operation would be significantly disturbed if one paravane became fouled on an obstruction. In addition, the skipper's action of steering to port when the vessel was heeling to starboard would have unfortunately affected the heeling to starboard.

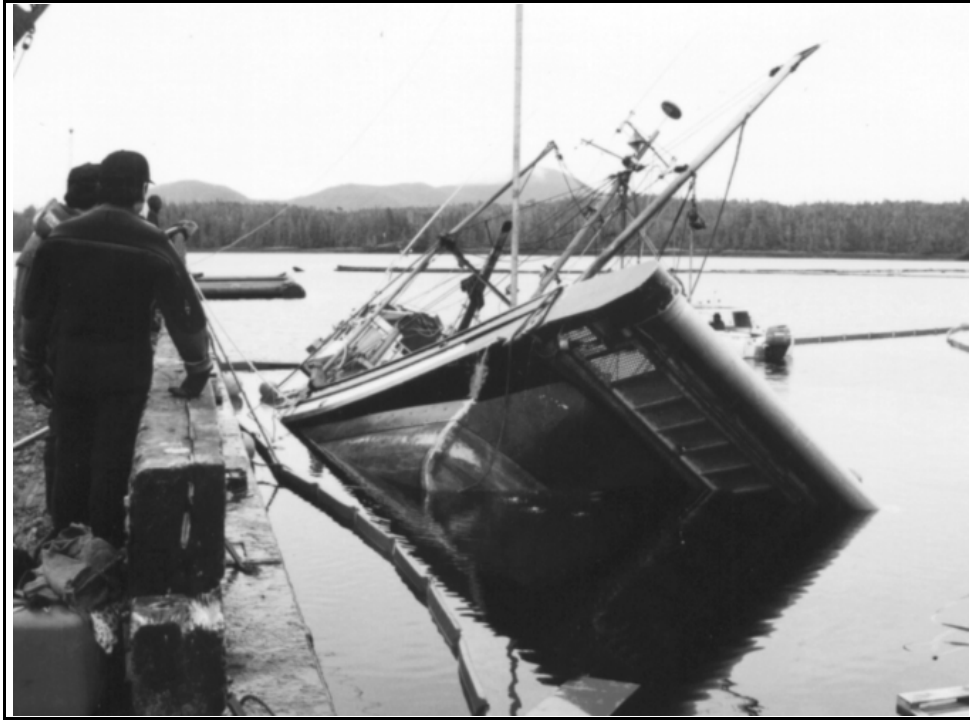
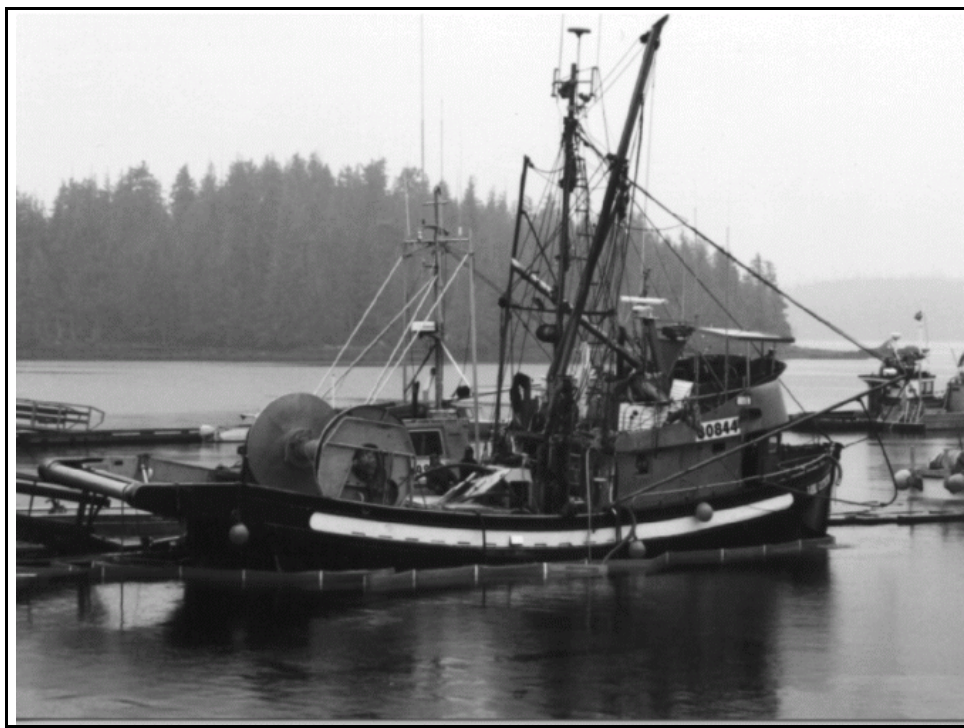
Appendix C - Photos

The "LORI CATHLYNN" was taken in tow to Shearwater, B.C., for salvage, inspection and repairs (see Appendix C, Photos 1 and 2).

The flush deck scuttles of the lazarette and of the port fish hold were missing and the main hatch of the fish holds was not in place when the vessel was recovered. The deck scuttles were lost, indicating that they had not been secured. Although required by regulations, the deck scuttle cover was neither hinged nor secured by a chain to the vessel's structure. The sudden heeling and the action of sea water swamping the vessel's deck would have dislodged them from the hatch coamings, allowing the ingress of water. The resultant downflooding of the lazarette and of the fish hold would have increased the heel and hastened the capsizing.
