MARINE INVESTIGATION REPORT

M00W0059

ACCIDENT ABOARD SHIP – ALONGSIDE

FISHING VESSEL – SALMON TROLLER “C - JOY”

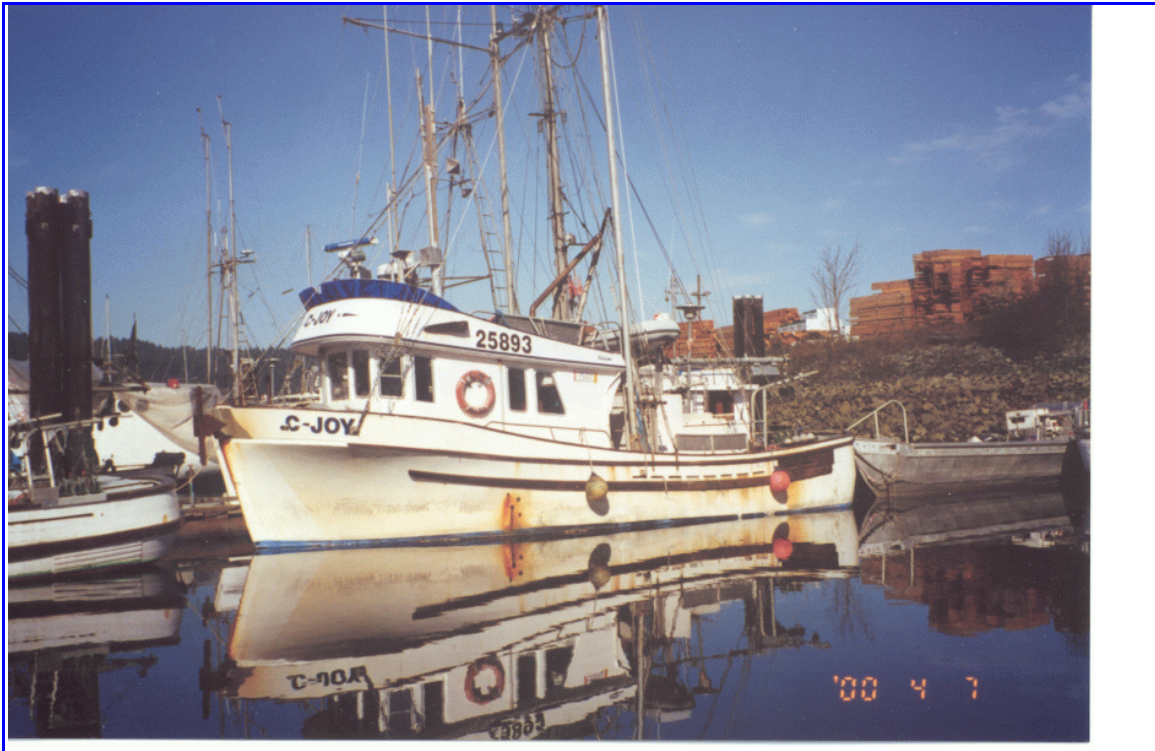
The "C- JOY" is a commercial salmon troller built in 1978 of moulded fibreglass construction. Below decks forward is crew accommodation. Aft it is the machinery space, aft of which (and separated from it by a watertight transverse bulkhead) is a refrigerated fish hold, at the after end of which is another watertight transverse bulkhead. Aft of this bulkhead is a lazarette terminating in a transom stern (see Photo 1).

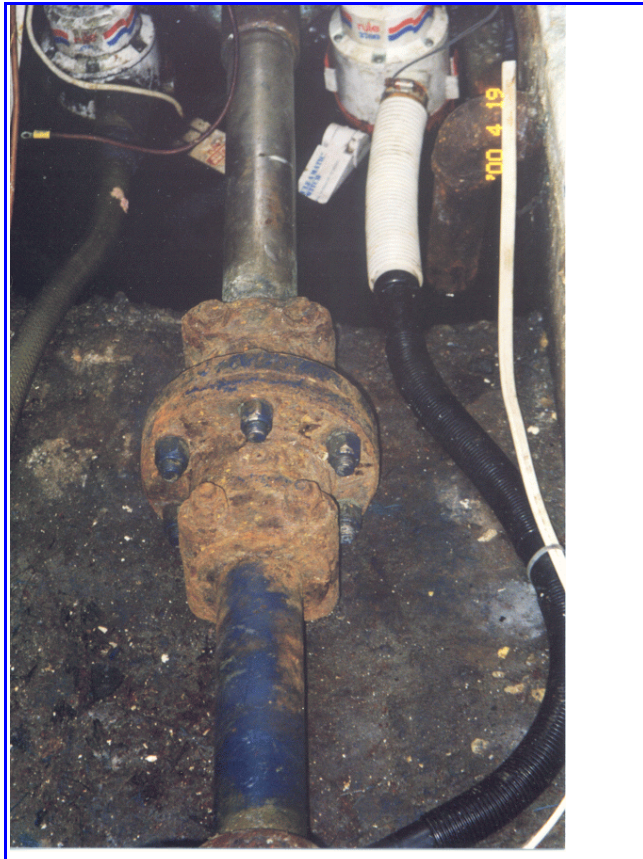
Beneath the centre line compartment is a recessed longitudinal void space (i.e., shaft well) through which pass the intermediate and propeller shafts connected by a shaft coupling (see Photo 2). This arrangement of shafts and coupling transmits power from the main engine to the vessel's propeller.

The shaft well is approximately 3.15 m long, 610 mm wide, and 310 mm high. The distance between the shaft coupling and the sides of the shaft well is approximately 150 mm. Access to the shaft well and shaft coupling is by a heavily constructed glass reinforced plastic cover, which extends as a

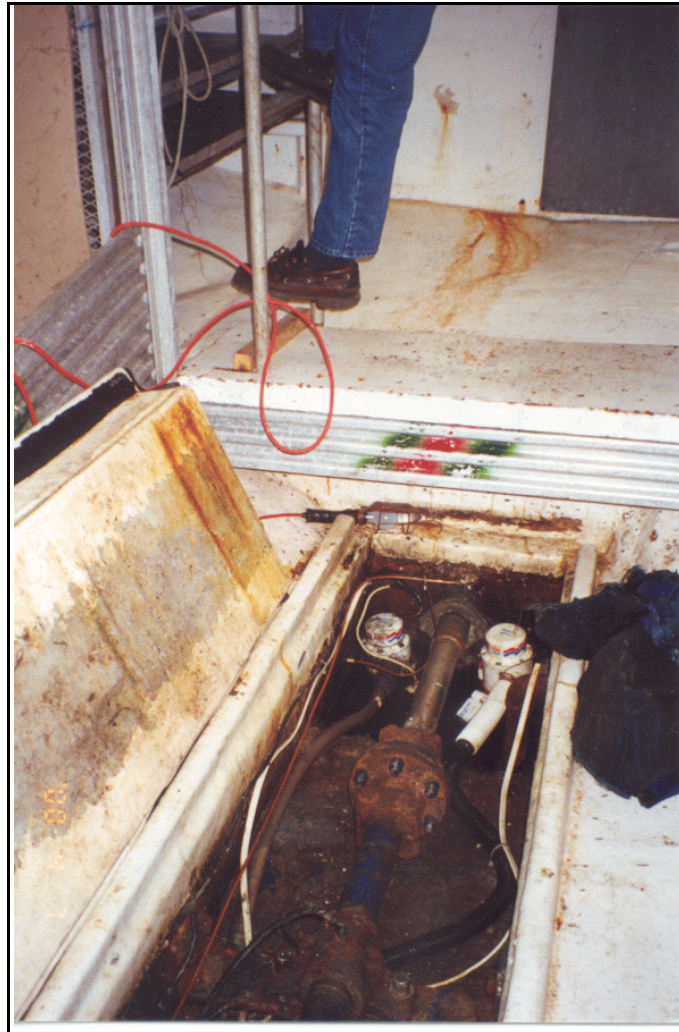
A four-rung aluminum ladder is fixed between the after starboard side of the raised hatch located on the main working deck and a painted, 1.19 m x 510 mm x 19 mm plywood platform in the fish hold at the base of the ladder. The surface of the platform, which is 40 mm above and directly abaft the shaft well, is gouged and worn (see Photo 3).

The one-piece shaft-well cover extends over most of the length of the fish hold. The removal of the cover to permit the owner/operator access to the stern gland also exposed the rotating shaft coupling located 600 mm forward of it.

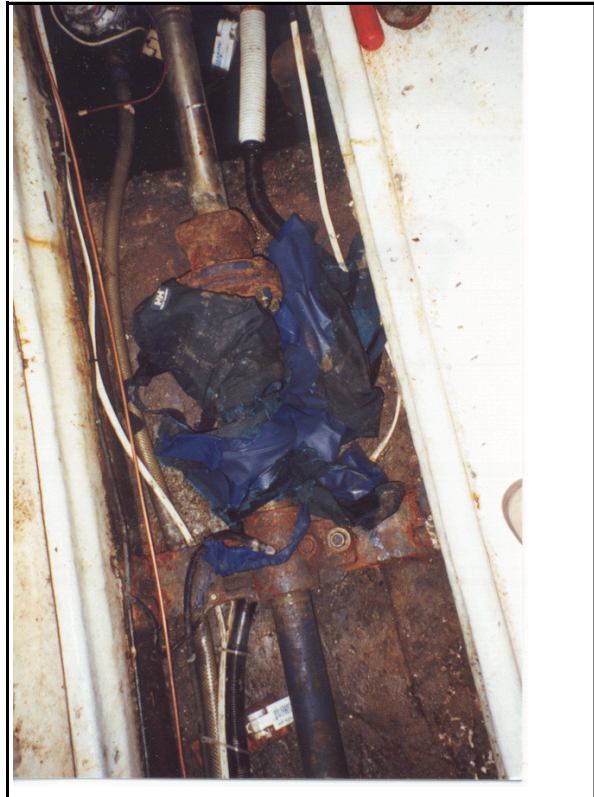
As the owner/operator reached the platform at the base of the ladder, he lost his footing. His legs went forward from underneath him and the left cuff of his weather protective trousers became entangled in the bolts of the rotating shaft coupling (see Photo 4). The operator's left leg was drawn progressively into the 150 mm void between a shaft coupling and the interior port side of the shaft well.

1. The owner/operator was working alone in a confined space where the guard on turning machinery had been removed.
2. The removal of the shaft well cover to work on the stern gland also exposed the rotating shaft coupling which caught and trapped the hem of the owner/operator's rain pants.
3. The severity of the owner/operator's injuries was due to his inability to stop the rotating propeller shaft and to the tear-resistant fabric of the rain pants worn by him. The fabric did not tear when first caught and the owner/operator's leg was drawn into the rotating shaft coupling with it.

The manufacturer of these tear-resistant garments will henceforth affix a warning label to the garments instead of to the garments' stowage bag.

The warning label itself has been re-phrased to caution the wearer not to wear the garments when working near exposed moving machinery. The exact wording of the new label is as follows:
