MARINE INVESTIGATION REPORT

M01C0008

STRIKING OF THE TANKER *HAMILTON ENERGY*

01 APRIL 2001

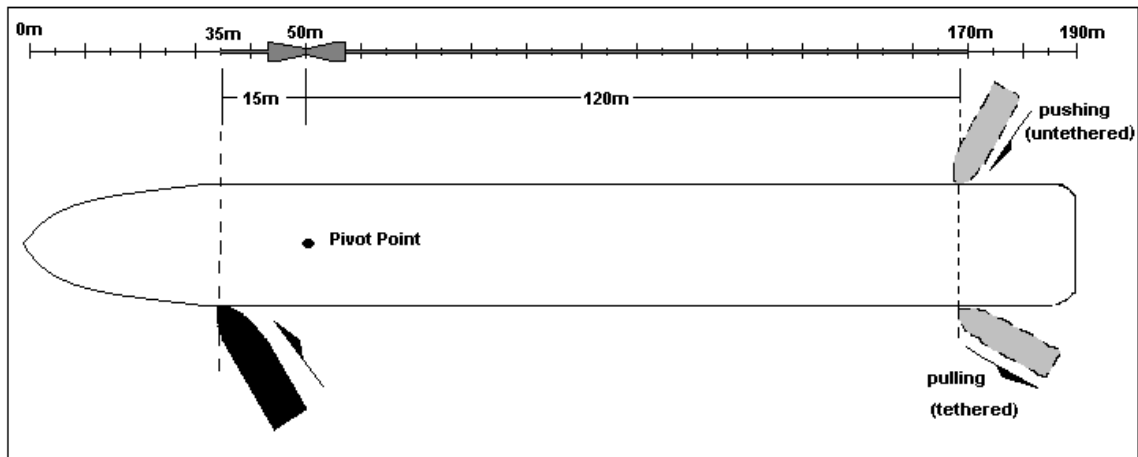
In this occurrence, the unsecured tug was pushing just aft of the break of the forecastle, or approximately 35 m from forward. Because the *Utviken* was making headway, the pivot point of the vessel would have been approximately 50 m from the bow, giving a turning lever of some 15 m for the forward tug. The aft tug would have had a turning lever in the order of 120 m. Even considering the relative difference in tug power (1100 hp forward versus 700 hp aft), the aft tug pulling on the port side, if made fast or pushing on the starboard side, would have produced about five times the turning moment of the forward tug (see Figure 2). Additionally, once the anchors were let go, the pivot point would have moved even further forward, to a point between the two windlasses. The forward tug's ability to effect a starboard turning moment at this time would have been minimal.

In the last minutes before the striking, the aft tug was not used in a manner most effective in turning the vessel to starboard. For the forward tug, the reduced turning lever, the angle of application of the pushing force, and the deployment of the assisted vessel's port anchor all decreased the effectiveness of turning the vessel to starboard. Although the instructions for the forward tug to push full on the port bow were taken in good faith and with the best of intentions, the starboard turning moment applied on the *Utviken* by this action was minimal. Also, contrary to the wishes of all concerned, the assisted vessel's speed reduction was hampered by the forward component of the pushing forces applied by the *Paul E No. 1*.

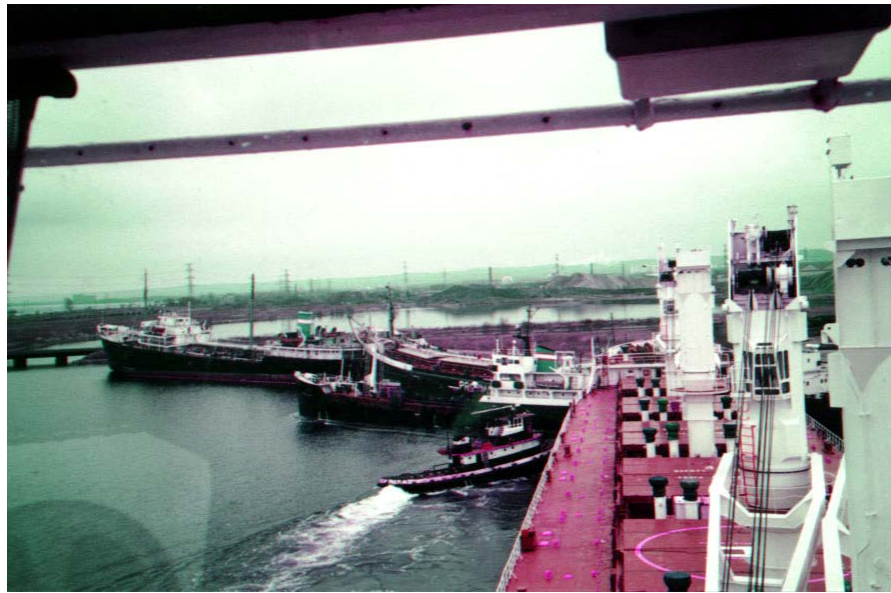
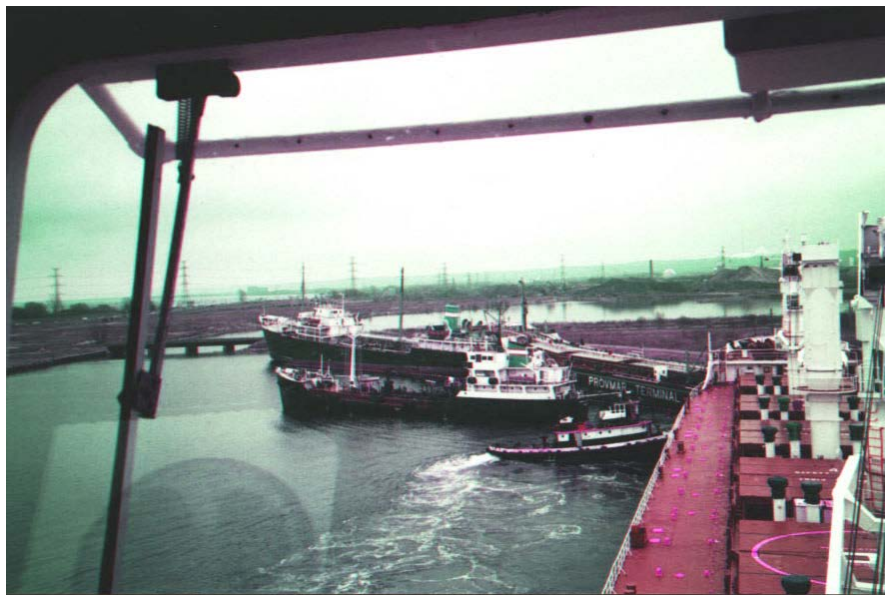
Appendix A – Photos

The *Hamilton Energy* sustained heavy damage. The skeg was displaced approximately 1.5 m and the propeller was damaged beyond further use. The rudder and pintle arrangement were significantly damaged and a thrust bearing became misaligned and distorted. The propeller shaft was driven inward, damaging the main engine block. The main engine installation was found to be a total loss. The steering gear flat and equipment sustained significant damage. The poop deck plating was deformed by 0.2 to 0.4 m in several locations. There was superstructure damage to the port and starboard side aft and the flag staff was bent over to at least 70 degrees from the vertical.

The *Provmar Terminal* also suffered heavy damage. Penetration by the bulbous bow of *Utviken* created a 4.0 m by 4.7 m opening into the engine room spaces below the waterline. The subsequent flooding damaged boilers, generators and other electrical equipment.

The *Utviken* suffered damage to the bulbous bow, which flooded the forepeak tank.
