MARINE INVESTIGATION REPORT  
M01C0063

PERSONS OVERBOARD

WATER JET BOAT *SAUTE MOUTONS 14*  
NIAGARA RIVER GORGE, ONTARIO  
02 SEPTEMBER 2001

Report Number M01C0063

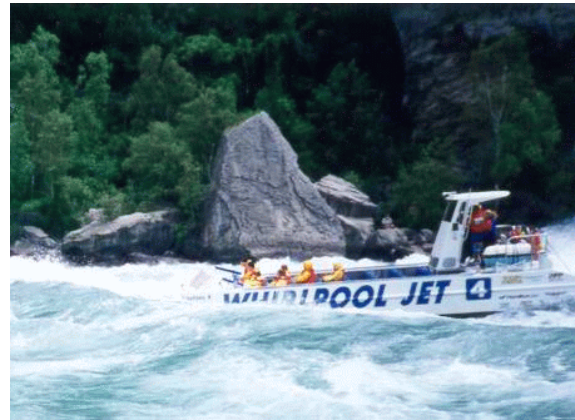
The water which accumulates in the passenger area can rise briefly to waist level before exiting through one-way water evacuation ports which are located aft, on the port and starboard sides. There are no other freeing ports. The steering and engine control station is located aft and is protected from spray by a partial enclosure with a windshield giving the operator clear visibility in all directions.

The excursion jet boat ride is advertised as a wet ride and the open passenger seating compartment is intermittently filled with water to waist level. While the water is evacuated relatively quickly through two one-way evacuation port openings at the after end of the passenger seating area, when so loaded with water, the vessel's draught increases. When moving ahead it is thus deeper in the water and tends to be less lively. The reduced freeboard also caused a large volume of water to flow over the port and starboard bows.

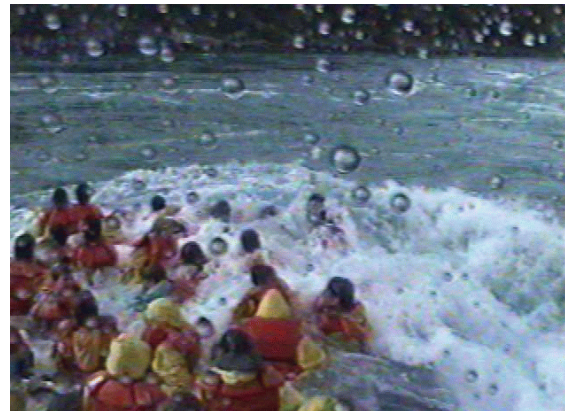
At approximately 1815, about three quarters of the distance through the rapids, the passenger area remained full with water and the vessel approached in quick succession, a large trough and subsequent wave. The vessel proceeded into the trough and wave with no let up in speed. The forward section of the vessel's windshield and the forward half of the passenger complement disappeared from view, after having passed through the wave. These passengers were completely submerged for approximately four to five seconds beyond the wave before the forward half of the vessel rose to the surface.

Immediately prior to the occurrence, the time between wave encounters did not allow the vessel to evacuate the water and re-acquire its normal operating draught. Thus, when the vessel bow dipped down into the next wave trough it did not rise with the next approaching wave but rather ploughed into it. The vessel continued to submerge its bow at a location beyond the wave as seen in the trip video replay. The availability of the high engine horsepower (1620 hp) applied to the water jets allowed the operator to continue to move the vessel, with the passenger compartment in a flooded condition. Power was not reduced until the forward section of the vessel had been driven underwater.

At the end of the 2001 season, Niagara Gorge Whirlpool Jet Boats Ltd. advised that the bailing ducts, which evacuate water from the passenger area, were expanded in size and re-designed. The previous design incorporated a 90 degree turn in the duct. The new design and larger construction will allow the same volume of water to be evacuated in a straight line direction aft and thus shed water faster from the passenger seating area. The weight of the water exiting in the reconstructed tubes helps to bring the bow up and drop the stern, further helping to trim the boat.
