MARINE INVESTIGATION REPORT

M01M0005

FIRE - STARBOARD ENGINE ROOM

THEBAUD SEA

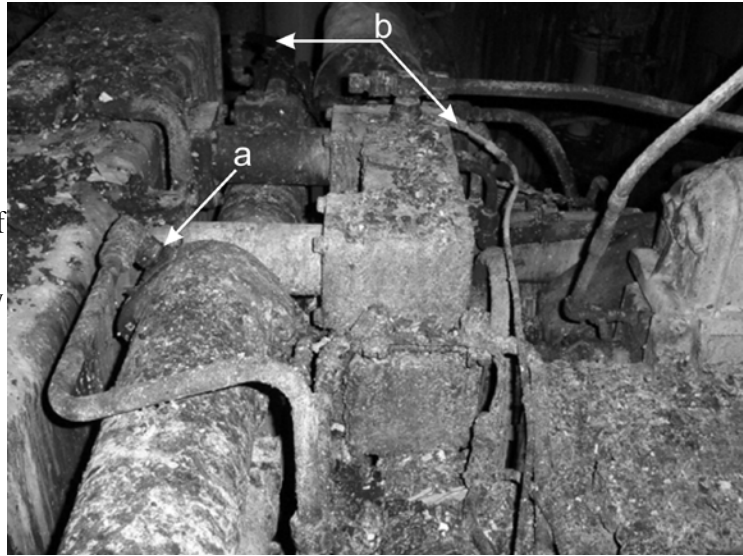
The No. 4 main generator was examined by the Transportation Safety Board of Canada (TSB) on the morning of 04 February 2001. The primary fuel oil filter housing runs the width of the generator and is located just forward of the generator and aft of the freshwater header tank. The secondary fuel oil filter housing runs half the breadth of the generator and is located directly above the primary fuel oil filter housing on the inboard side of the generator. The fuel oil selector cock was found to be in the "MAIN RUN" position, indicating the primary fuel oil filter was in use at the time of the occurrence. Directly aft of the primary and secondary fuel oil housings are the cylinder heads, a charge air after-cooler and the metal shielded exhaust manifolds. The two exhaust manifolds, with temperatures of about 1150° F (620° C), are within 60 cm of the failed fuel fitting/connection.

The area of the generator in way of the fuel oil filters, freshwater header tank and forward-most cylinder heads was charred and covered with a combination of soot and debris that had fallen through the overhead grating. An area of “clean burn” was noted directly overhead of the fuel filters in way of distorted sections of open steel grating. There are also indications in the form of oily soot that fuel oil had flowed down the front of the generator. Inspection of sooting, charring and shadowing patterns on the generator indicate that the seat of the fire was located aft of the fresh water header tank on the generator, and extended aft toward the exhaust manifold located between the cylinder banks.

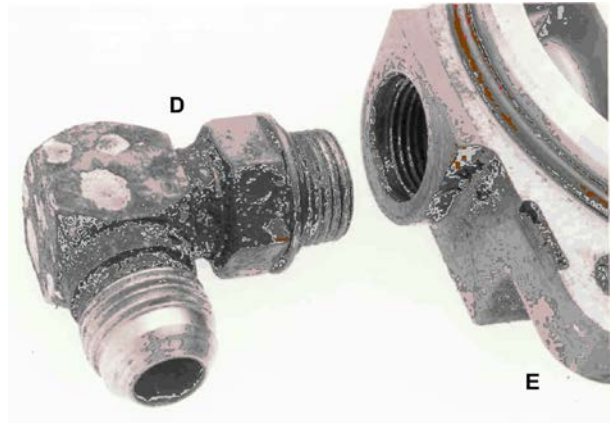
As part of the investigation, the failed fuel fitting/connection and the damaged flexible fuel hose were sent to the TSB Engineering Branch for evaluation. A thorough examination and analysis of the items were carried out and Engineering Report LP 16/2001 yielded the following conclusions.

- Separation of the 90° elbow connection resulted from extensive wear of the mating threads of the elbow and the internal threads of the fuel filter end bell fitting, probably initiated by a loss of torque or backing off of the jam nut assembly. The original looseness in the connection, provided by the combination of straight threads on the connector and slightly tapered threads in the end bell fitting, would have facilitated the relative motion of the threads driven by the normally imposed generator vibrations. Leakage past the degenerated threads of the connection would appear to have provided the source of fuel for the fire.

- The hoses used in the generator would appear to be of a satisfactory type and construction for use in pressurized fuel systems using marine fuel oil.
- The fuel hose, which was found separated after the fire, was believed to have failed well into the fire sequence.

The fuel oil pressure alarm switches were relocated to eliminate the requirement of running a pressurized fuel oil line in the vicinity of the exhaust manifold.

Splash guards were fitted to the fuel oil filters to redirect any potential fuel leaks to the bilge.

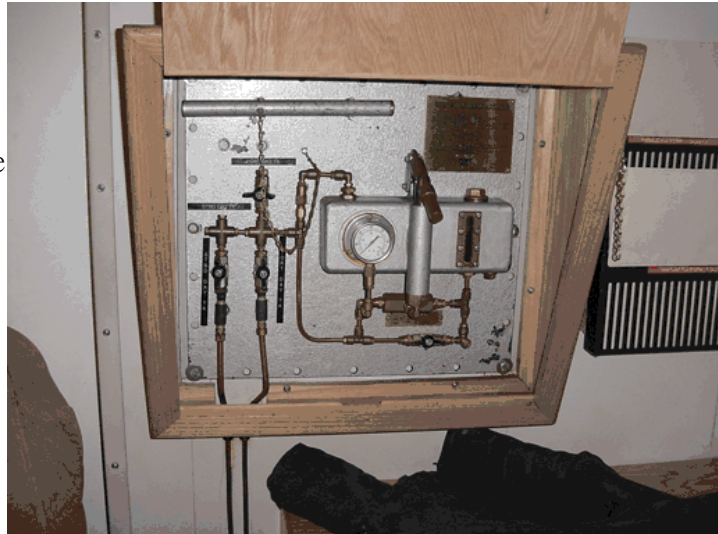
The vessel is equipped with a manually operated, hydraulically actuated quick-closing valve system. The actuating system is connected through tubing and a series of petcocks to quick-closing isolation valves in the port and starboard engine rooms. The quick-closing valves, connected to the port and starboard day tanks, are used to quickly isolate all fuel flow from the selected tank in the event of an emergency. To prevent inadvertent operation of the quick-closing valves, the petcocks are normally left in the open position. This prevents any pressure build up in the signal lines as a result of temperature rise, by allowing the oil in the lines to expand and bleed back to the small header tank.

To activate/close a valve, the appropriate petcock is left open and all remaining petcocks are closed. A small hydraulic hand pump is operated and produces pressure in the signal line, which activates a small piston mounted on top of the respective valve. This in turn trips/closes the valve. Once tripped, the only way to open the valve is to go to the valve and manually reset it.

Prior to re-establishing main and auxiliary power onboard the vessel, an inspection of the quick-closing fuel valves by the chief engineer revealed that valves to both engine rooms were in the tripped position. This resulted in fuel starvation for all machinery in the port and starboard engine rooms and the subsequent blackout. The blackout occurred at the time the starboard engine room fuel trip had been activated. This would suggest that accidental activation of the port engine room fuel trip occurred around this time and would account for the blackout.
