MARINE INVESTIGATION REPORT

M02W0102

CAPSIZING

SMALL FISHING VESSEL *FRITZI-ANN*
NEAR KELSEY BAY, BRITISH COLUMBIA

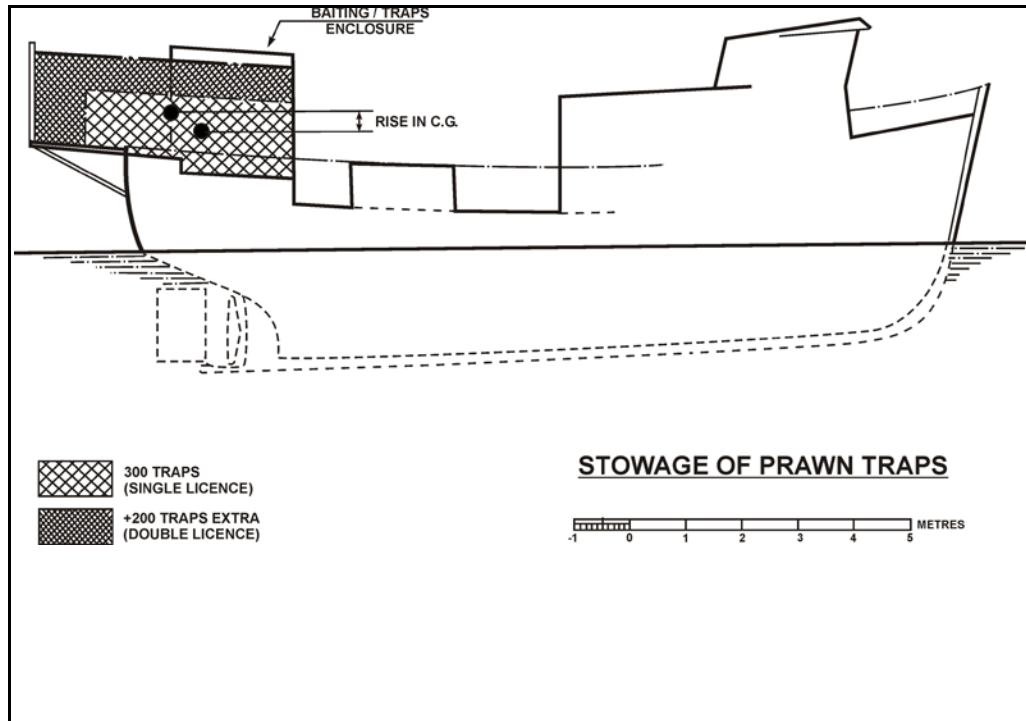
The RTL licence granted to the *Fritzi-Ann* led to practices that further adversely affected the vessel's transverse stability. The area of the deck and platform extensions available for the stowage of traps increased 20 per cent by adding the second extension, but the trap capacity increased in volume by 67 per cent. This resulted in the

Fritzi-Ann carrying 500 traps at an average height about 40 per cent greater than the 300 carried previously as a single licensed vessel (see Figure 1).

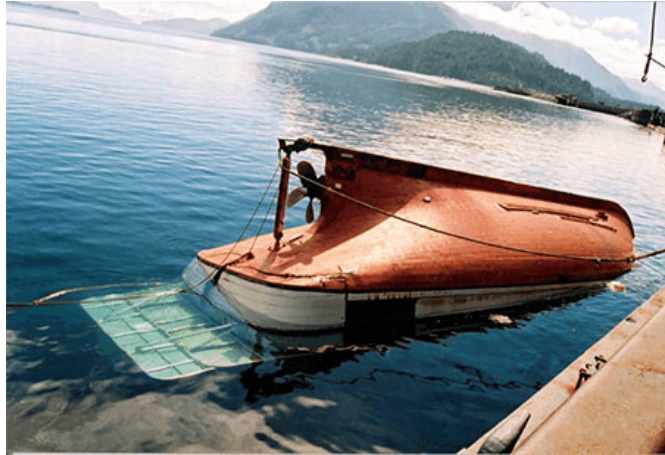
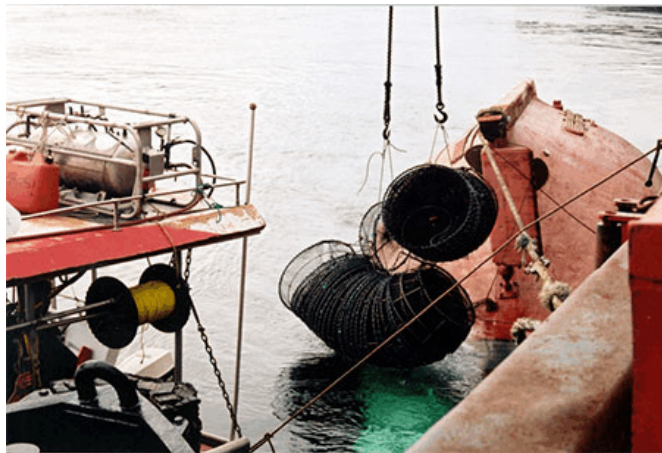
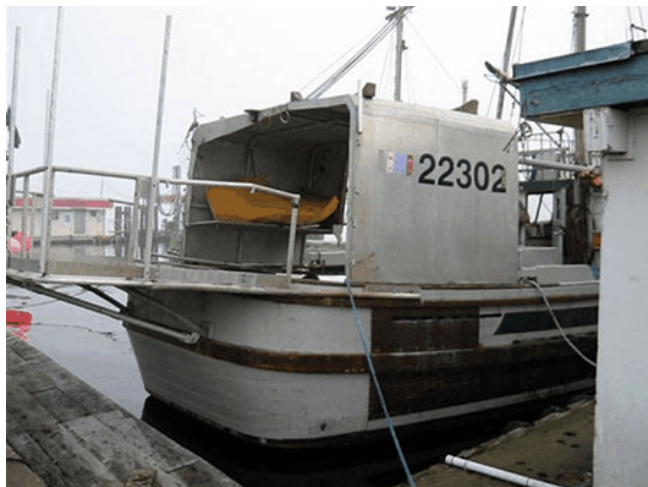
Appendix B – Photographs

When the radiotelephone failed to work, the skipper broke the wheelhouse window, re-entered and, using VHF channel 16, informed Comox Marine Communications and Traffic Services (MCTS) of their position and their situation. The skipper retrieved log books before escaping from the wheelhouse and rejoining the other crew members. All three donned their immersion suits and abandoned the vessel into the liferaft. Minutes later, the vessel capsized completely, floating in the overturned condition. (See Appendix B for photographs of the capsized *Fritzi-Ann*.)
