MARINE INVESTIGATION REPORT

M02W0135

SWITCHBOARD FIRE

PASSENGER VESSEL *STATENDAM*
STRAIT OF GEORGIA, BRITISH COLUMBIA
04 AUGUST 2002

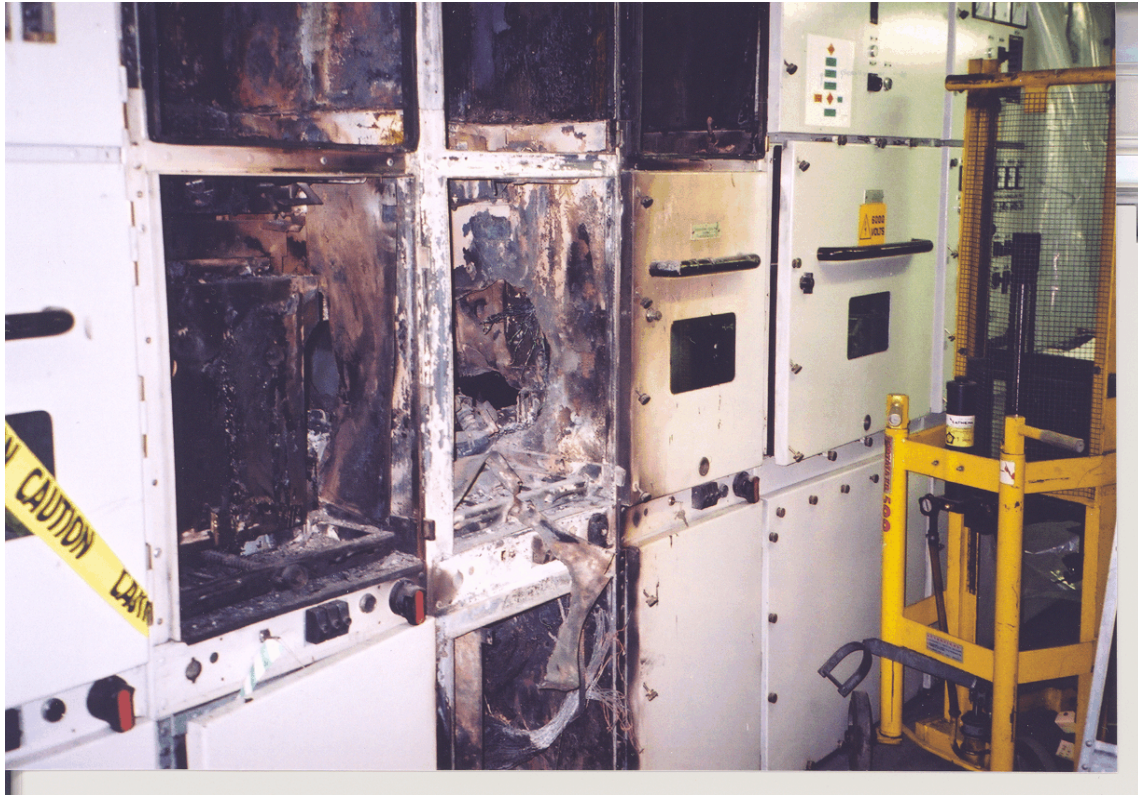
After DG 2 was restarted at 2025, its main circuit breaker failed with the violent release of a large amount of thermal energy. An electrical arc was generated, which seriously damaged circuit breakers, relays, and switchgear in the panels on either side, above, and below. The bus bars in the immediate vicinity were vaporized, and there was considerable damage to the high-tension and control cables. Radiant heat from the MSR was rapidly transmitted to the ECR through the MSR deckhead, where it ignited electrical cables located beneath the deck plates.

At 2025:57, approximately 35 seconds after the engine was restarted, the DG 2 circuit breaker failed catastrophically. The violent release of thermal energy associated with the failure vaporized many of its components and caused considerable collateral damage. Consequently, a forensic examination of the circuit breaker or its protection relays to determine the cause of the failure could not be done. Therefore, establishing a causation scenario is the result of eliminating the less likely scenarios and considering the data gathered from the event logger.

1. In all probability, a “dead short” within the diesel generator 2 circuit breaker generated an arc that shattered its epoxy-resin case. The resulting heat and flame, accompanied by the sudden release of pressurized sulphur hexachloride (SF6) gas, ignited the fire.
2. The lack of fire-retardant insulation between the main switchboard room (MSR) and the engine control room (ECR) allowed radiant heat to be rapidly transmitted to the ECR. This caused cables above the ECR deck to ignite and spread the fire.

Photo 1. View of DG 2 circuit breaker and relay consoles. DG 1 and bus-tie breaker consoles are on either side.

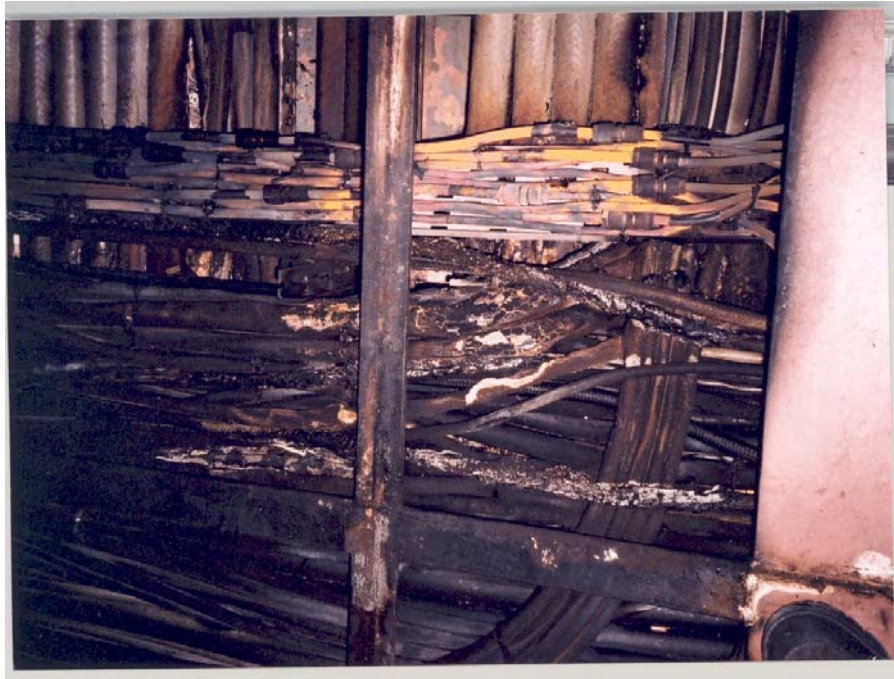
Photo 2 – View of Burned Cabling Above Deck of Engine Control Room. 52

Photo 2. View of burned cabling above deck of engine control room (note effect of heat on copper tubing)

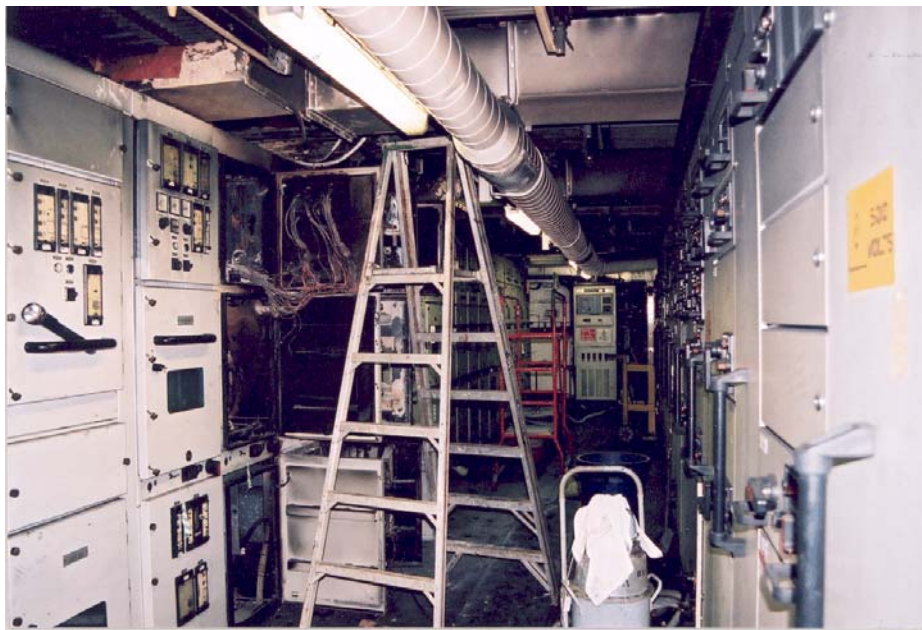
Photo 3. View of deckhead above main switchboard
