## MARINE INVESTIGATION REPORT

M03L0148

### GROUNDING

**BULK CARRIER *YONG KANG***  
**OFF SAINT-JEAN, ÎLE D'ORLÉANS, QUEBEC**  
**06 DECEMBER 2003**

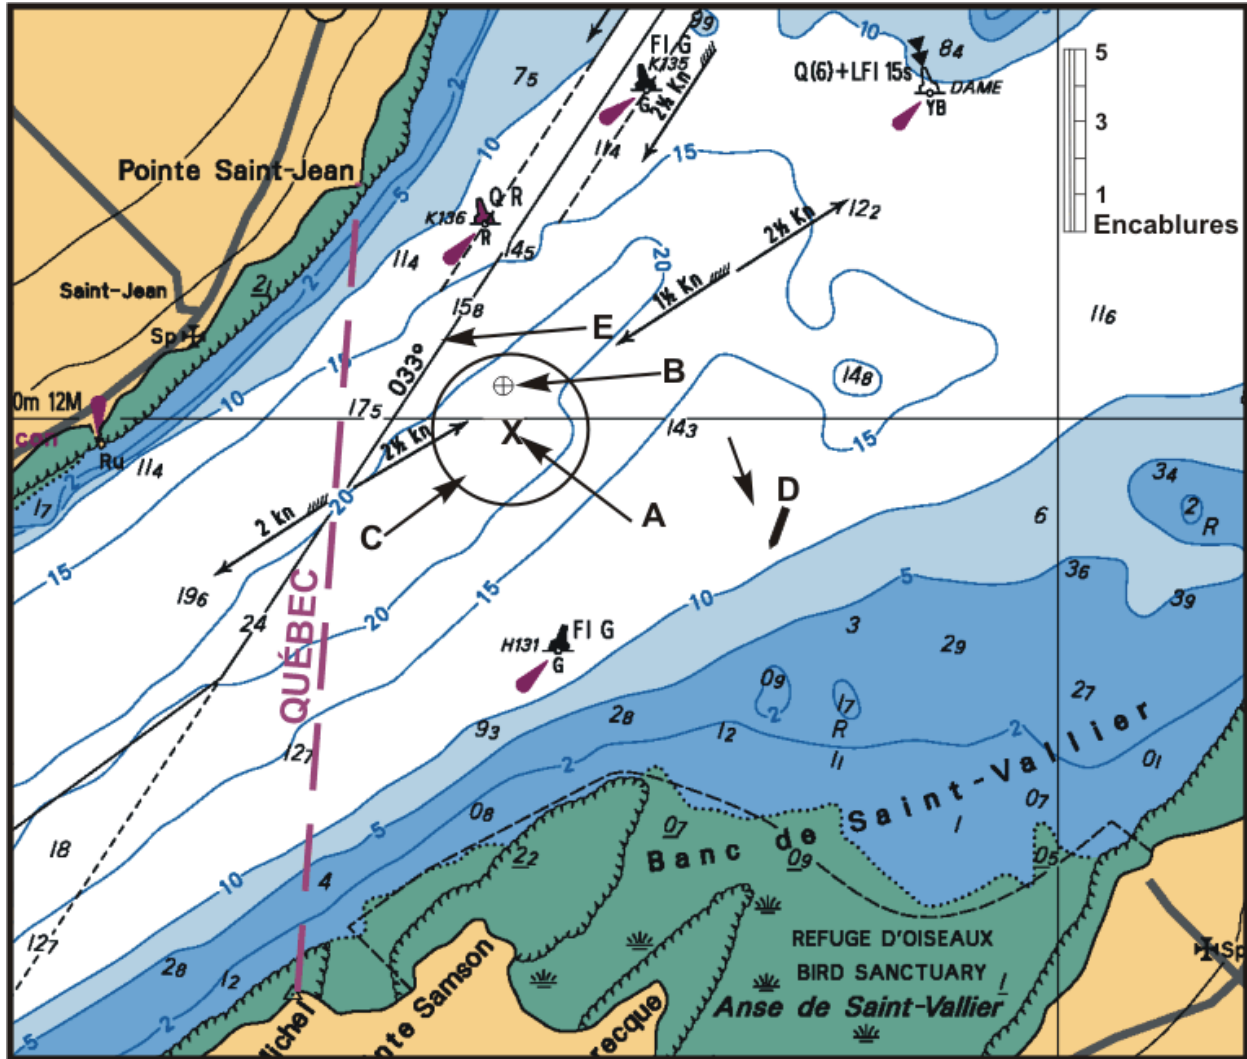
Figure 2. Saint-Jean anchorage

- A. Initial position of the *Yong Kang* anchor
- B. Position of the *Yong Kang* as reported by pilot in transit at about 2205 on 03 December 2003
- C. Swinging room around the anchor
- D. Position of the *Yong Kang* grounding on 06 December 2003
- E. Saint-Michel range

The "Saint-Jean anchorage" is not included in the Sailing Directions. It is found southeast of Pointe Saint-Jean, Île d'Orléans, where it provides a mud-bottom anchorage 10 to 24 m deep. Located at the upstream intersection of the Chenal du Sud and the Traverse du Nord, it is marked on the north by buoy K135 and on the south by buoy K131. Its western edge approximates the eastern end of the port of Québec. To the northeast is the south cardinal buoy DAME, which shows the start of the Île Madame Reef. The northwest edge of the anchorage is in proximity to the Saint-Michel range, which runs 033° - 213° (see Figure 2).
