MARINE INVESTIGATION REPORT

M04F0016

**OF PRIVATE DOCKS AND A PLEASURE CRAFT
BY TUG AND BARGE *EVANS McKEIL* AND *OCEAN HAULER*
ST. CLAIR RIVER, MICHIGAN, UNITED STATES
10 JULY 2004**

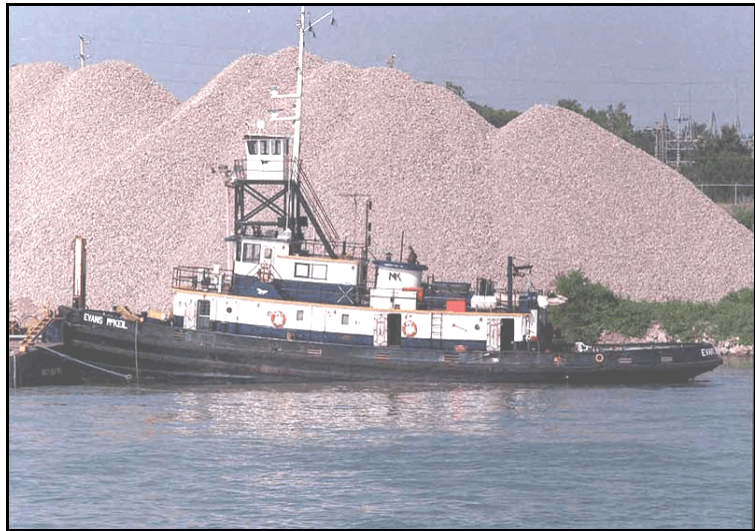
The *Evans McKeil* is a tug of steel construction and has two conning positions. An elevated “upper” wheelhouse is located on a vertical gantry above the main “lower” wheelhouse. Which wheelhouse is used depends upon whether the barge is carrying dry cargo on its open deck, or liquid cargo in its tanks. When the barge is in ballast or unladen, only the upper wheelhouse is used to provide the best line of sight (see photos 1 and 2).

Photo 1. Tug *Evans McKeil*

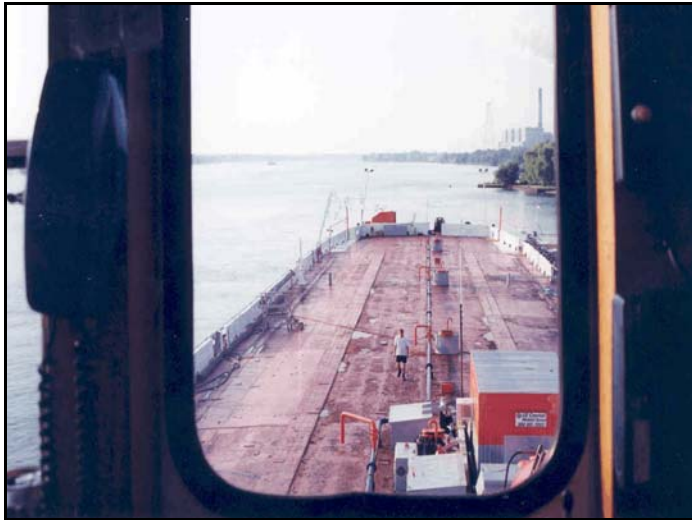
Although the upper wheelhouse can accommodate two persons, there is only room for one navigating officer at the forward wheelhouse windows, and it presents a challenge to correctly position a second person as lookout. However, a clear view can be had from an exterior catwalk around the perimeter of the wheelhouse platform.

Photo 2. View of barge from upper wheelhouse

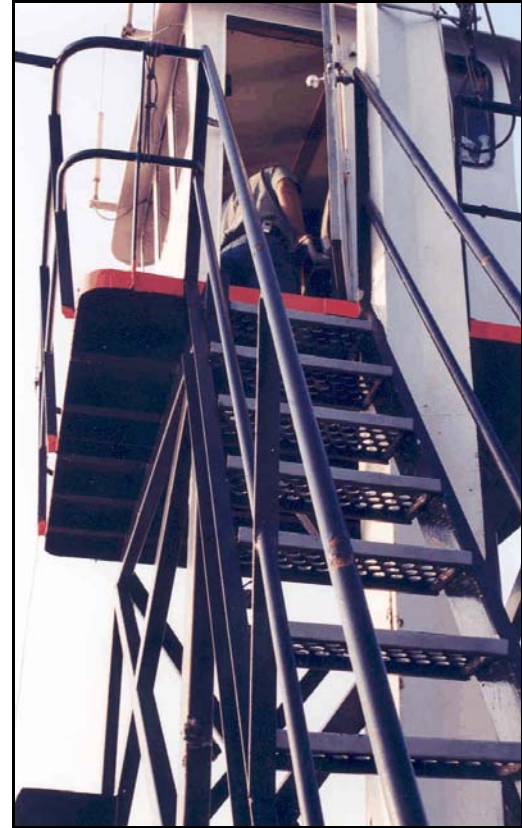
Photo 3. Stairway to upper wheelhouse

A person leaving the upper wheelhouse must go down 15 steps on the gantry stairway to the top of the lower wheelhouse (see Photo 3), descend a ladder to the bridge deck, then walk several metres toward the stern and climb down another deckhouse ladder to reach the main deck. The estimated time to accomplish this safely is approximately 1 minute 30 seconds. The master's cabin is located on the bridge deck immediately aft of the lower wheelhouse.

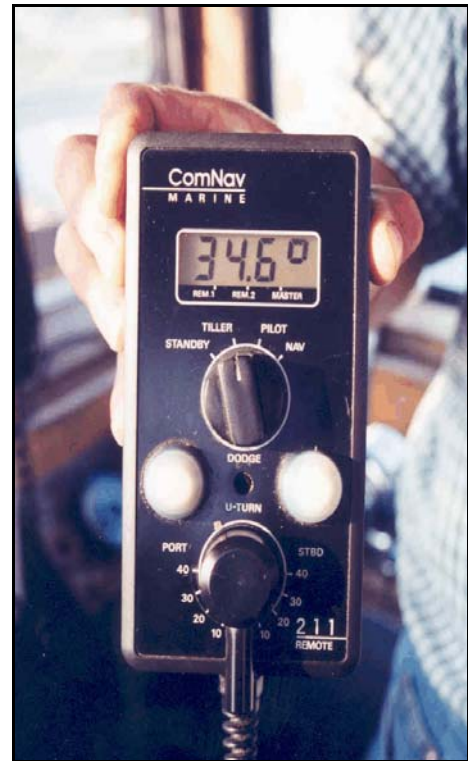
The remote steering controller has switch settings for four modes; "Standby," "Tiller," "Pilot," and "Nav," and above the switch is a small rectangular LED display that indicates the rudder angle/course change setting in degrees (see Photo 4).

Photo 4. Remote steering controller

When the first officer was returning to the upper wheelhouse, the tug-barge unit was heading on a converging course with the shoreline; between buoy G37 and the shoreline, which was approximately 25 m away. Upon arrival in the upper wheelhouse, he attempted to switch the remote steering controller to the "Tiller" setting to change the direction of the unit. Initially, the helm did not respond but, within seconds, the "Tiller" setting was properly engaged to bring the rudder hard over to starboard.

When the OOW inadvertently switched the autopilot to the incorrect mode, and then left the bridge, there was no one available to detect the error.

- The vessel shall be on hand steering (autopilot shall NOT be used) when navigating in rivers, canals or sheltered waters, areas of heavy traffic, poor visibility and during other hazardous navigational situations.

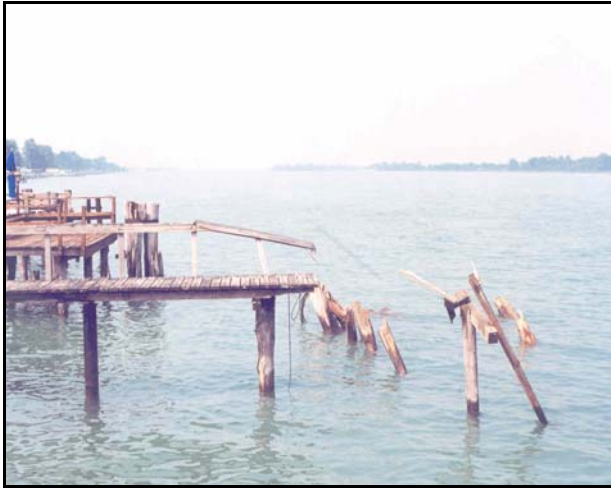
At 0337:20, the unit altered course to starboard to 359°T and the tugs's engine was put to "full astern" as the barge struck some private mooring docks and severely damaged a 10 m pleasure craft (see photos 5 and 6). The unit continued on through shallowing water.

Photo 5. A damaged private dock

Both tug and barge remained undamaged. However, six privately owned mooring docks were damaged and one pleasure craft was rendered a constructive total loss.

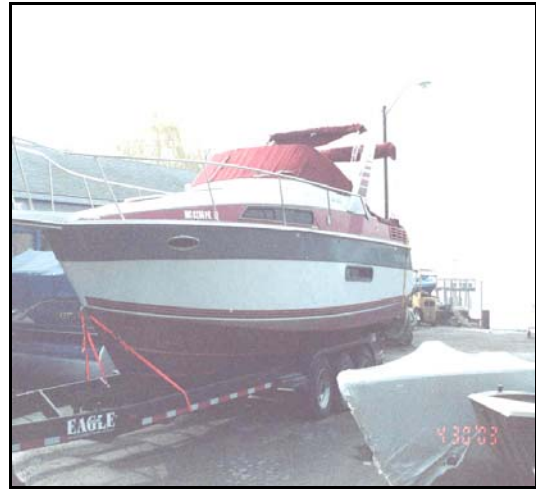
Photo 6. Pleasure craft before damage

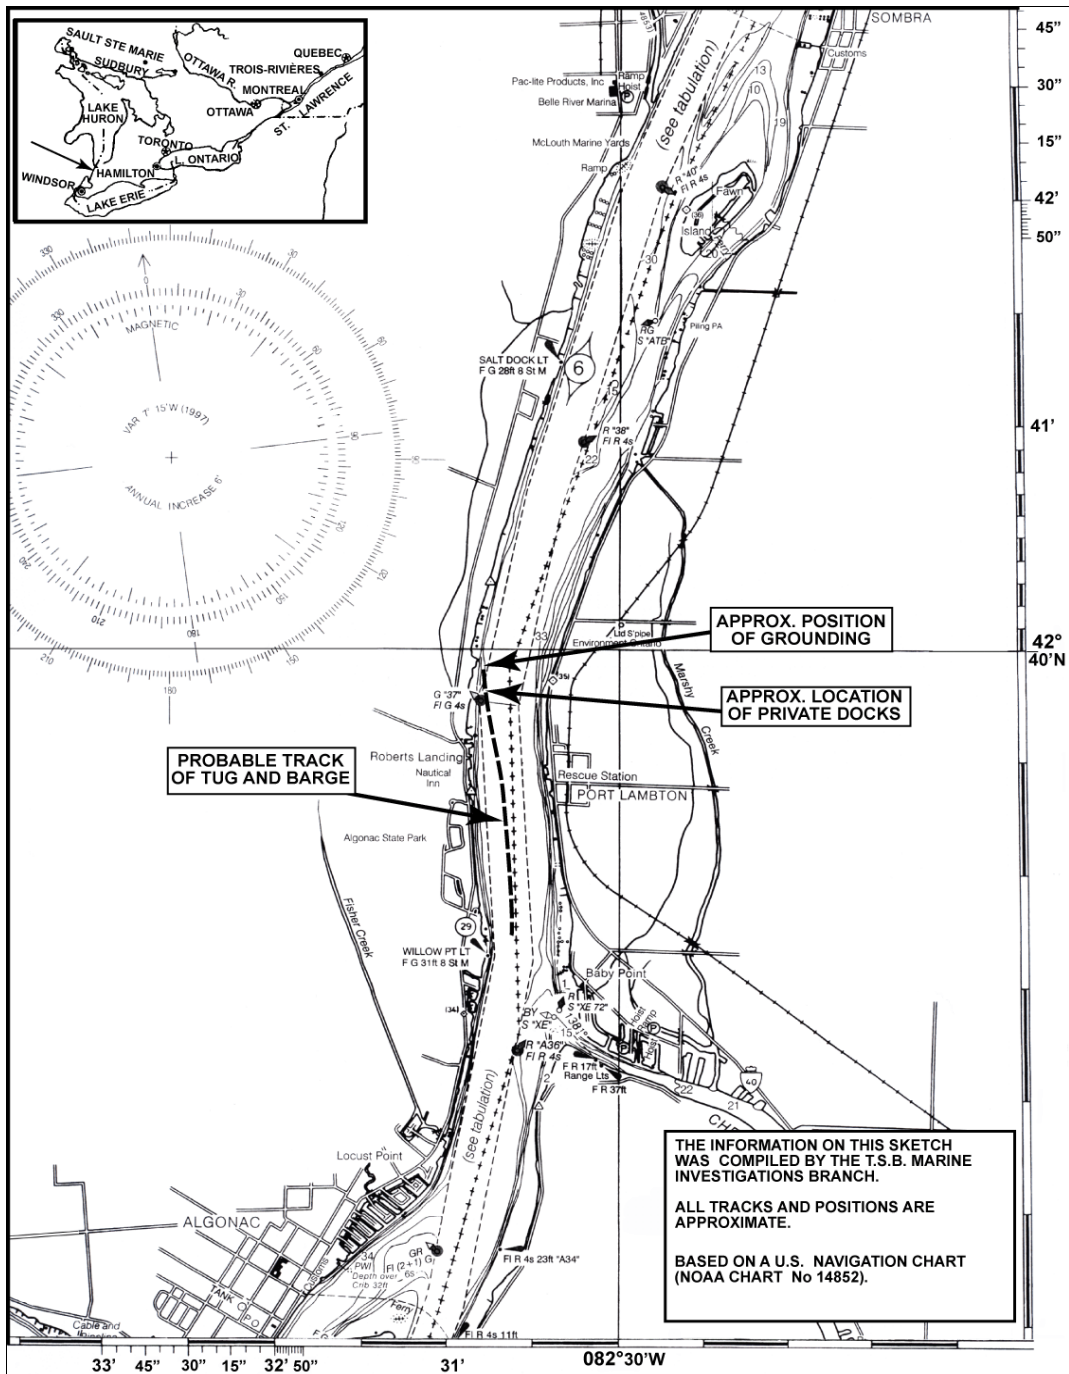
Appendix A – Sketch of the Occurrence Area

At 0340, the tug ran aground due to its draught being almost twice that of the barge but remained connected to the floating barge. The grounding occurred at position 42°39'50" N and 082°30'51" W, some 30 m north of light buoy G37 in the lower St. Clair River (see Appendix A).
