**MARINE INVESTIGATION REPORT**  
**M04M0002**

**SINKING AND LOSS OF LIFE**

**SMALL FISHING VESSEL *LO-DA-KASH***  
**SAND COVE, NEW BRUNSWICK**  
**23 JANUARY 2004**

Report Number M04M0002

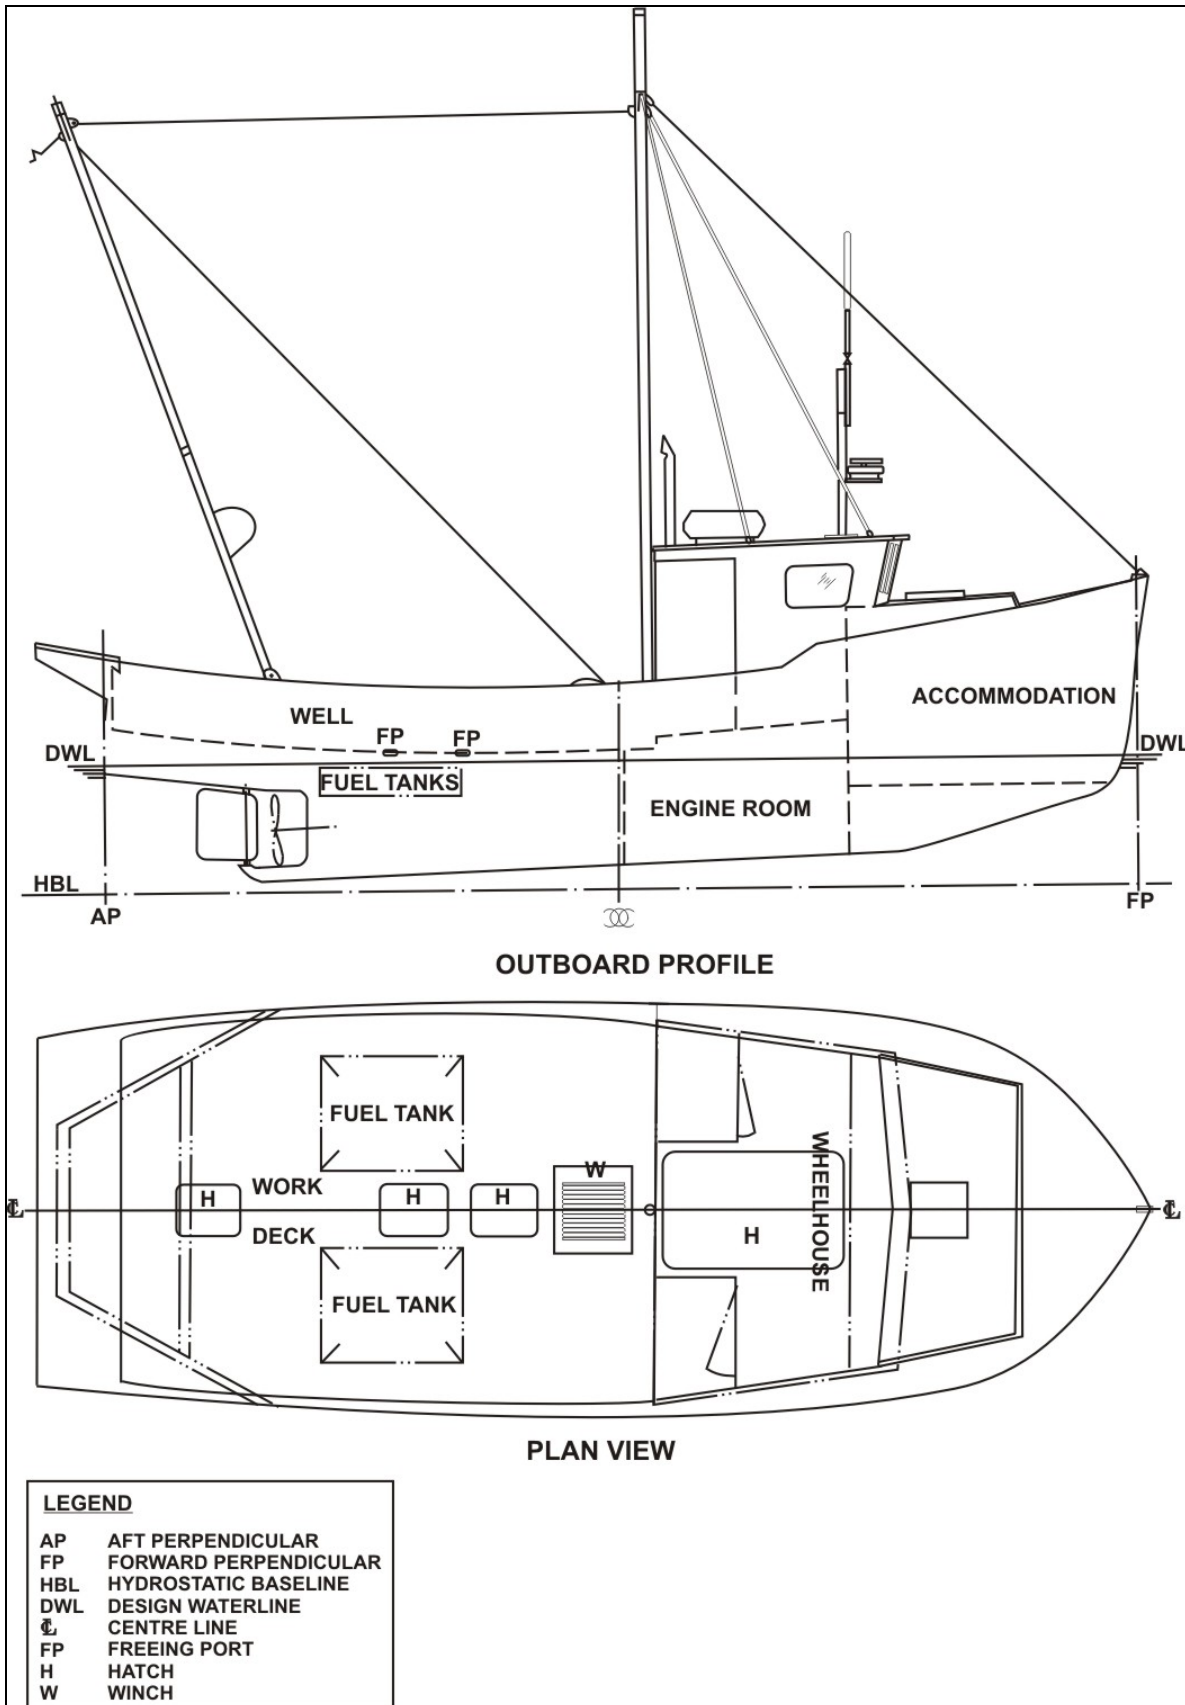
Figure 1. Outline arrangement

The *Lo-Da-Kash* was a small fishing vessel of the Cape Island design, constructed of moulded, glass-reinforced plastic, with the wheelhouse and accommodation forward, the engine room beneath the wheelhouse, and the work deck aft. Access to the wheelhouse was through a hinged door on the starboard side. Access to the engine room was through a large hatch cover located in the wheelhouse. No watertight bulkhead was fitted below deck (see Figure 1).

The work deck had three flush hatches, capable of being secured watertight by four screws, located along the centreline and providing access to the below-deck space in way of the steering gear, the fuel oil tanks, and a bilge pump. Two freeing ports of about 150 mm by 50 mm each were located in the bulwark at the level of the deck on each side, and the vessel had a low freeboard.

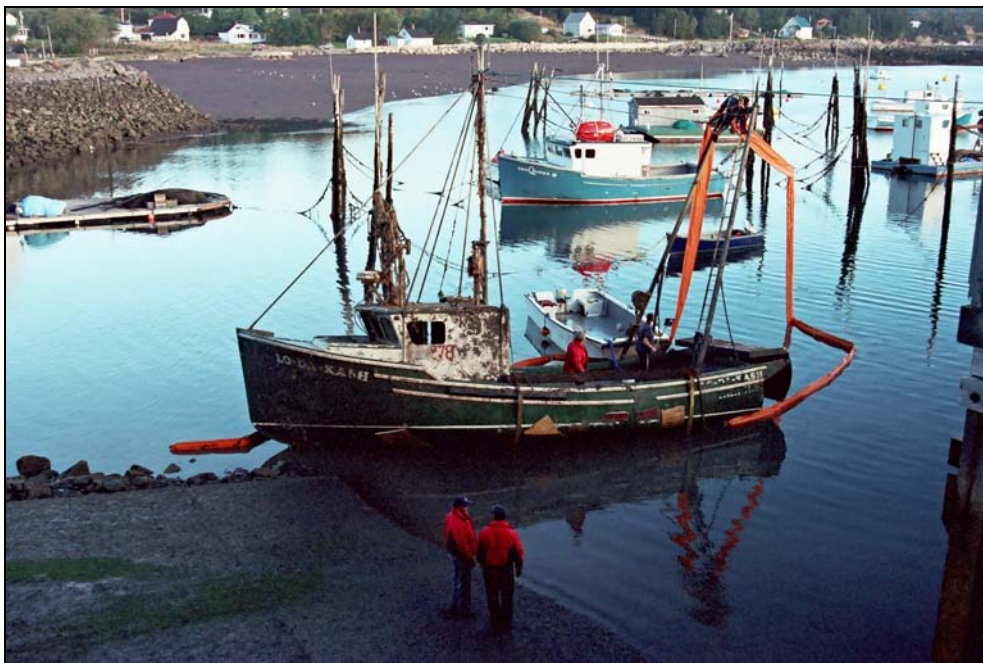
**Photo 1.** *Lo-Da-Kash* post-recovery

On September 27, the *Lo-Da-Kash* was raised and towed to Beaver Harbour, New Brunswick. The vessel was beached and temporary patches were placed over three holes found in the hull. After the vessel was afloat, an inclining experiment was carried out to assess its stability.

- the three holes on the port side were consistent with holes that would occur after prolonged contact and chaffing against rocks on the sea floor;
- the access covers for the hatches on the work deck were not in place;
- the last few wraps of the cable on the deck winch were deeply embedded in the remaining cable;
- when stretched out, the end of the cable from the deck winch reached the top block on the A-frame;

- the cable winch was found with the clutch engaged;
- the spare urchin drag was still made fast to the boat;
- both VHF radios were turned on;
- the vessel's anchor was hooked into the spare trawl with no anchor line attached;
- the engine controls were in the slow astern position, and the ignition key was set in the ON position; and
- a post-recovery disassembly of the engine and gearbox revealed no anomalies.

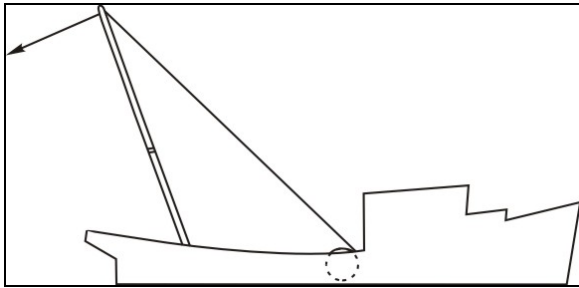
**Figure 2.** Vessel towing without chain

Operators of urchin dragging boats typically deploy the drag over the stern, with the cable running through the top block (see Figure 2 and Figure 3). Prior to the drag being towed along the bottom, the cable is brought down from the block to a level closer to the transom of the vessel to reduce the heeling moment. On the *Lo-Da-Kash*, this is achieved by attaching a chain to a strong point on the vessel's deck with a snatch block at the end. The snatch block is then attached to the towing cable while leading vertically down from the top block on the A-frame.

When the vessel begins to drag, the stress comes on the snatch block. In this instance, the chain arrangement had not been installed the evening before the *Lo-Da-Kash* departed for Campobello.
