MARINE INVESTIGATION REPORT

M05W0141

CAPSIZING AND SINKING WITH LOSS OF LIFE

FISHING VESSEL *OCEAN TOR*

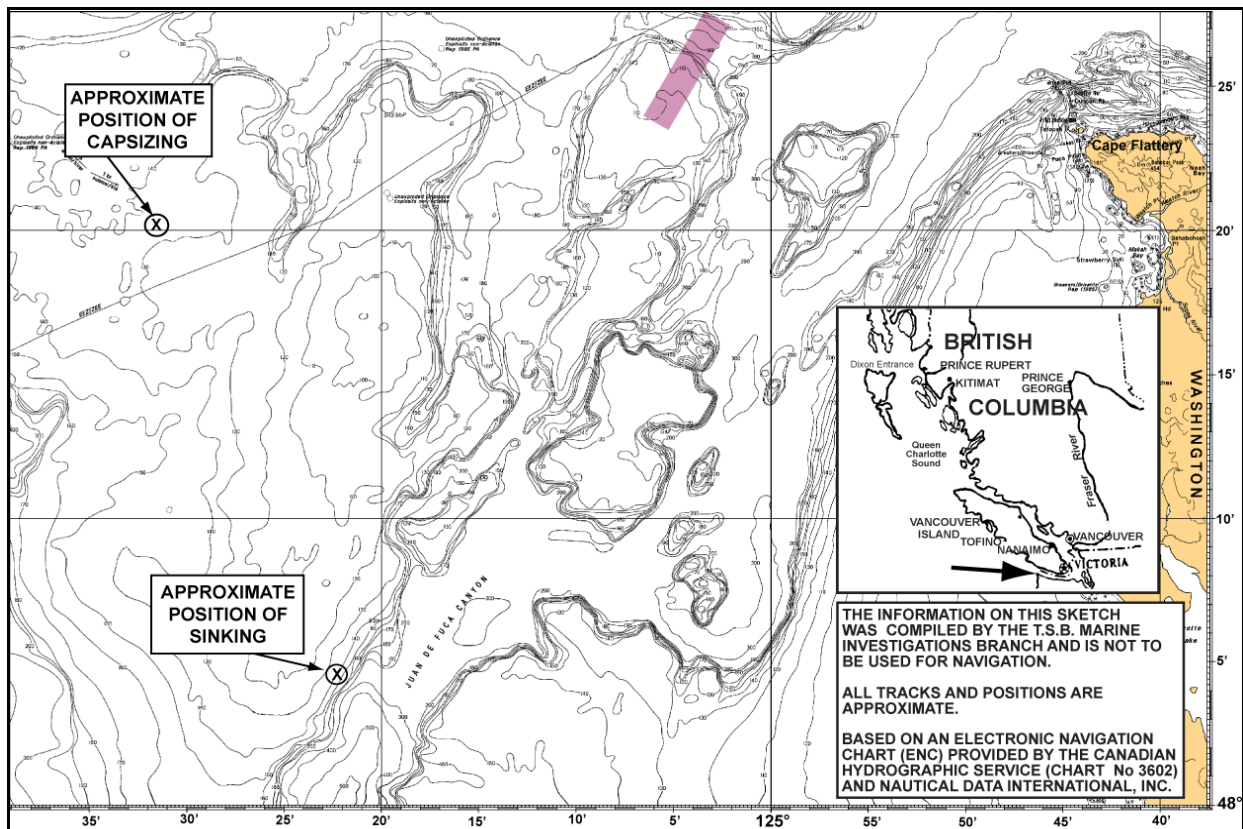
Before the skipper reached the wheelhouse, the vessel began listing to port, sinking further by the stern. It shortly began downflooding through the open engine-room door, vents, and other deck openings, until the *Ocean Tor* lay over on its port beam ends at about 1700 and subsequently capsized in position 48°20.2' N, 125°31.6' W (see Figure 1).
