MARINE INVESTIGATION REPORT
M09L0068

CAPSIZING

RESCUE BOAT 1815
OFF SAINTE-THERÈSE ISLAND
MONTRÉAL, QUEBEC
01 MAY 2009

Report Number M09L0068

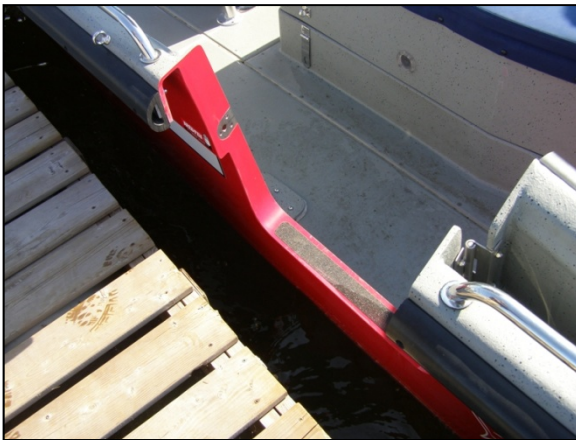
The door was cut into the hull side, is generally rectangular in shape and has the following approximate dimensions: 630 mm wide (at top), 605 mm wide (at bottom) and 580 mm high.¹⁴ The door is hinged aft, opens inward and, when closed, locks in place via a single deadbolt locking mechanism on the forward side of the door.

Photo 2. Side door opened inward

The TSB conducted a post-occurrence watertightness test,²² pursuant to ISO 12216, on the door of one of the RFV-22 HammerHeads owned by the fire department. The door failed to meet the requirement for watertightness degree 2 by a significant margin.

The manufacturer of the RFV HammerHead notified operators not to use the door in their vessels until the TSB investigation is complete and the causes of the capsizes are known.

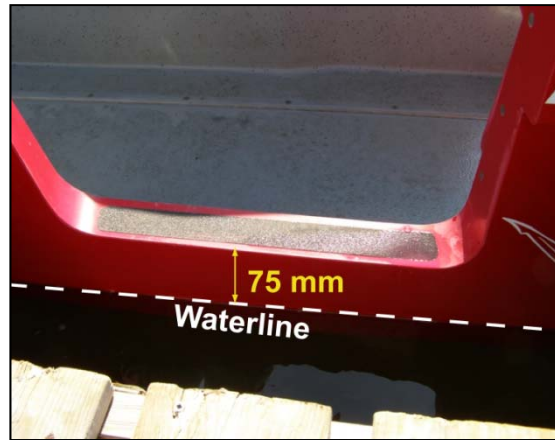
Photo 3. Door sill (four persons aboard)

In a lightly loaded condition, the door sill on rescue boat 1855 (sister vessel of rescue boat 1815) was 135 mm above the waterline. With four firefighters aboard (total mass = 385 kg), simulating as closely as possible the conditions at the time of the occurrence, the door sill was approximately 75 mm above the waterline.

3. The height of the door sill above the waterline was insufficient to prevent significant water ingress when the door was opened.
4. The distribution of the weight of the firefighters on board, the free-surface effect of water in the cockpit and possibly the wind acting on the hard top as the vessel listed to port caused the vessel to capsize rapidly.
