## MARINE INVESTIGATION REPORT

M09N0031

### TAKING ON WATER AND SINKING

**SMALL FISHING VESSEL *SEA GYPSY ENTERPRISES***

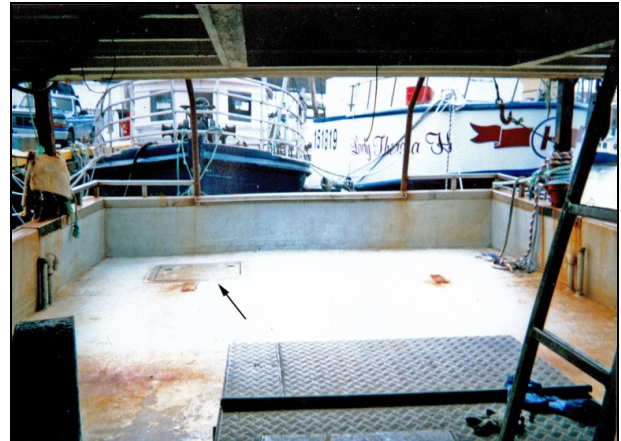
**Photo 2.** Access hatch to lazarette.

At about the same time, it was noted that the hatch cover for the lazarette, which had not been secured, had become dislodged and was lying diagonally across the opening. It was also noted that the lazarette was completely flooded.<sup>7</sup> Two crewmembers put the hatch cover in place but were unable to secure it using the dogs. Instead, they kept it in place by standing on the cover. Meanwhile, the bilge pump for the lazarette was started. No water was noticed leaking into the engine room from the propeller shaft packing gland in way of the engine room aft bulkhead.

In this occurrence, the lazarette's hatch cover was in position but unsecured, held in place merely by its own weight. It was therefore not watertight and, as the vessel shipped seas, water would have downflooded into the lazarette. Calculations show that this water would have added approximately 13 tonnes of weight to the stern, reducing the vessel's freeboard by some 68 cm.

1. The unsecured hatch cover permitted downflooding into the lazarette, thereby increasing the vessel's after draft.
2. Without the benefit of an alarm or some other means to detect water ingress, the crew did not detect the flooding until it was too late.
3. Additional water likely entered the steering gear compartment, possibly through the rudder stock packing gland.

The issue of unsecured hatch covers has been addressed previously. In April 1998, TC issued Ship Safety Bulletin (SSB) 06/1998, *Responsibilities of Shipowners and Masters Respecting Maintenance of Weathertight Integrity of their Vessels*, reminding masters to ensure that hatch covers are closed at sea when necessary, and to make certain that openings to compartments within the hull are maintained closed except when in use.
