MARINE INVESTIGATION REPORT

M12W0062

CAPSIZING AND SINKING

SMALL FISHING VESSEL *PACIFIC SIREN*
OFF BANKS ISLAND, HECATE STRAIT, BRITISH COLUMBIA
09 MAY 2012

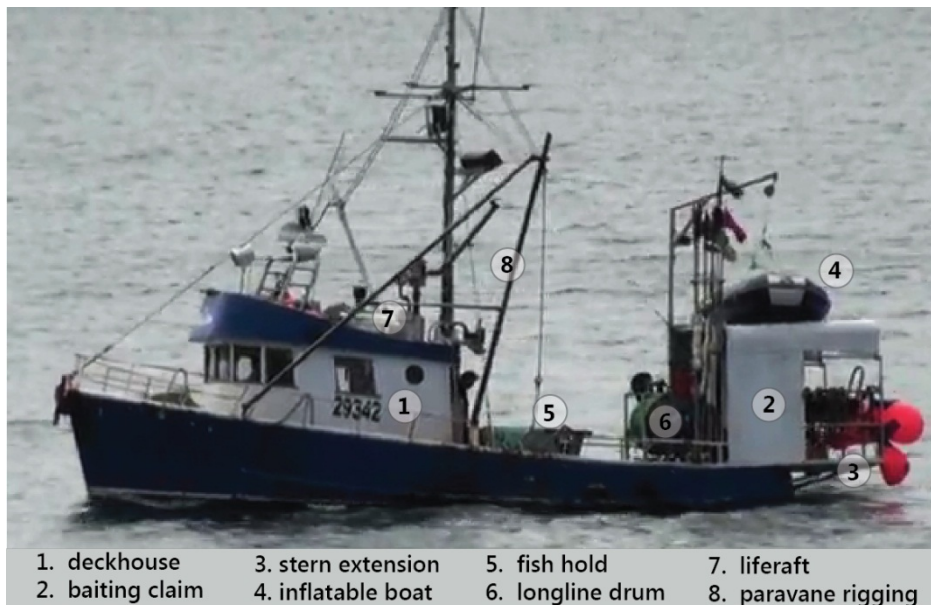
The *Pacific Siren* was a small carvel-built fishing vessel of closed construction with a rounded bilge and steel hull (Photo 1). It was constructed in 1984 as a trawler/troller and was modified to a longline/trap vessel in 2007. The main deck was surrounded by solid bulwark and railings. A fibreglass-over-plywood deckhouse contained the galley, dinette, and helm station and was located forward of amidships on the main deck. The deckhouse was accessible through a door on the starboard side of the main deck.

Photo 1. The *Pacific Siren's* general arrangement.
