Transportation Safety Board
of Canada

MARINE INVESTIGATION REPORT
M12L0147

GROUNDING

BULK CARRIER *TUNDRA*
SAINTE-ANNE-DE-SOREL, QUEBEC
28 NOVEMBER 2012

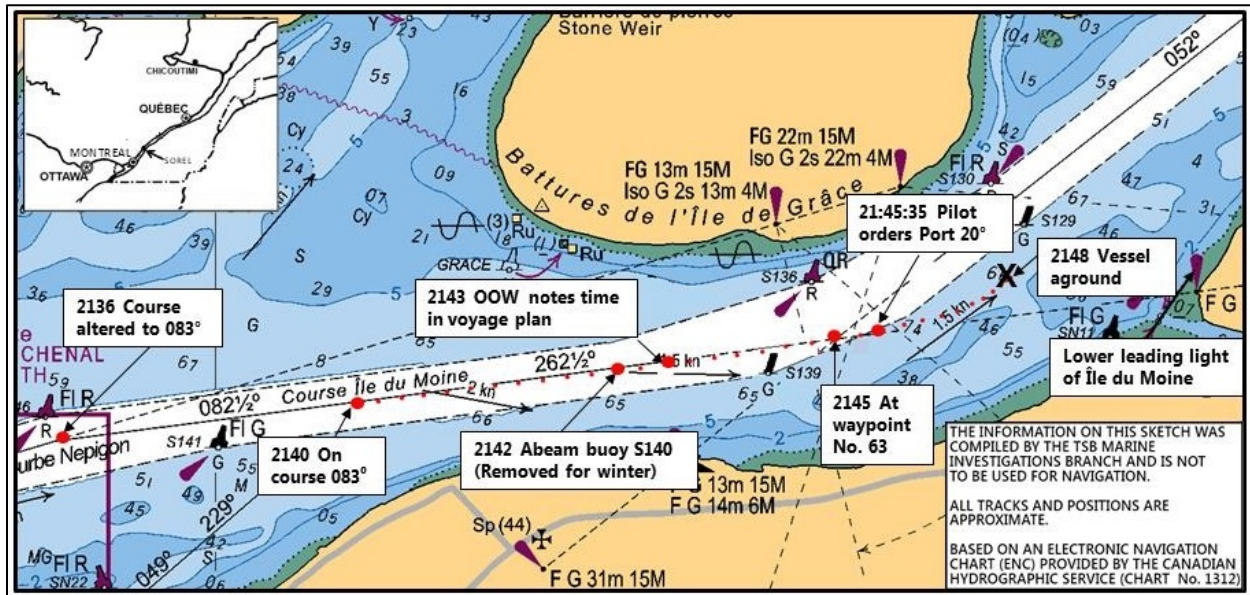
The next course was 052°T,⁸ and the pilot's passage plan included an intermediate course of 060°T that was to be initiated when buoy S-140⁹ was abaft of the vessel (Figure 1). However, buoy S-140 had been removed 7 days earlier as part of normal CCG operations, and the next lateral buoy on the port side was S-136.¹⁰ The vessel's passage plan did not include the intermediate course; it indicated the next course change (waypoint No. 63) as being 0.44 nm downriver of buoy S-140's announced position,¹¹ at the intersection of courses 083°T and 052°T (Figure 1).

Figure 1. *Tundra's* track leading up to grounding. The chart reflects the location and type of buoys in place at the time of occurrence.

At 2142, the vessel passed abeam of buoy S-140's announced position and continued on course 083°T (Figure 1). No additional helm orders were issued by the pilot, who remained seated on the port side of the bridge. At 2143, 2 minutes before the vessel reached waypoint No. 63, the OOW logged the time and date in the list of pre-established waypoints on the vessel's passage plan. At 2144:54,¹² the vessel passed waypoint No. 63, at which point it became more difficult for the helmsman to maintain the course of 083°T due to bank effect¹³ as the vessel began to exit the navigation channel.

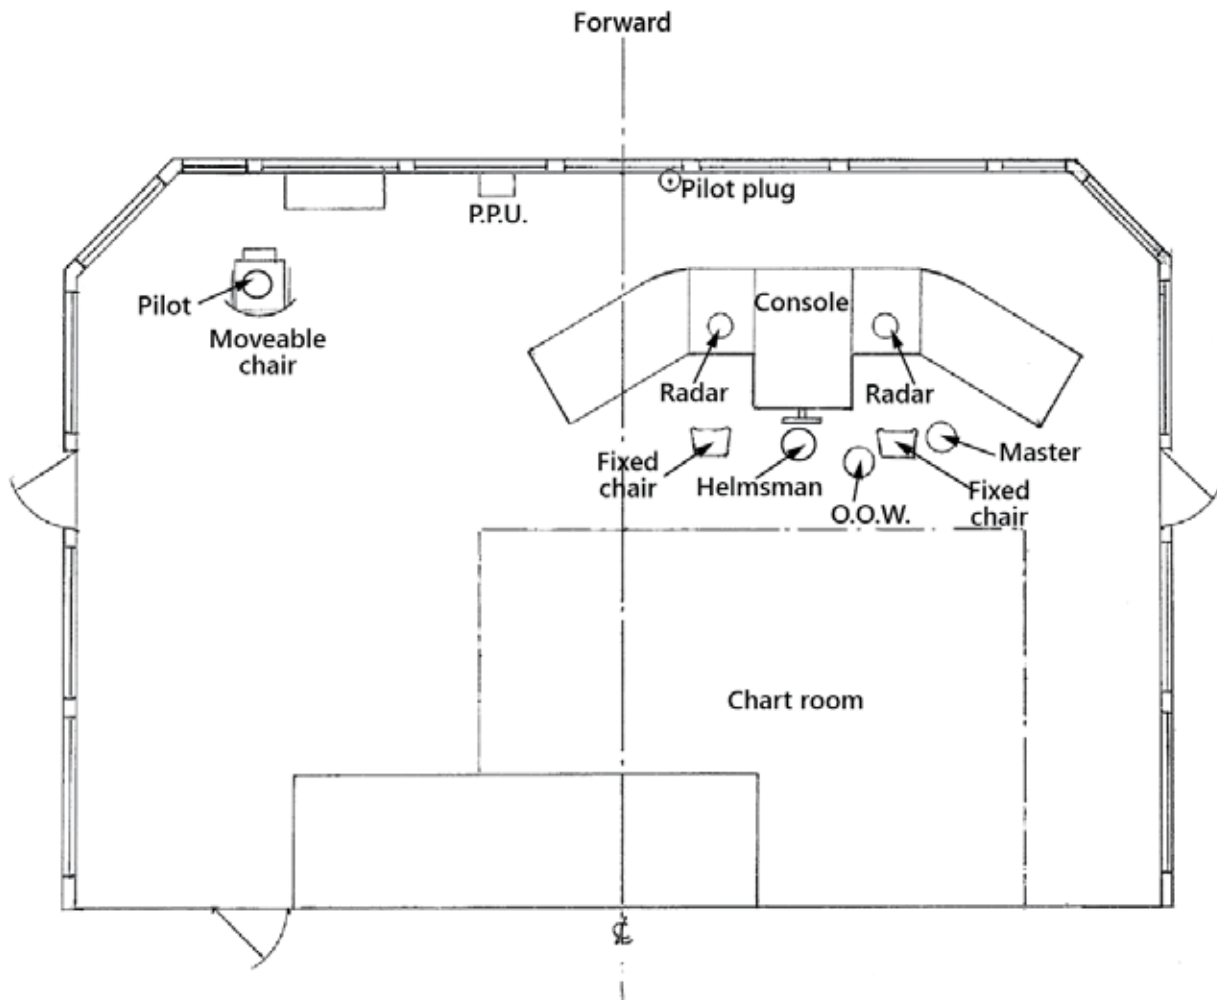
Appendix A – Bridge layout on the Tundra

The bridge console is located slightly starboard of the vessel's centreline and consists of a conning position, engine controls, and 2 fixed chairs (Appendix A). The navigation chart table and Global Maritime Distress Safety System station are located aft of the bridge console. The bridge is equipped with the required navigational equipment, including 3 cm and 10 cm radars located in front of both the port and starboard fixed chairs.
